HIR-26-03

School Bus Roadway Departure and Overturn

Millstone, West Virginia
March 4, 2024

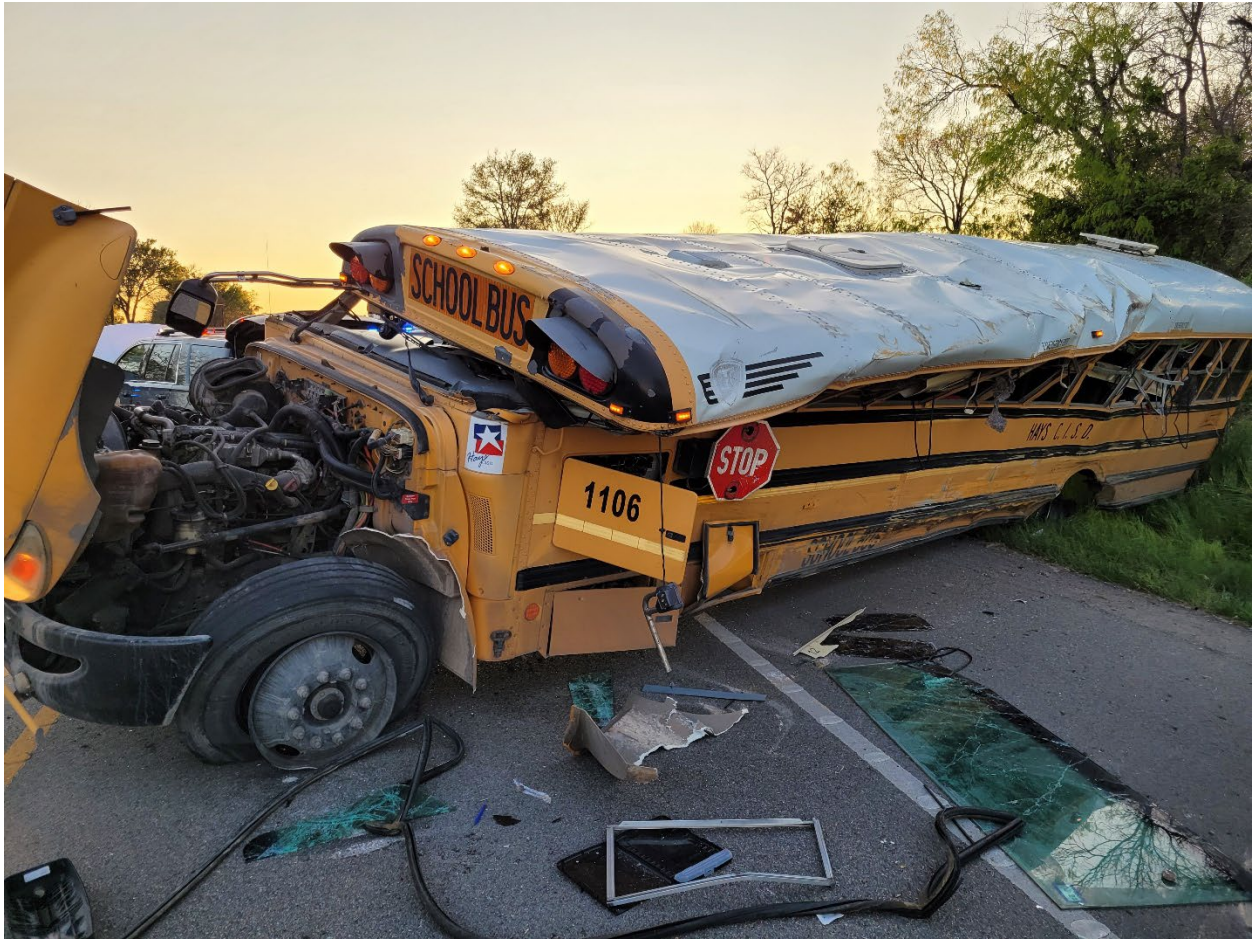
The bus, which was substantially damaged by the impact and rollover (see figure 6), was equipped with a lap/shoulder belt for the driver but was not equipped with passenger lap or lap/shoulder belts.²⁹ Video footage from the school bus's cameras showed that as the truck hit the bus on the left side, near the middle, the unbelted passengers were thrown to the left side of the bus; some passengers were thrown from their seating compartments.³⁰ As the bus rolled to the right, passengers were thrown back to the right side of the bus. As the rollover continued, passengers were ejected from their seating compartments and struck the roof and then the floor.³¹ According to the Texas Department of Public Safety crash report, one student who was partially ejected out of a left-side window sustained non-incapacitating injuries. Other occupants came to rest on top of each other.

Figure 6. Postcrash photograph of the school bus involved in the Dale, Texas, crash. (Source: Texas Department of Public Safety)
