PRELIMINARY REPORT

HIGHWAY

HWY20FH006

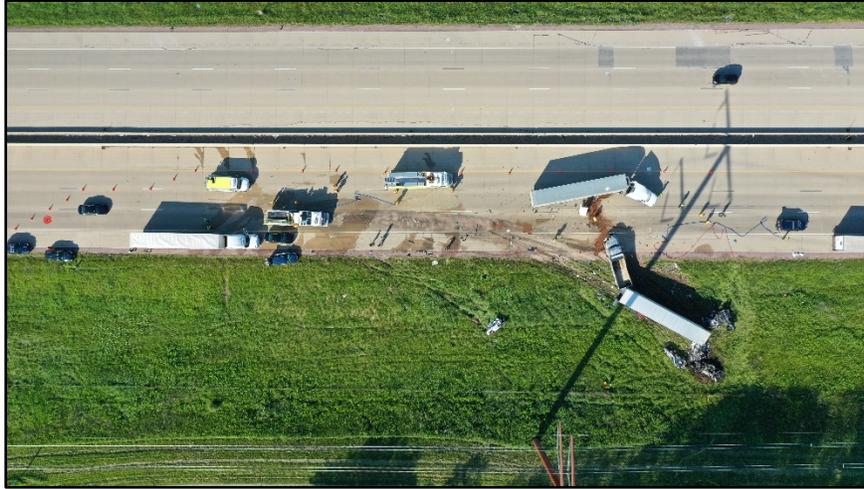
Figure 1. Aerial view of crash scene. (Source: Wisconsin State Patrol)

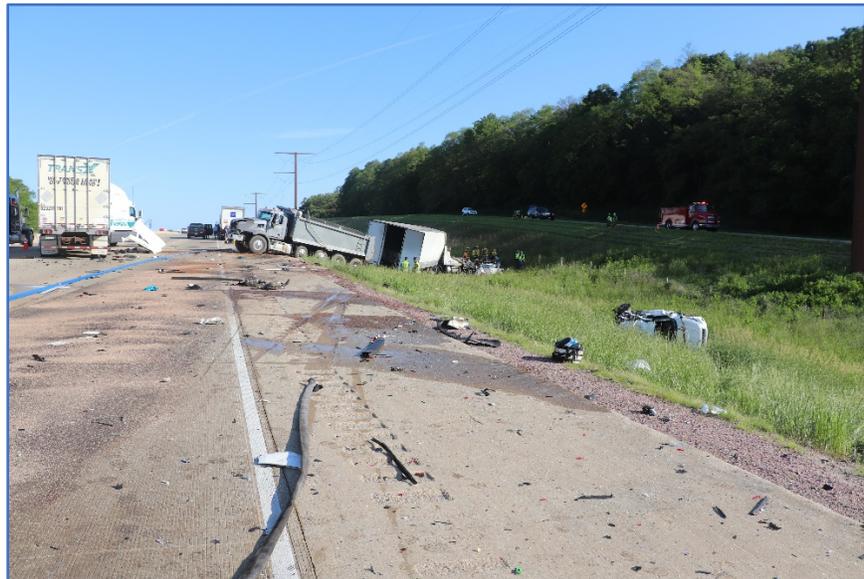
Figure 2. Final rest of (left) 2020 Peterbilt truck-tractor in combination with 2014 Utility semitrailer; (center) 2018 Mack dump truck, 2013 Freightliner truck-tractor in combination with 2017 Utility semitrailer, and 2006 Volkswagen; and (right) 2021 Kia. (Source: Wisconsin State Patrol)
