PRELIMINARY REPORT

HIGHWAY

HWY20FH007

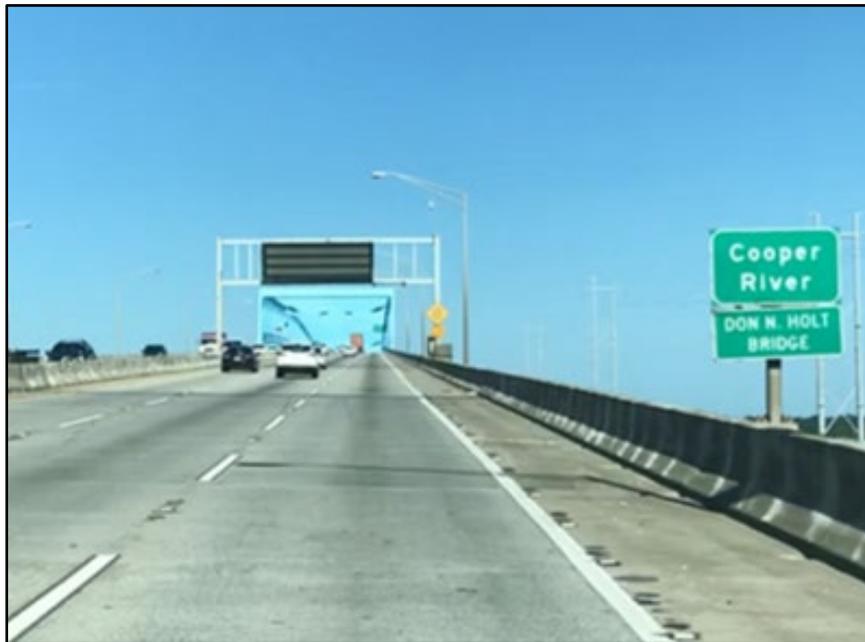
Figure 1. Westbound view on I-526 approaching crash location.

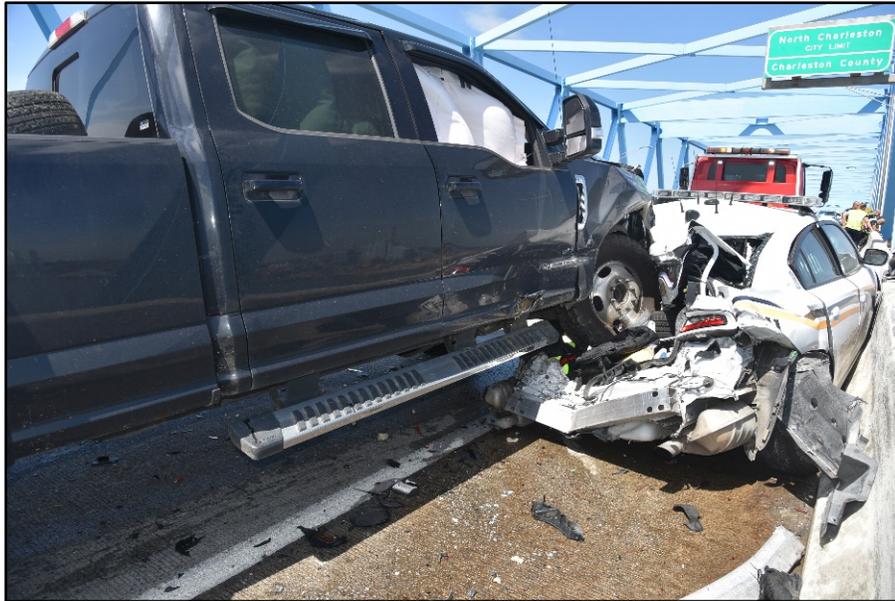
At 9:50 a.m., a 2018 Ford F350 pickup truck with an attached unladen trailer was traveling west in the right lane of I-526, approaching the blocked lanes. The truck, which was engaged in a commercial interstate trip, struck the rear of the parked patrol vehicle, pushing it into the deputy. The patrol car continued forward into the rear of the disabled SUV. The SUV was pushed forward and across all three travel lanes, coming to rest on the left shoulder next to the center barrier. The driver of the SUV, who had reentered his vehicle before the collision, was uninjured. The pickup truck continued to push the patrol car forward, eventually striking the tow truck driver, who was thrown off the bridge and into the river below. The patrol car struck the rear of the parked tow truck before coming to final rest. The deputy sustained serious injuries, and the tow truck driver was fatally injured. The driver of the pickup truck was uninjured.

Figure 2. Pickup truck at final rest on top of patrol car. Flatbed tow truck is visible in background. (Source: Charleston County Sheriff's Office)
