National Transportation Safety Board Marine Accident Brief

Sinking of Fishing Vessel Viking II

Accident no. DCA-13-NM-001

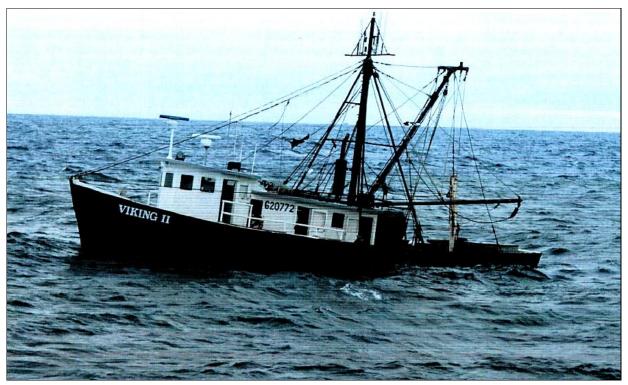
The Viking II at sea. Photo provided by the Coast Guard.
