# National Transportation Safety Board

## Marine Accident Brief

### Stranding and Subsequent Loss of the Fishing Vessel *Miss Annie*

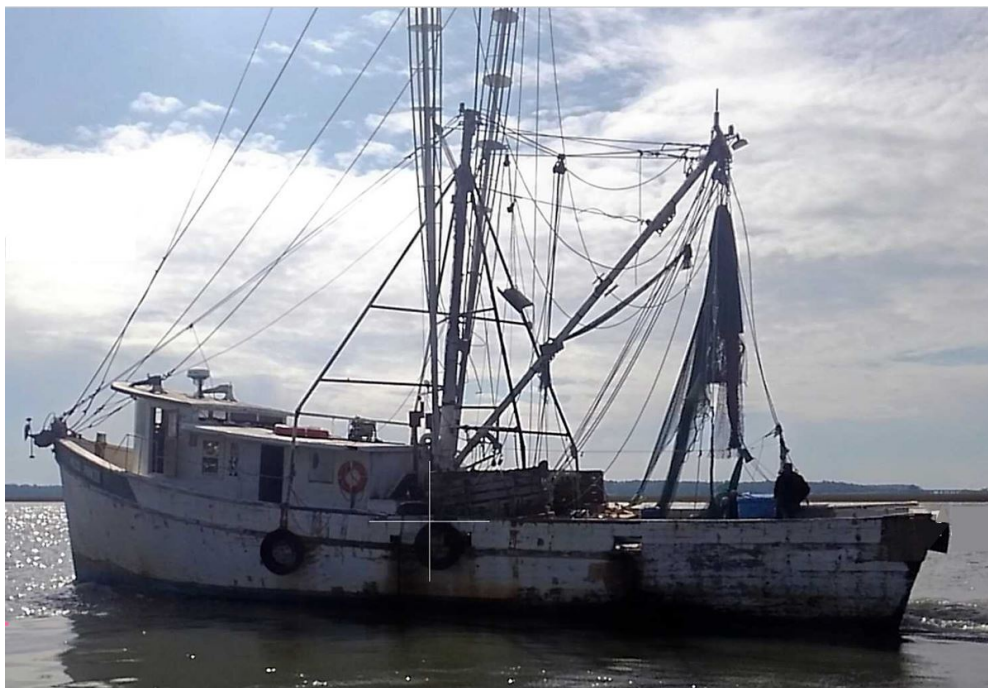
*Miss Annie* underway. (Source: Coast Guard)

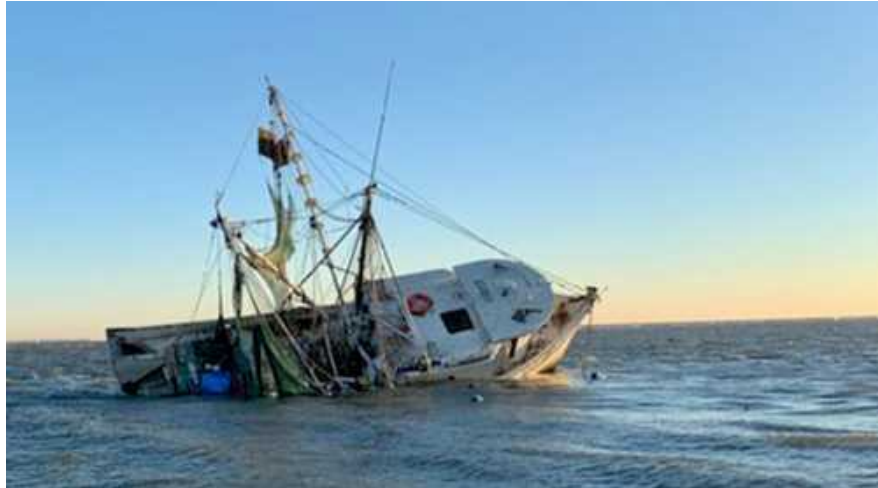
**Miss Annie shortly after all three crew were rescued. (Source: Coast Guard)**

by 0740, the RB-M was alongside the *Miss Annie* at the stern. The *Miss Annie* continued to list farther to starboard. After the first crewman boarded the RB-M at 0745, the *Miss Annie* rolled, causing the remaining two crewmembers to slide into the water. By 0747, the crew of the RB-M had recovered the two persons from the water.

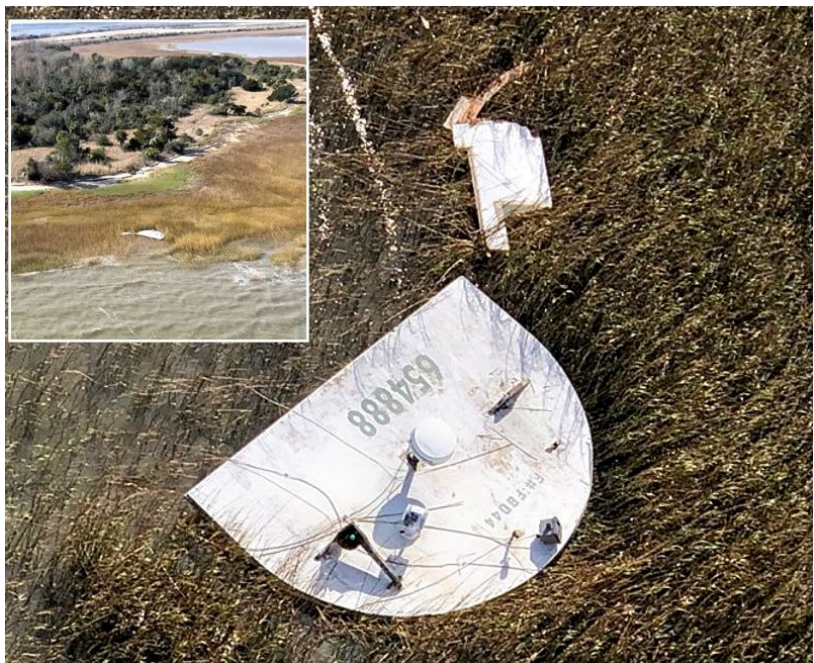
*Miss Annie* had broken apart. Large pieces of the vessel were photographed adrift and on shore by a Coast Guard aircraft.

**Miss Annie top of wheelhouse and debris washed ashore. (Source: Coast Guard)**

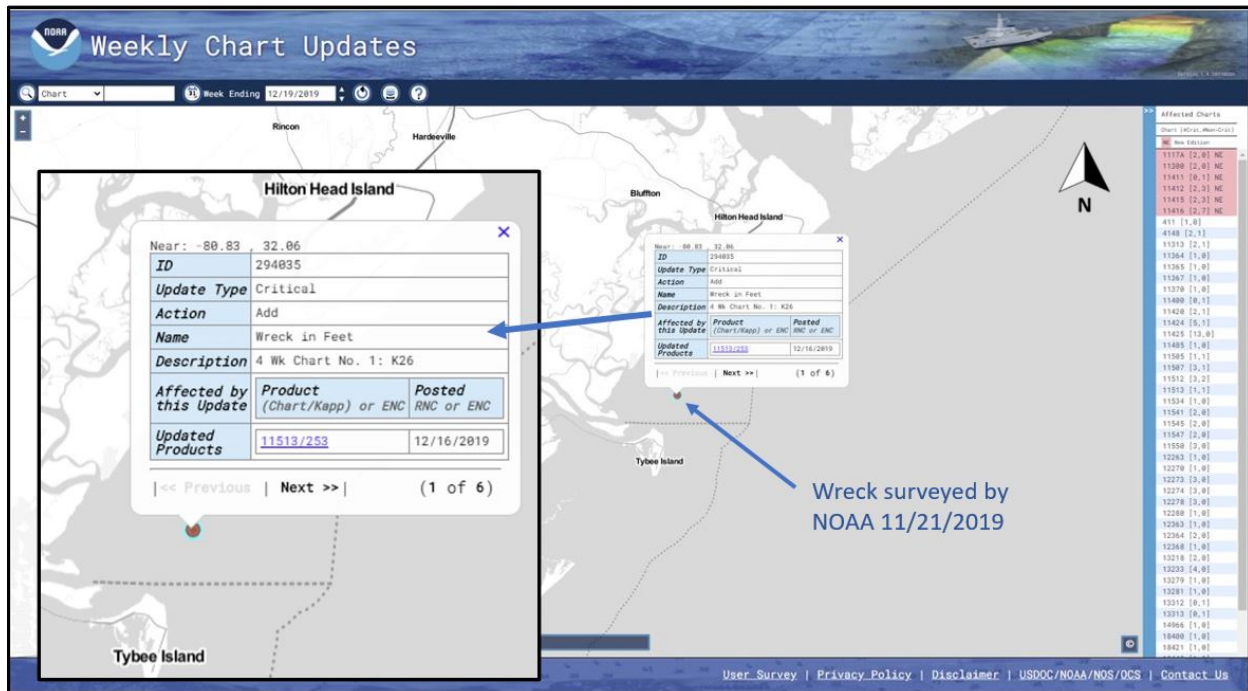
About 3 weeks after the survey, on December 19, the accident date, NOAA released corrections for their charts covering the area, marking the wreck found during the survey. Following NOAA’s update for the accident area, the Coast Guard published the information in the Week 52/19 LNTM dated December 23, 2019, for the waters of the Seventh Coast Guard District.

**NOAA Weekly Chart Update for the area of Hilton Head Island and Tybee Island (Week ending 12/19/2019). (Source: NOAA) Inset: Enlarged table of the chart update details. (Source: NOAA)**

Situation awareness demands a mariner should be alert for new hazards that can appear along their intended route. NOAA and the Coast Guard track these hazards and publish chart corrections each week. Mariners should adopt a process for identifying new hazards that are not marked on their paper or electronic chart system, before getting underway.
