# National Transportation Safety Board

## Railroad Accident Brief

### Film Crew Trespassing on CSX Right-of-Way

<b>Accident No.:</b>	DCA14FR005
<b>Location:</b>	Jesup, Georgia
<b>Date:</b>	February 20, 2014
<b>Time:</b>	4:30 p.m. eastern standard time
<b>Train:</b>	Q12519
<b>Railroad:</b>	CSX Transportation
<b>Property Damage:</b>	\$0
<b>Injuries:</b>	6
<b>Fatalities:</b>	1
<b>Type of Accident:</b>	Trespasser

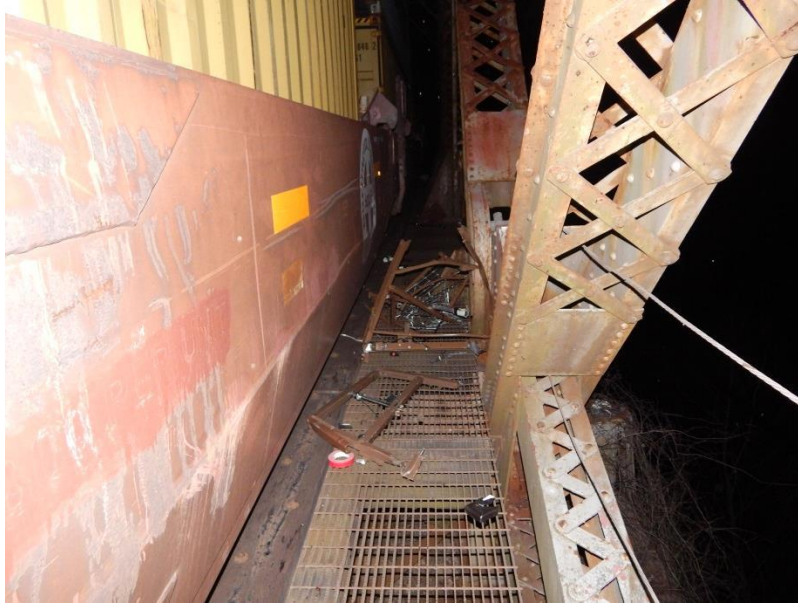
**Figure 3. The walkway on east side of railroad trestle and remnants of the prop after being struck by the train. (Photo by CSX.)**

The forward-facing camera on the train recorded the accident. As the train approached the highway-rail crossing, its horn and bell were activated. After the crossing became visible in the video, people were discernable on and next to the tracks. As the train entered the crossing, the bed prop fell onto the tracks.<sup>8</sup> Then, as the train approached the entrance of the bridge, six people were discernable near the bridge and six people were discernable on the bridge walkway. When the train passed the filming location, it hit the prop. The impact with the prop caused the train video image to shake. Debris from the prop struck several people on the bridge walkway.
