Amtrak Train Collision with Maintenance-of-Way
Equipment
Chester, Pennsylvania
April 3, 2016

NTSB/RAR-17/02
PB2018-100263

Railroad Accident Report

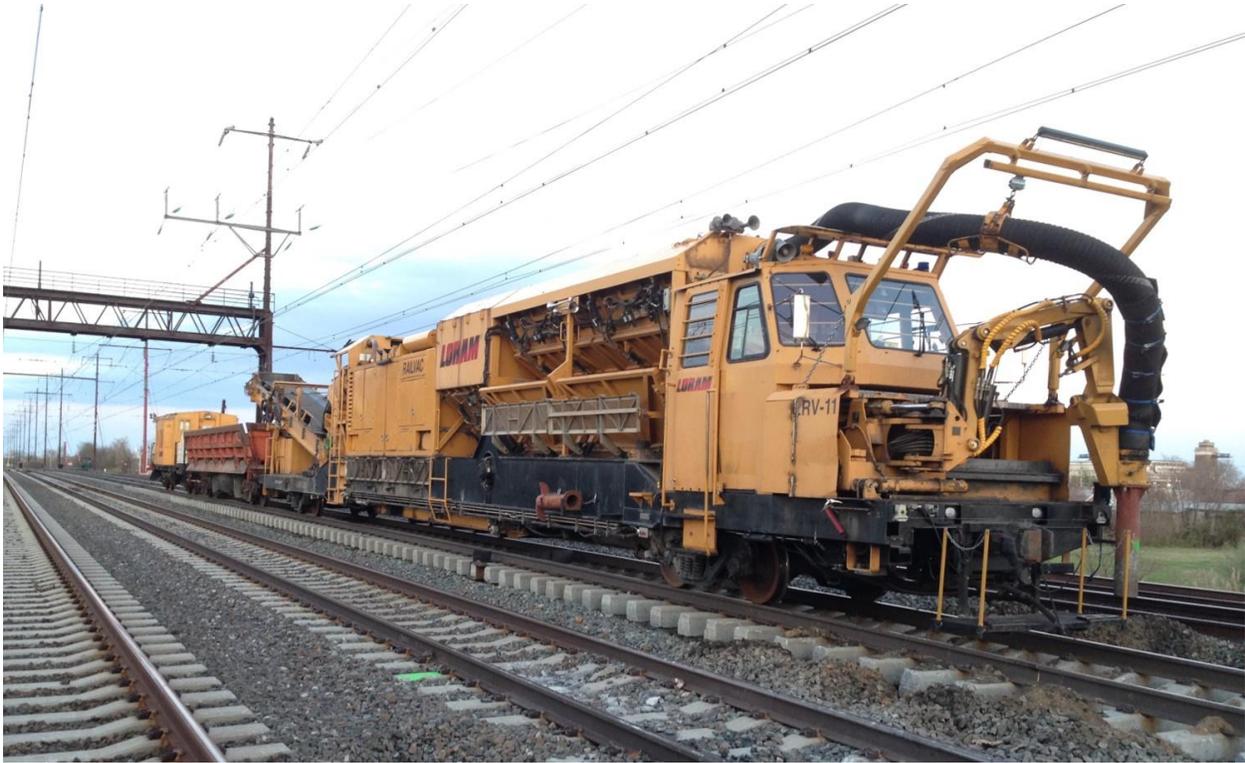
Figure 2. RailVac vacuum excavation machine on track 2 at the accident site.

Also on April 1, track 2 was taken out of service with Form D track authority so the work could begin.¹⁰ A Loram RailVac vacuum excavation machine (RailVac) occupied the track while the work was performed. (See figure 2.) To facilitate the ballast-vacuuming, Amtrak used a backhoe situated on track 3 that could reach over into track 2 to loosen the foul ballast before the vacuuming operation began. (See figure 3.) However, the backhoe cannot adequately loosen or move ballast from under the crossties, and additional hand work is often needed to rake the ballast into the space between the ties for better retrieval by the RailVac. When the RailVac was full of captured fouled ballast, it traveled to a preselected spot to off-load onto the right-of-way by extending its conveyor across, and thus fouling, track 1. Therefore, the foreman used foul time periodically on tracks 1, 3, and 4 to keep trains off those tracks to allow the backhoe and workers to foul tracks 1, 3, and 4.¹¹ To conduct the work safely, all four tracks had to be protected, because (1) the boom of the RailVac fouled track 1 when it off-loaded spoils, (2) the backhoe on track 3 could cross over any of the other tracks when it was operating, and (3) the workers could be on or near any of the four tracks at any time during the project.

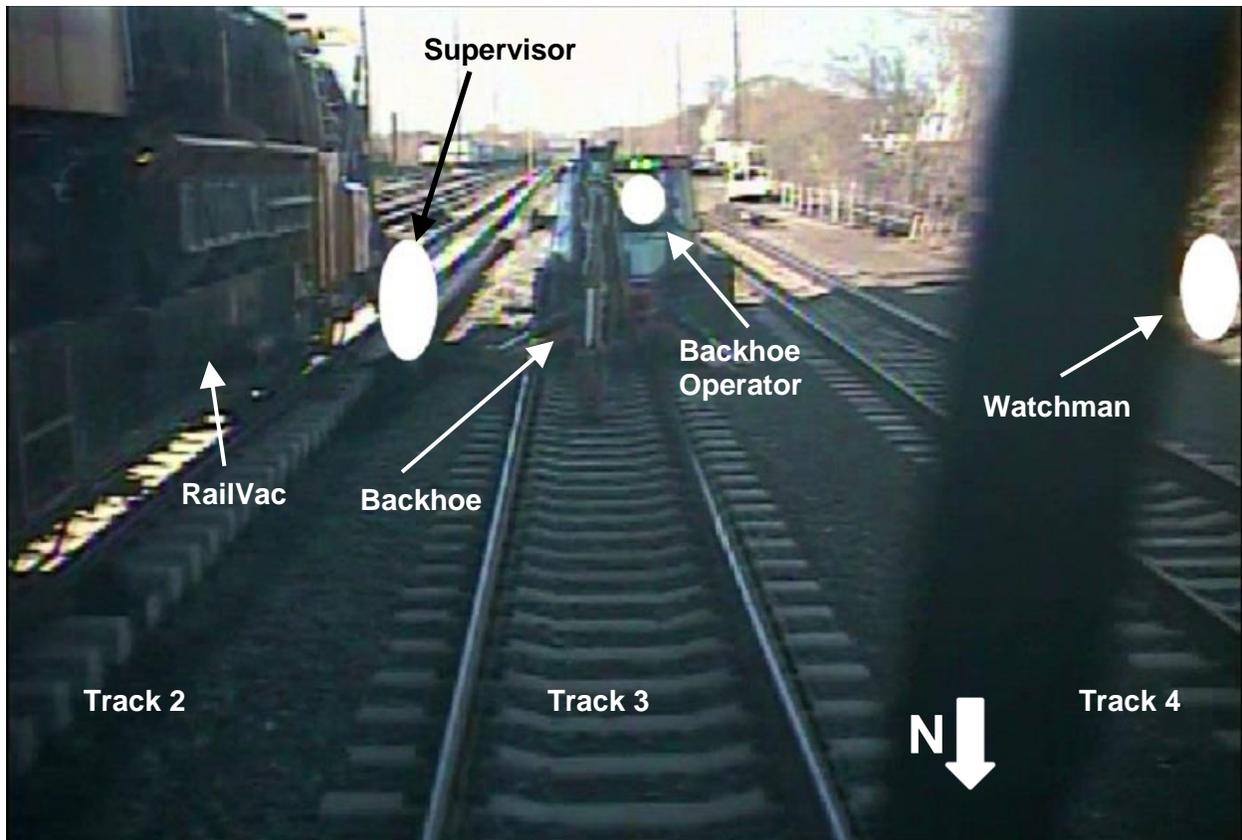
Figure 3. RailVac and backhoe taken from forward-facing video recorder just before accident.

The forward-facing video on the accident train showed the work area just before the accident occurred. On the video, the watchman can be seen running moving away from his position outside of track 4. The watchman told NTSB investigators that he saw the train approaching and attempted to warn the workers by sounding his air horn and waving a disc to the train above his head.

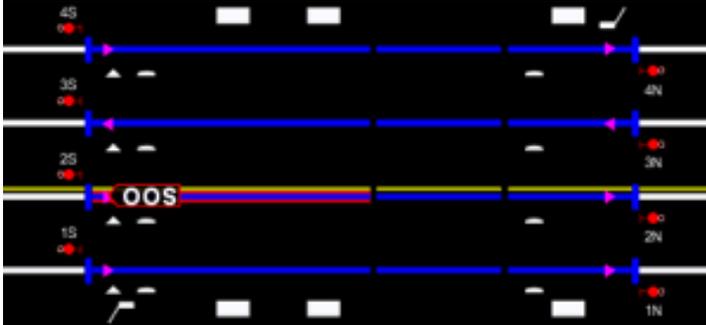
Figure 4. Dispatcher's display screen at 7:25 a.m. showing tracks 1–4 between Control Points Baldwin and Hook. Track 2 is out of service track (magenta), and tracks 1, 3, and 4 have electronic blocks (blue).

After the train dispatcher authorized foul time, he was required to make an entry into the train dispatcher's log and in the dispatching system indicating that the track covered by foul time was occupied, causing that area of track to show as blue on the dispatcher's board indicating that a blocking device is applied, also called a "blue block." Similarly, when an employee in the field placed a supplemental shunting device (SSD) on the track it caused that area of track to show as red on the dispatcher's board indicating track occupancy, also called a track occupancy light (TOL). In his interview, the train dispatcher referred to magenta (or blue over red) when describing what the dispatcher's board would indicate with a blocking device applied and a TOL.¹⁷ At the time of the accident, the dispatcher had removed the electronic block from track 3, so it appeared without any color highlighting; it was white. Figures 4–7 illustrate the dispatcher's display screen at critical times between 7:25 a.m. and 7:49a.m.

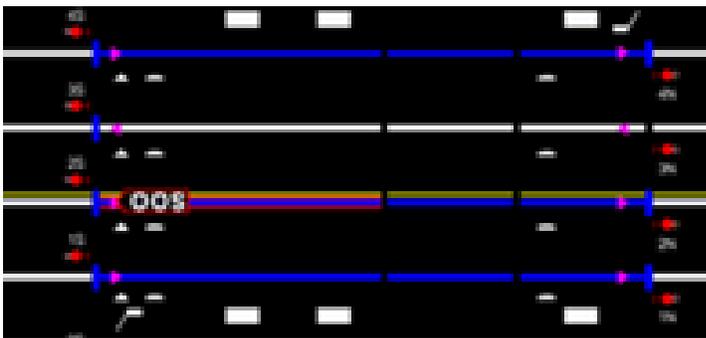
Figure 5. Dispatcher's display screen at 7:31 a.m. showing that the dispatcher has removed the electronic blocking device from track 3.

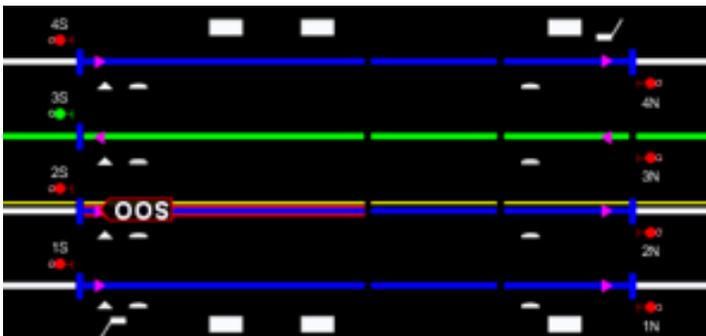
Figure 6. Dispatcher's display screen at 7:34 a.m. with a clear signal for train movement on track 3 indicated by the green highlight.

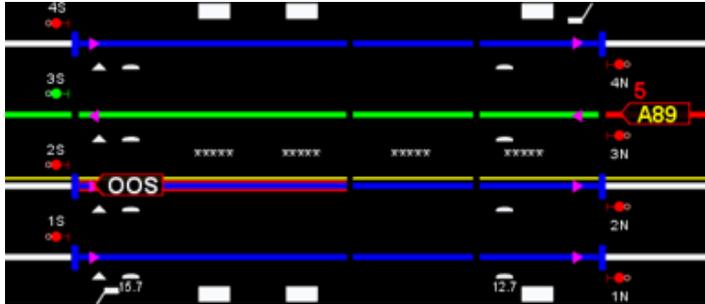
Figure 7. Dispatcher's display screen at 7:47 a.m. with train 89 on track 3 shown by the A89 designation.

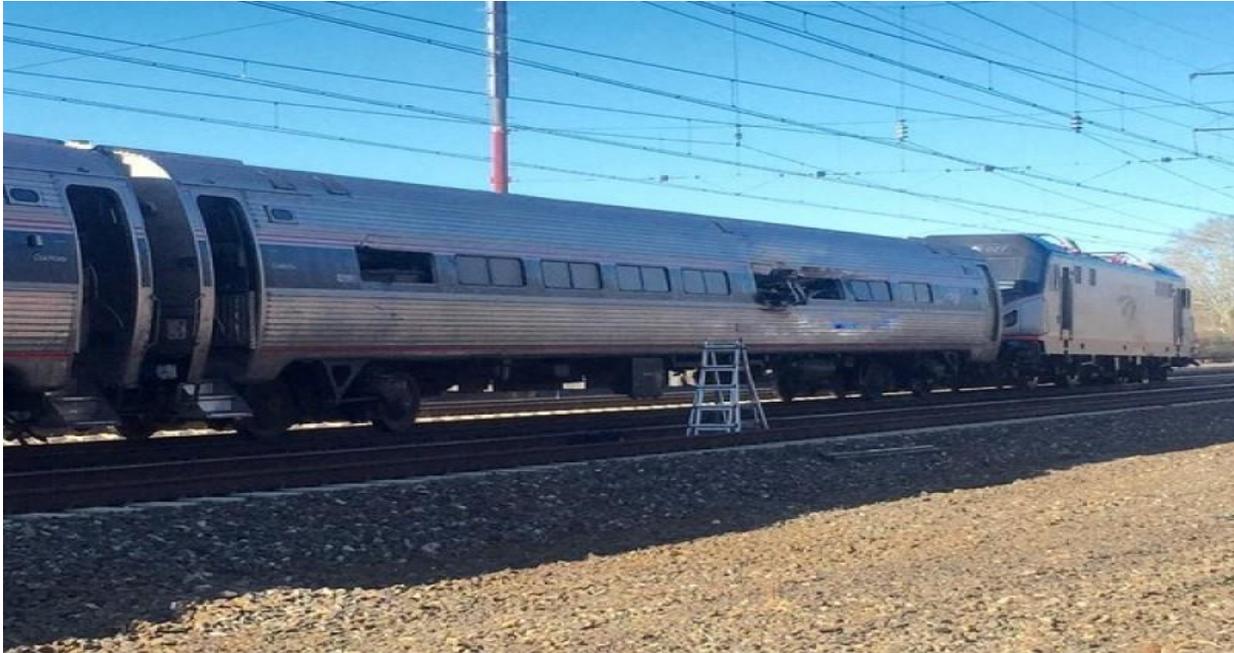
Figure 9. Damage to lead passenger car.

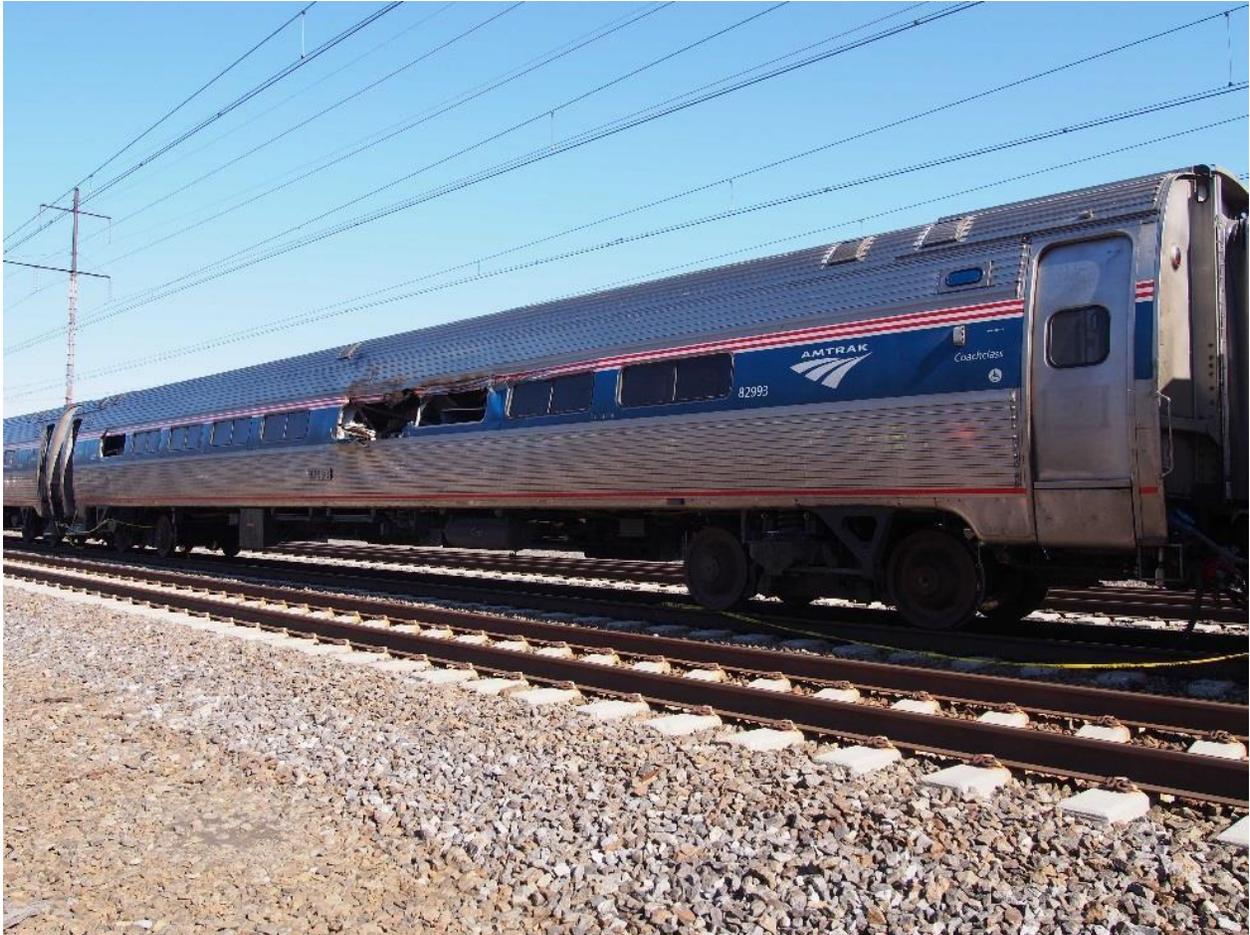
Debris from the backhoe struck the right side of the lead passenger car. The impact deformed the exterior right side, causing inward movement of the sidewall between the second and fourth windows. (See figure 10.) Damage above the second and third windows included a horizontal gouge mark on the side sheet, and the rear edge of the second window had been pushed partially inward. The collision pushed the third and fourth windows completely into the car. The side sheet between the third and fourth windows was torn, with gouge marks around the window opening. The ninth window was completely pushed into the car with a gouge mark at the upper rear corner of the window opening.

Figure 10. West (right) side of lead passenger car in Train 89.

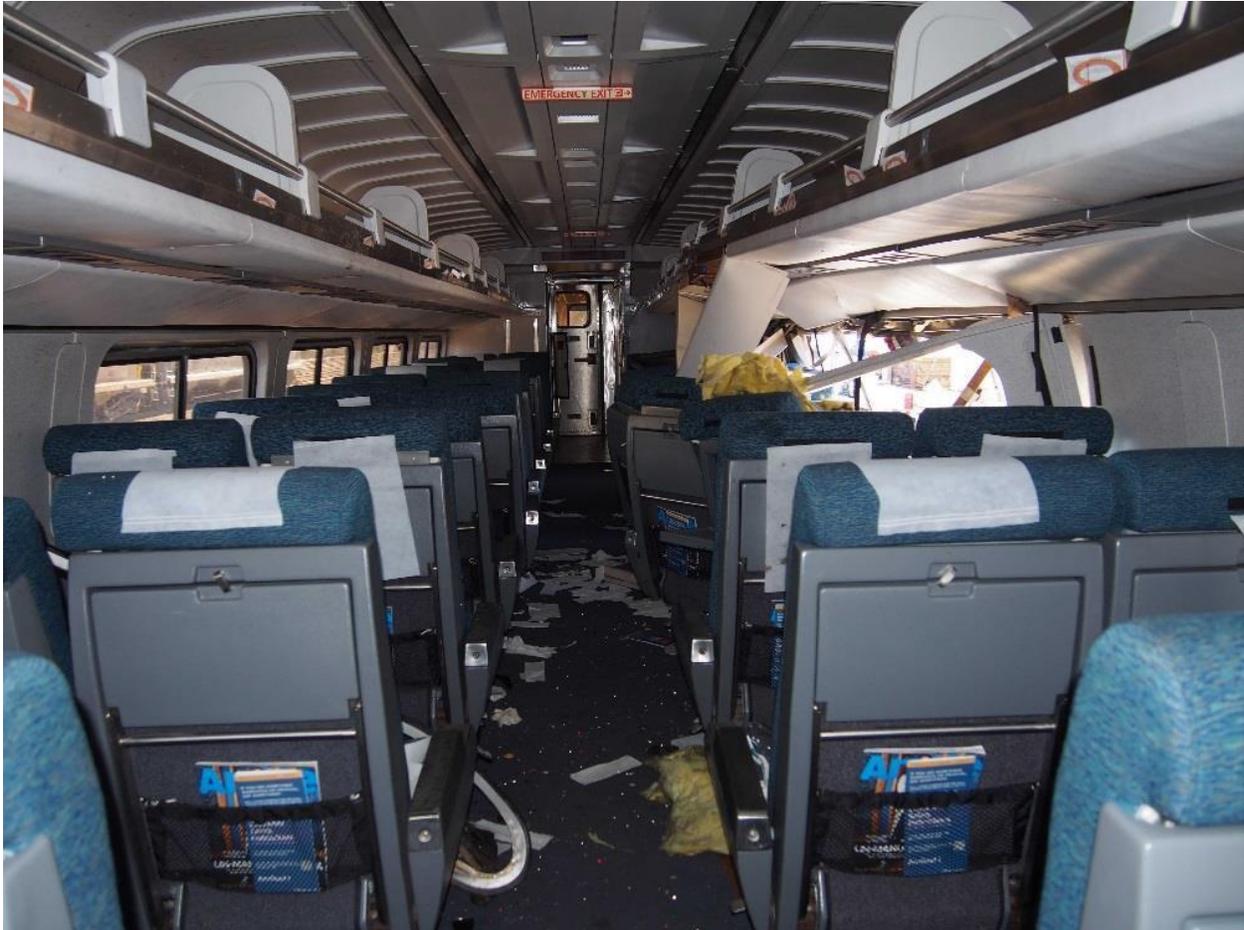
Inside the lead passenger car, investigators found the right sixth-row and seventh-row seats separated from the wall and floor pedestal. (See figure 11.) Near the right eighth-row seat, the baggage rack was bent upward, the ceiling panels had fallen onto the seats, and the interior wall panels at the windows were cracked and torn. The right fifth- and the eighteenth-row seats had partially rotated. The first aid kit was empty, and all its supplies had been used.

Figure 11. Interior of lead passenger car.
