PRELIMINARY REPORT

**SEPTA Passenger Killed
While Walking Between Cars
on a Moving Subway Train**

Philadelphia, Pennsylvania
September 23, 2018
RRD18FR011

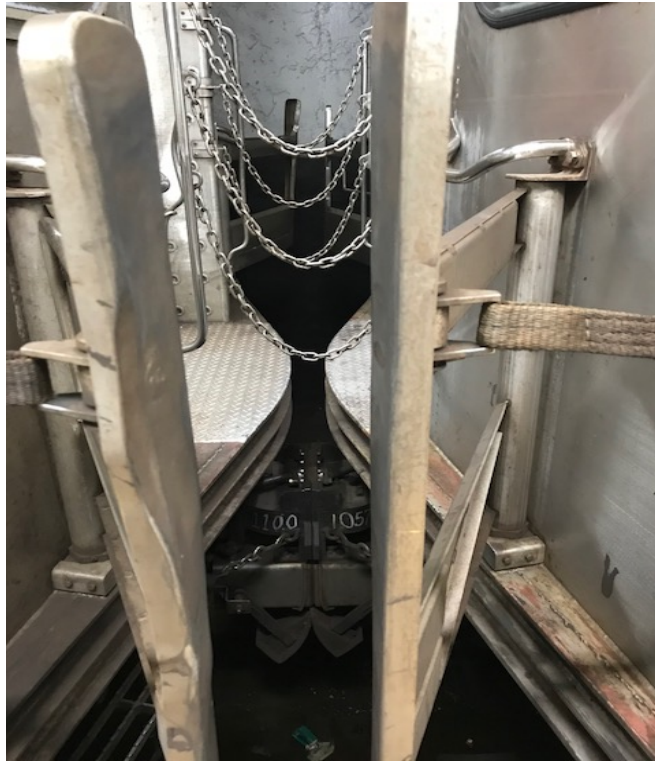
On September 23, 2018, about 5:35 p.m., eastern daylight time, a Southeastern Pennsylvania Transportation Authority (SEPTA) subway train operator stopped a SEPTA southbound subway train between the Alleghany Station and the North Philadelphia Station on the Broad Street Line when a passenger activated an emergency alert.¹ While stopped, the train dispatcher instructed the train operator to perform a ground level inspection of the train. While performing the inspection, the operator found, between the running rails about 10 feet south of the Alleghany Station platform, a child that had been struck by the train. According to witness statements to SEPTA officials, the 7-year-old boy attempted to walk from car 516 to car 536 through the end-of-car doors as the train moved out of the Alleghany Station through an underground subway tunnel. After the boy passed through the end-of-car door of car 516, he fell between the cars. (See figure 1.)

Figure 1. Photograph of the area between SEPTA Broad Street Line subway cars 516 and 536.

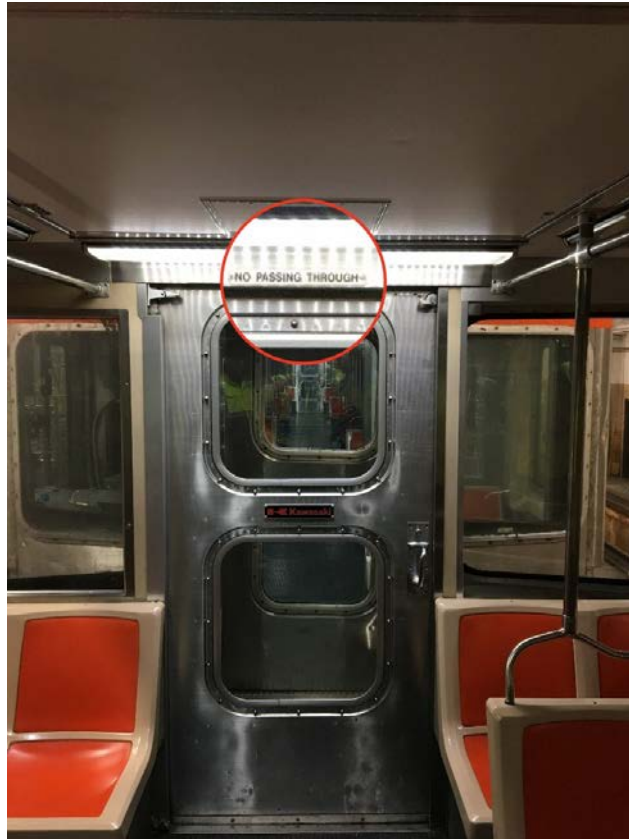
NTSB investigators interviewed SEPTA System Safety and Transportation Management officials who indicated that although passengers are permitted to walk between the cars, this action is highly discouraged. At the time of the accident, SEPTA Broad Street Line subway end-of-car doors were equipped with a singular sign warning that passengers should not use the end-of-car doors to pass between cars. The sign read “NO PASSING THROUGH,” and is located between an overhead light bar and the top of the door. In the following photograph, the sign is magnified and circled in red. (See figure 2.)

Figure 2. Photograph of a SEPTA subway end-of-car door warning sign.

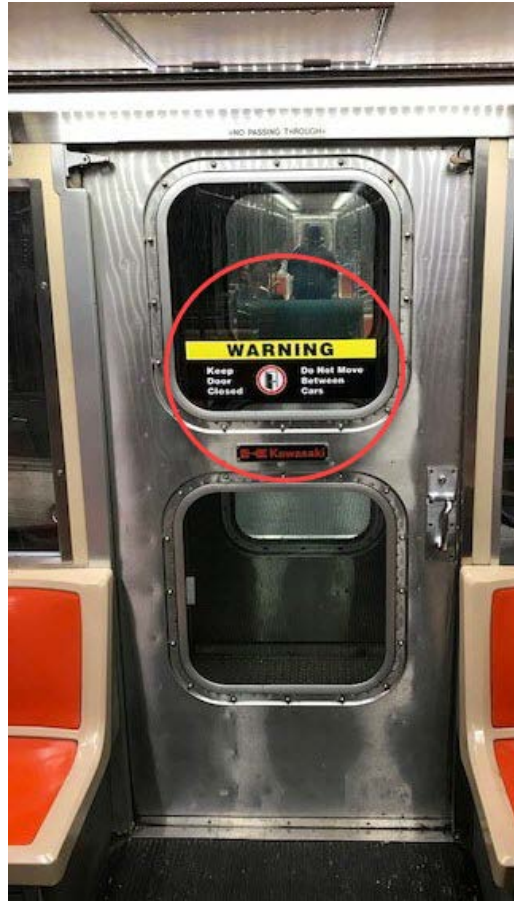
Figure 3. Photograph of an enhanced warning sign on a SEPTA subway end-of-car door.

Immediately after the accident, SEPTA officials began placing larger and more prominent warning signs on the interior of the end-of-car doors on the entire SEPTA subway fleet. (See figure 3.) SEPTA also began making station and on-board train announcements to remind passengers that the end-of-car door passage is for emergency use only.
