PRELIMINARY REPORT

Collision Between Sacramento Regional Transit District Light Rail Vehicles

**Sacramento, California
August 22, 2019
RRD19FR011**

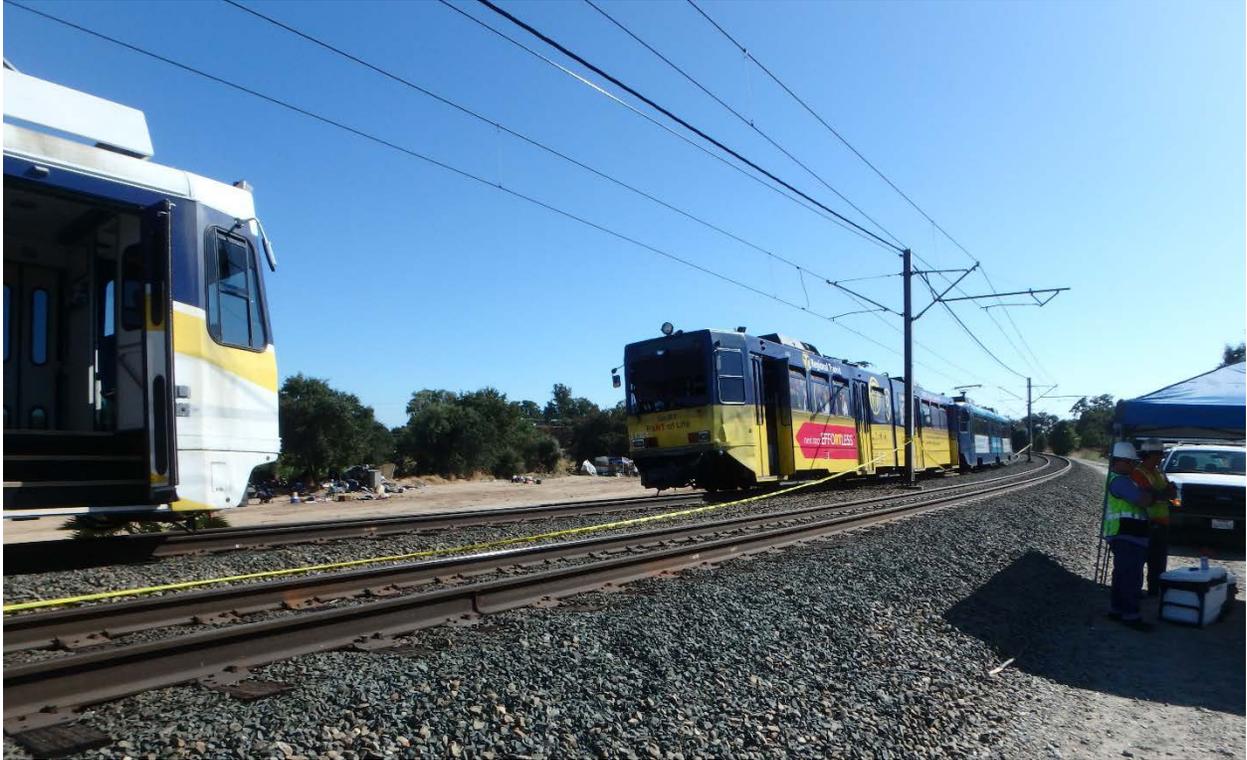
Figure 1. Photo taken facing south. Passenger train No. 9 is to the right in the photo, with the maintenance LRV No. 310 to the left.
