Midair Collision Involving US Army PAT25 and PSA Airlines Flight 5342 Washington, DC January 29, 2025

Captain Van S. McKenny IV
Helicopter Operations Group Chairman

Overview of Helicopter Operations

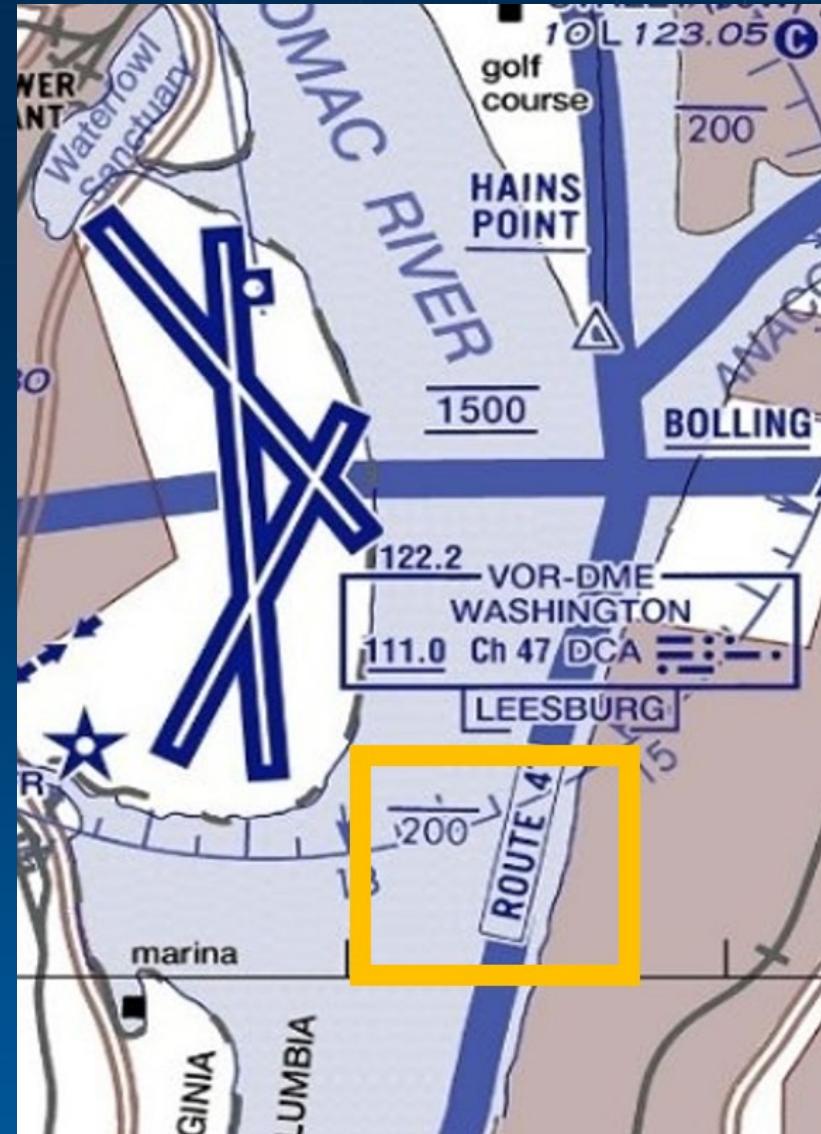
Helicopter Route Chart

- “Recommended paths” without defined lateral boundaries
- Conflicting information about whether published route altitudes were “recommended” or “maximum”
- Potential for pilot confusion

Recommended Route Altitude
500 Minimum 500 Maximum 500 Recommended

- Regarded published altitudes as maximums
- Incorrectly presumed published altitudes separated them from airplanes
- Rarely encountered airplanes circling to runway 33
- ATC typically instructed them to hold for arriving airplanes

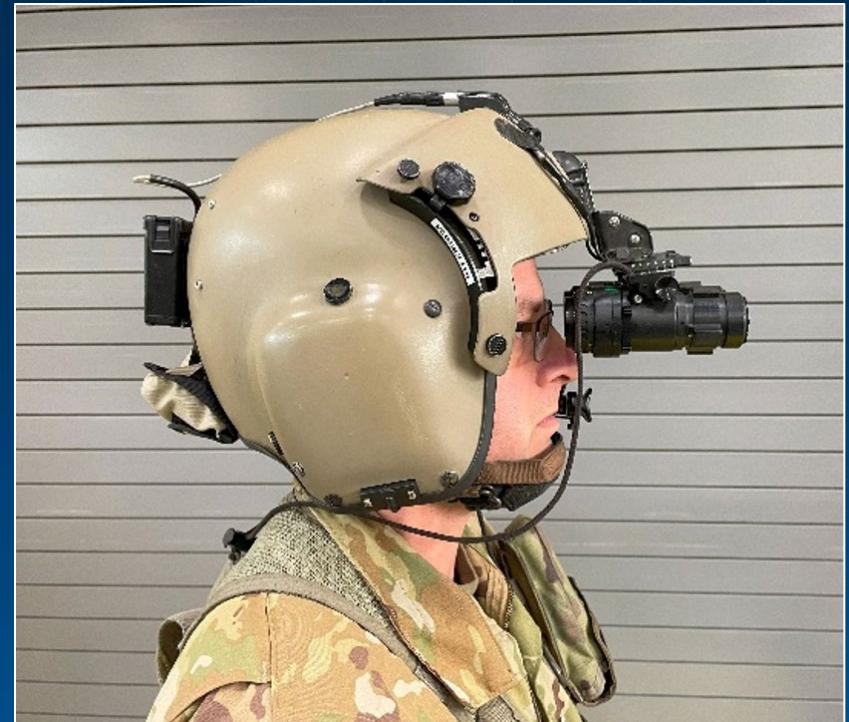
- NVGs amplify low ambient light levels, which provides enhanced vision to air crew
- Advantages of NVGs include:
 - Night visual acuity of unilluminated objects improved
 - Ability to identify objects, obstacles, and other aircraft at a distance

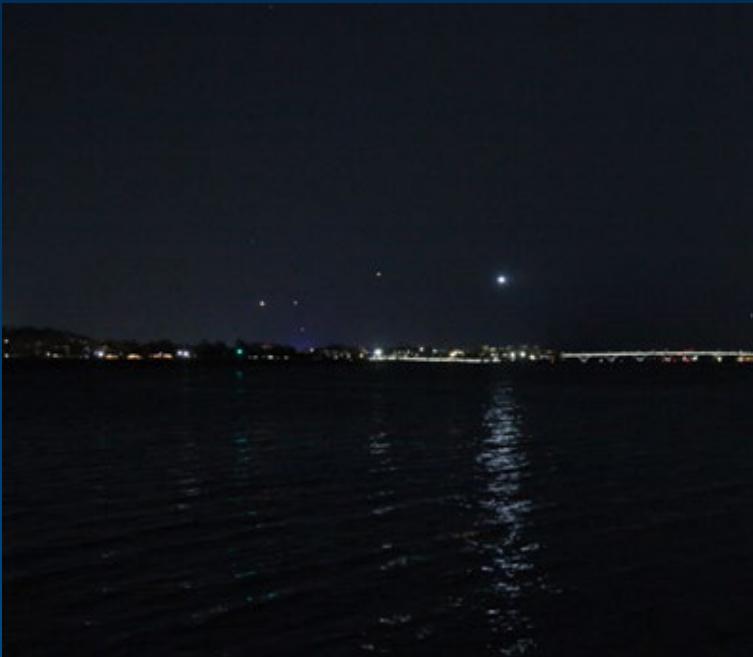
Normal unaided night vision

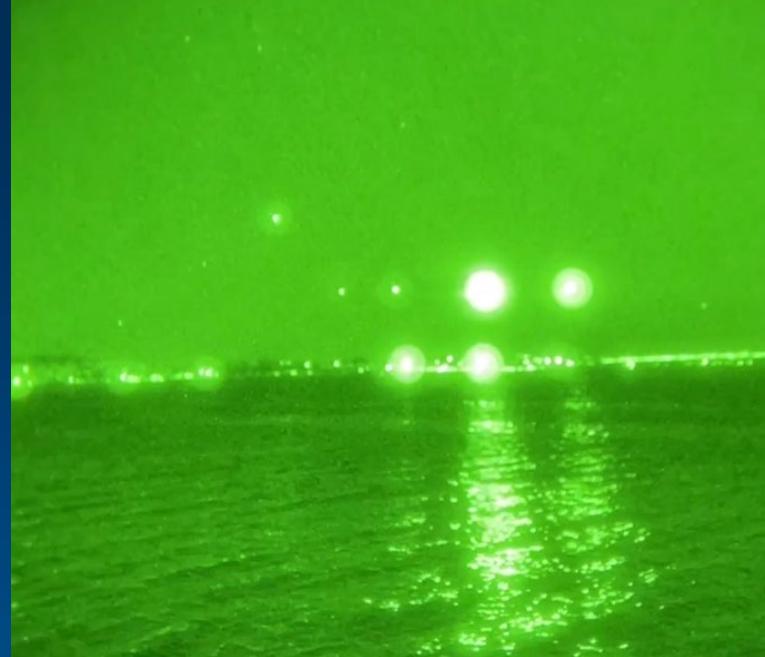
Night vision aided by green and white NVGs

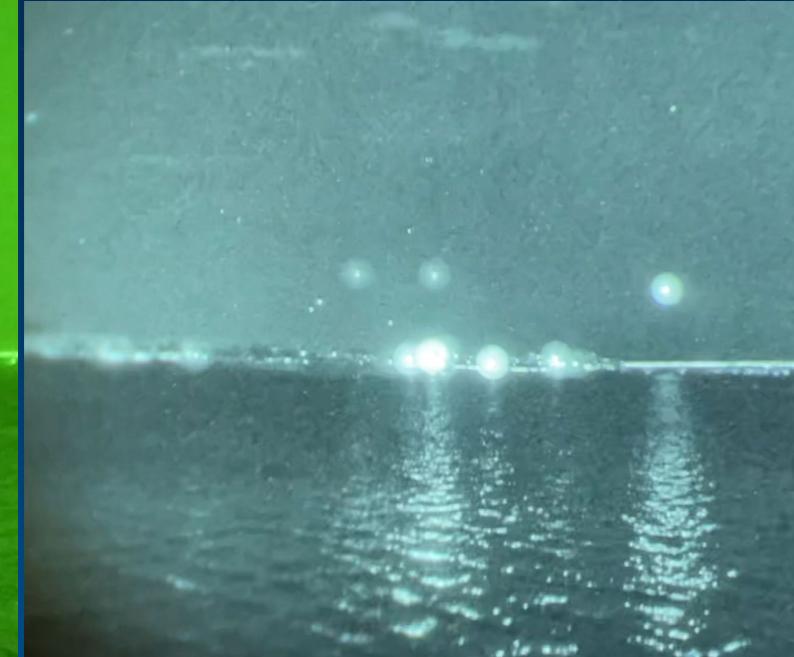
Disadvantages of NVGs

- Field of view limited to 40°
- Monochromatic images
- Degraded depth perception (difficult to determine distance of an object)
- Ground and airborne lights appear similar
- Halos around point light sources
- Aircraft silhouettes are very faint, difficult to determine type and size
