Midair Collision Involving US Army PAT25 and PSA Airlines Flight 5342 Washington, DC January 29, 2025

William Bramble, PhD
Operations-Human Performance Group Chairman

Overview of Human Performance (Aircraft)

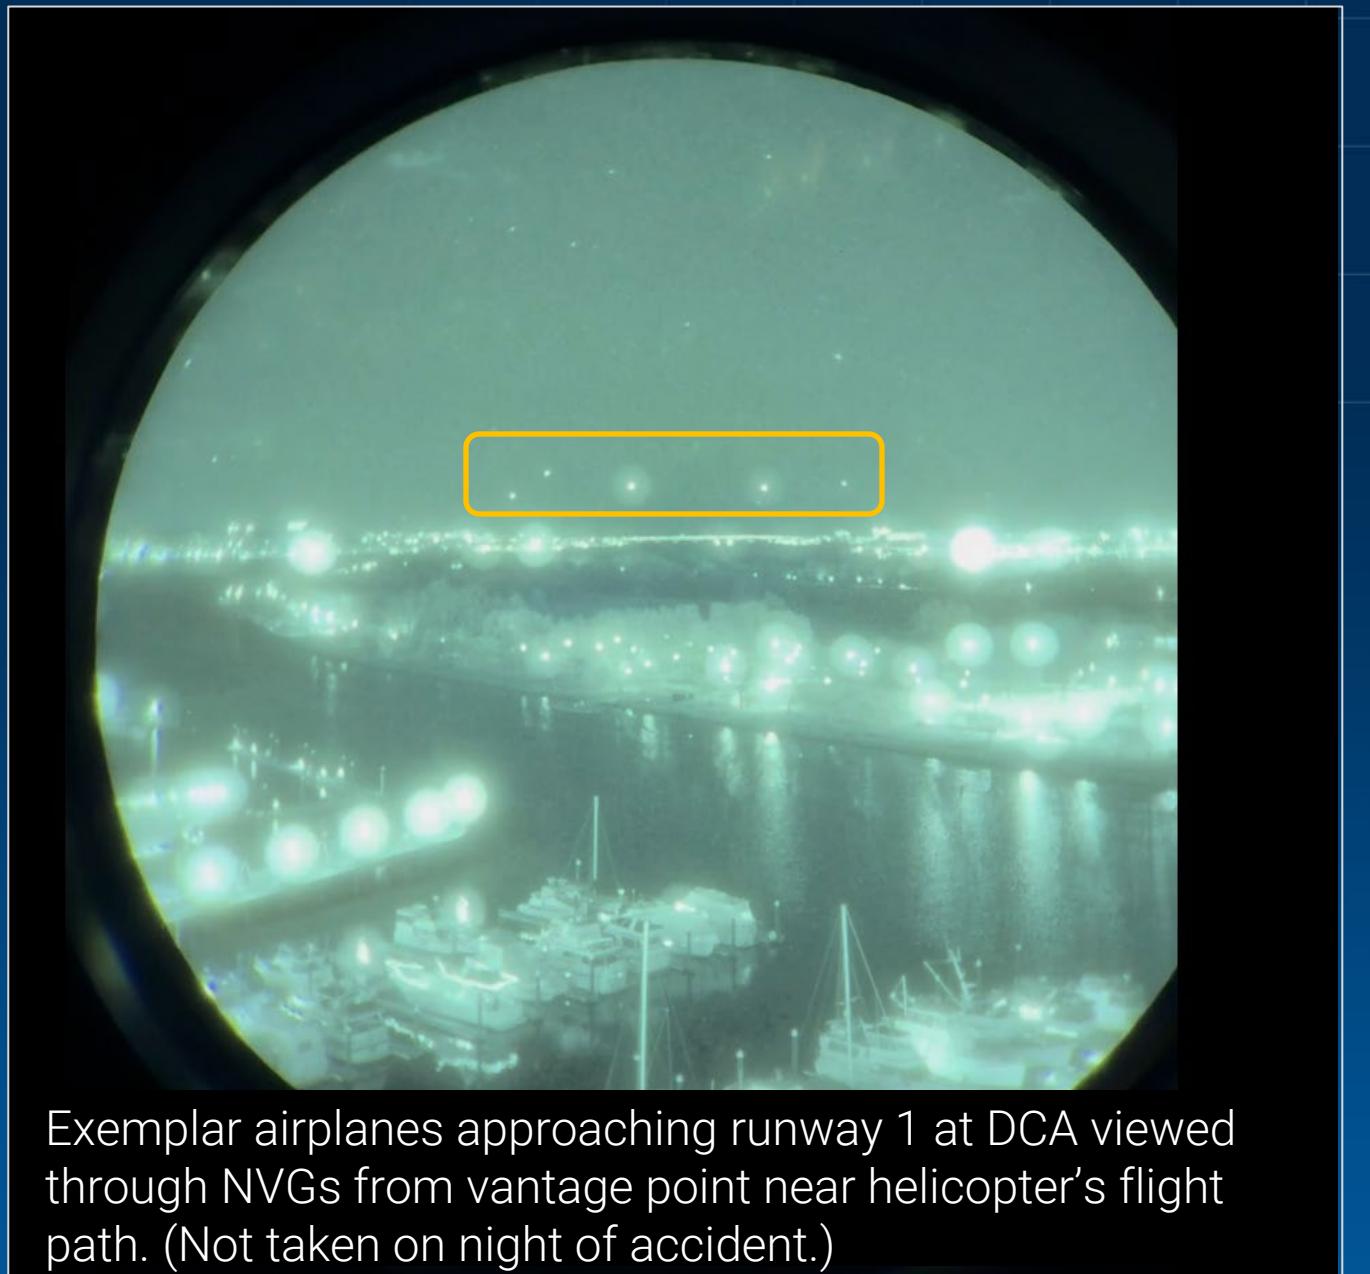
- Controller advised:
 - “PAT two five traffic just south of Wilson Bridge is a CRJ at 1,200 feet for runway 33”
- Several other aircraft were visible in same area
- Helicopter flight crew likely unable to identify “CRJ” in question

Exemplar airplanes approaching runway 1 at DCA viewed through NVGs from vantage point near helicopter's flight path. (Not taken on night of accident.)

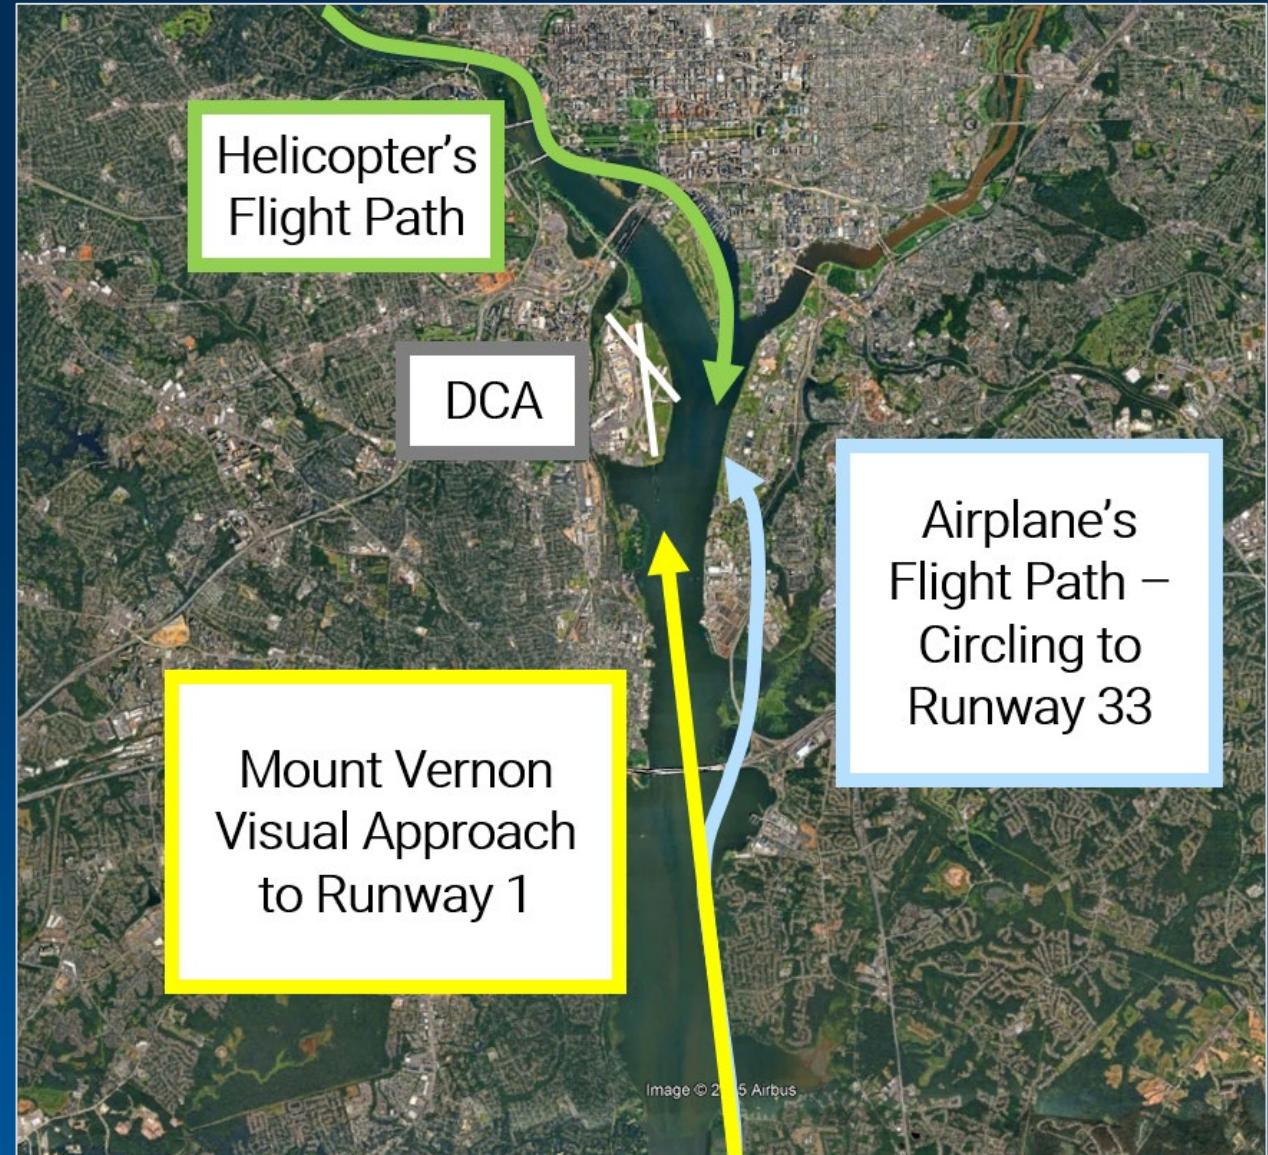
- Controller's transmission that airplane was "circling" was inaudible due to static interference
- Crew's workload was high at that time
- Hearing "circling" might have helped crew better anticipate CRJ's flight path

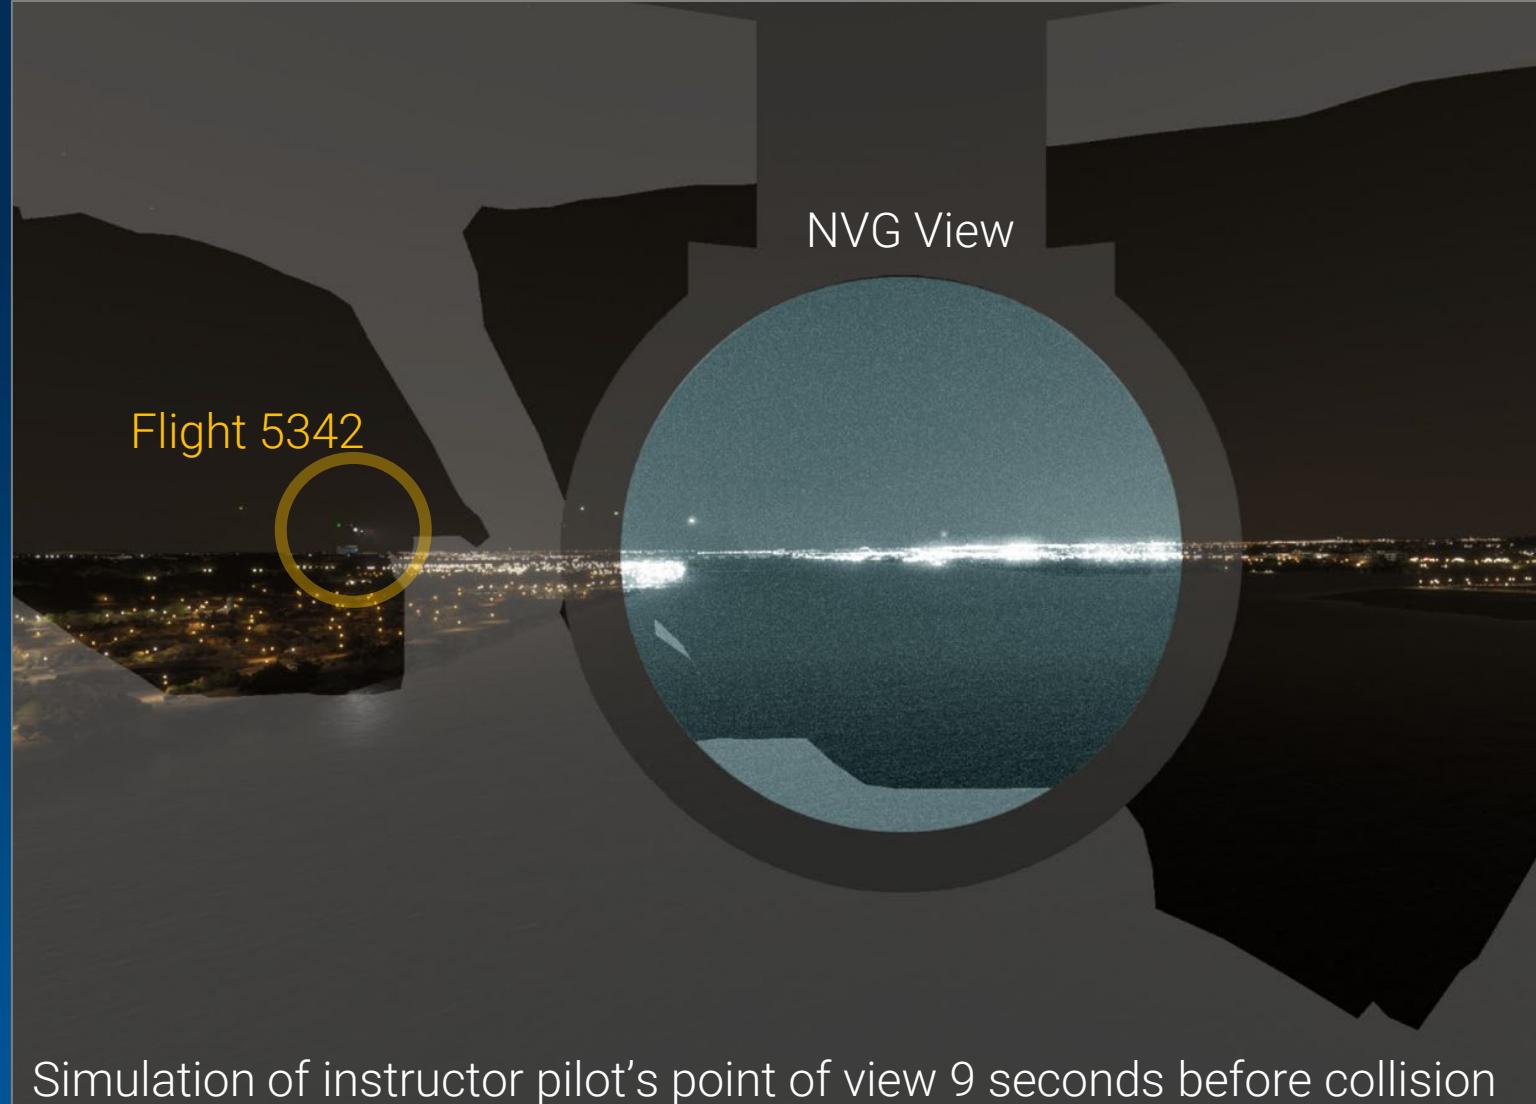
- Night vision goggle (NVG) narrow field of view
- Window post
- Complex array of adjacent city lights
- Workload
- Divided attention
- Lack of apparent motion

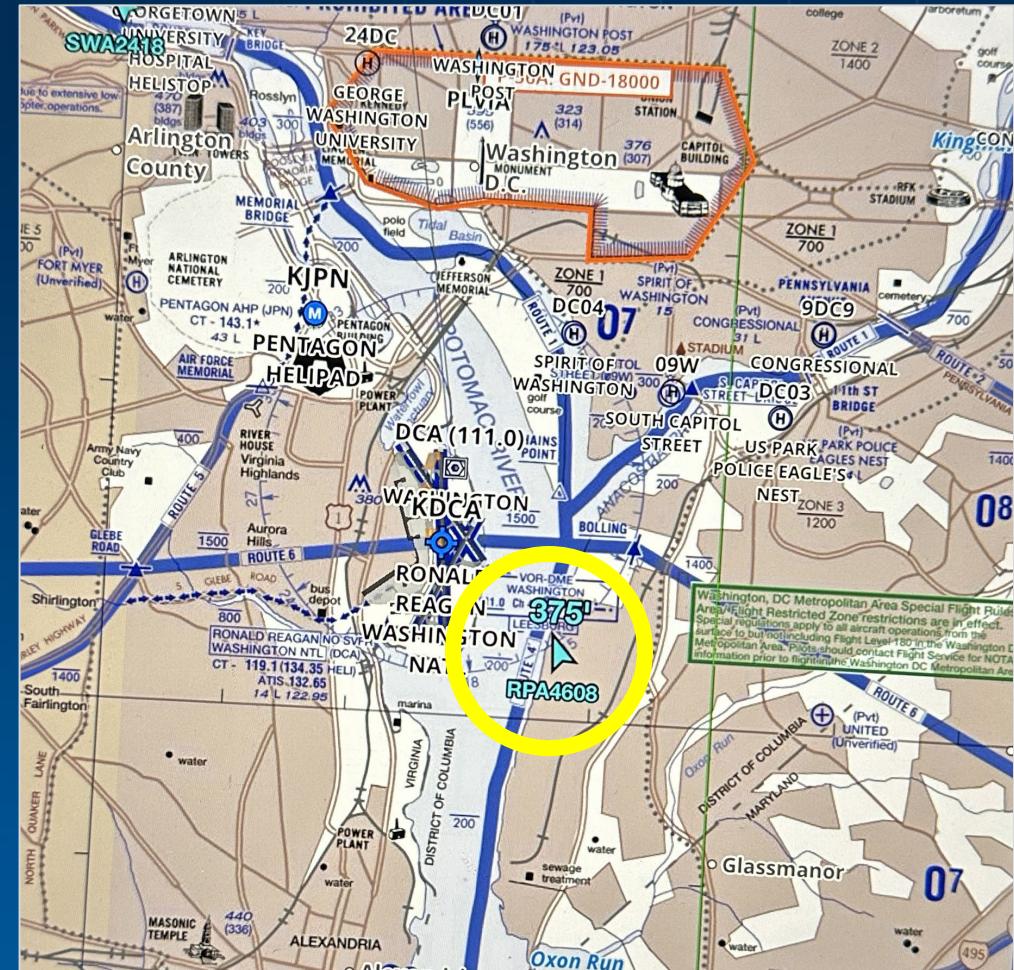
- Pilots carried electronic tablets
- Tablets wirelessly connected to Stratus ADS-B receiver providing ADS-B In
- ForeFlight mobile application could display traffic symbols

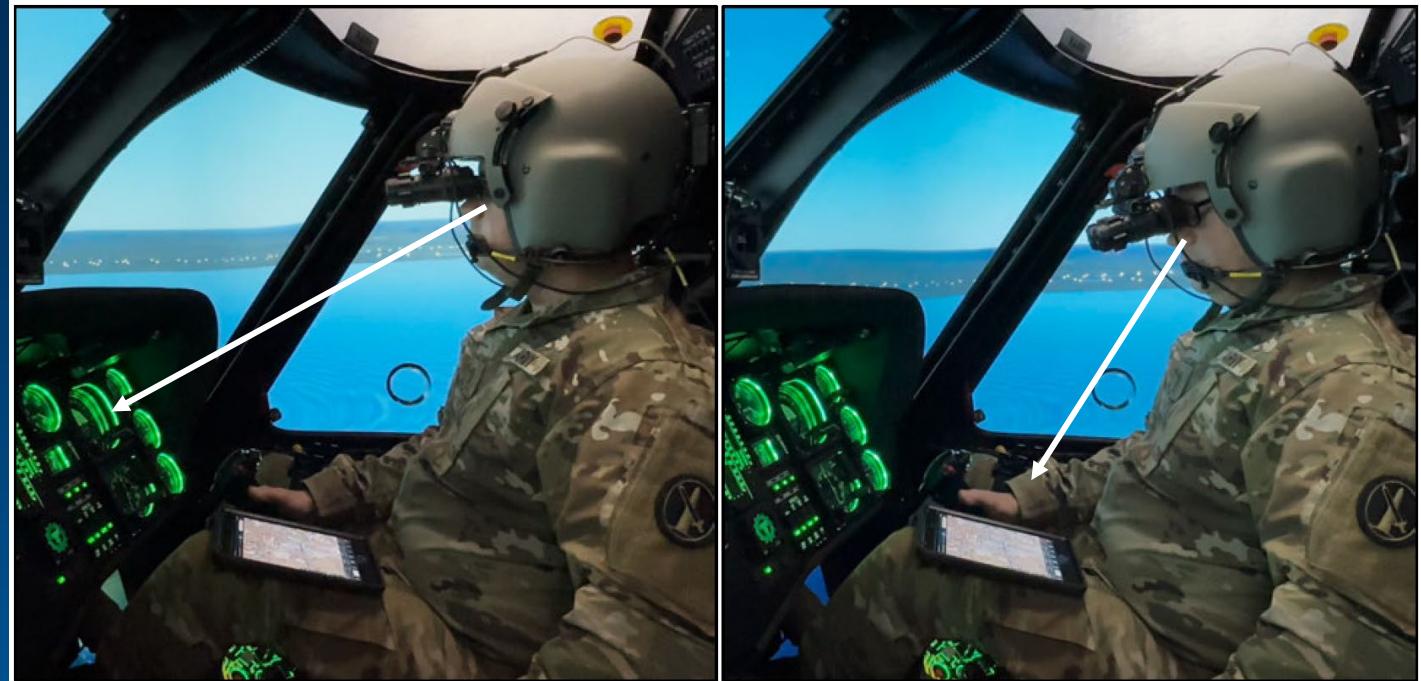
- Pilots strapped tablet to thigh, viewing required tilting heads down
- Pilots did not typically reference when flying low-level on DC helicopter routes
- Crew of PAT25 likely did not reference tablets when flying on route 4

Pilot shown with tablet in a UH-60L simulator.

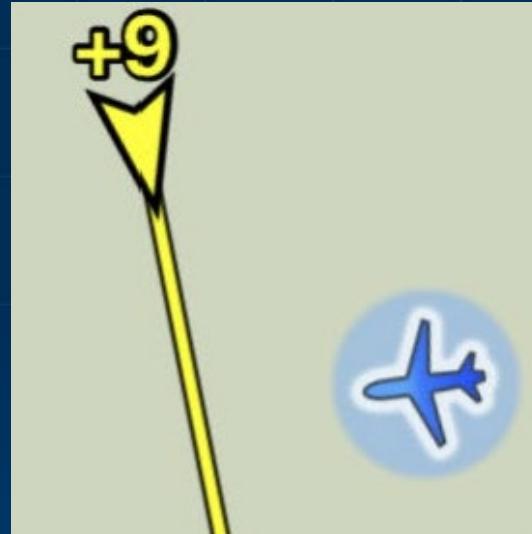
Traffic
Caution

- ForeFlight capable of visual and aural alerts
- Visual alerts unseen without visual inspection
- Aural alerts likely inaudible due to lack of integration with helicopter's intercom system
- Unknown if tablets were on and configured for alerting

Collision avoidance system with audible aural alerting and traffic display could have drawn the pilots' attention to the developing conflict and the location of the airplane

- One recommendation to FAA
- One recommendation to Department of War

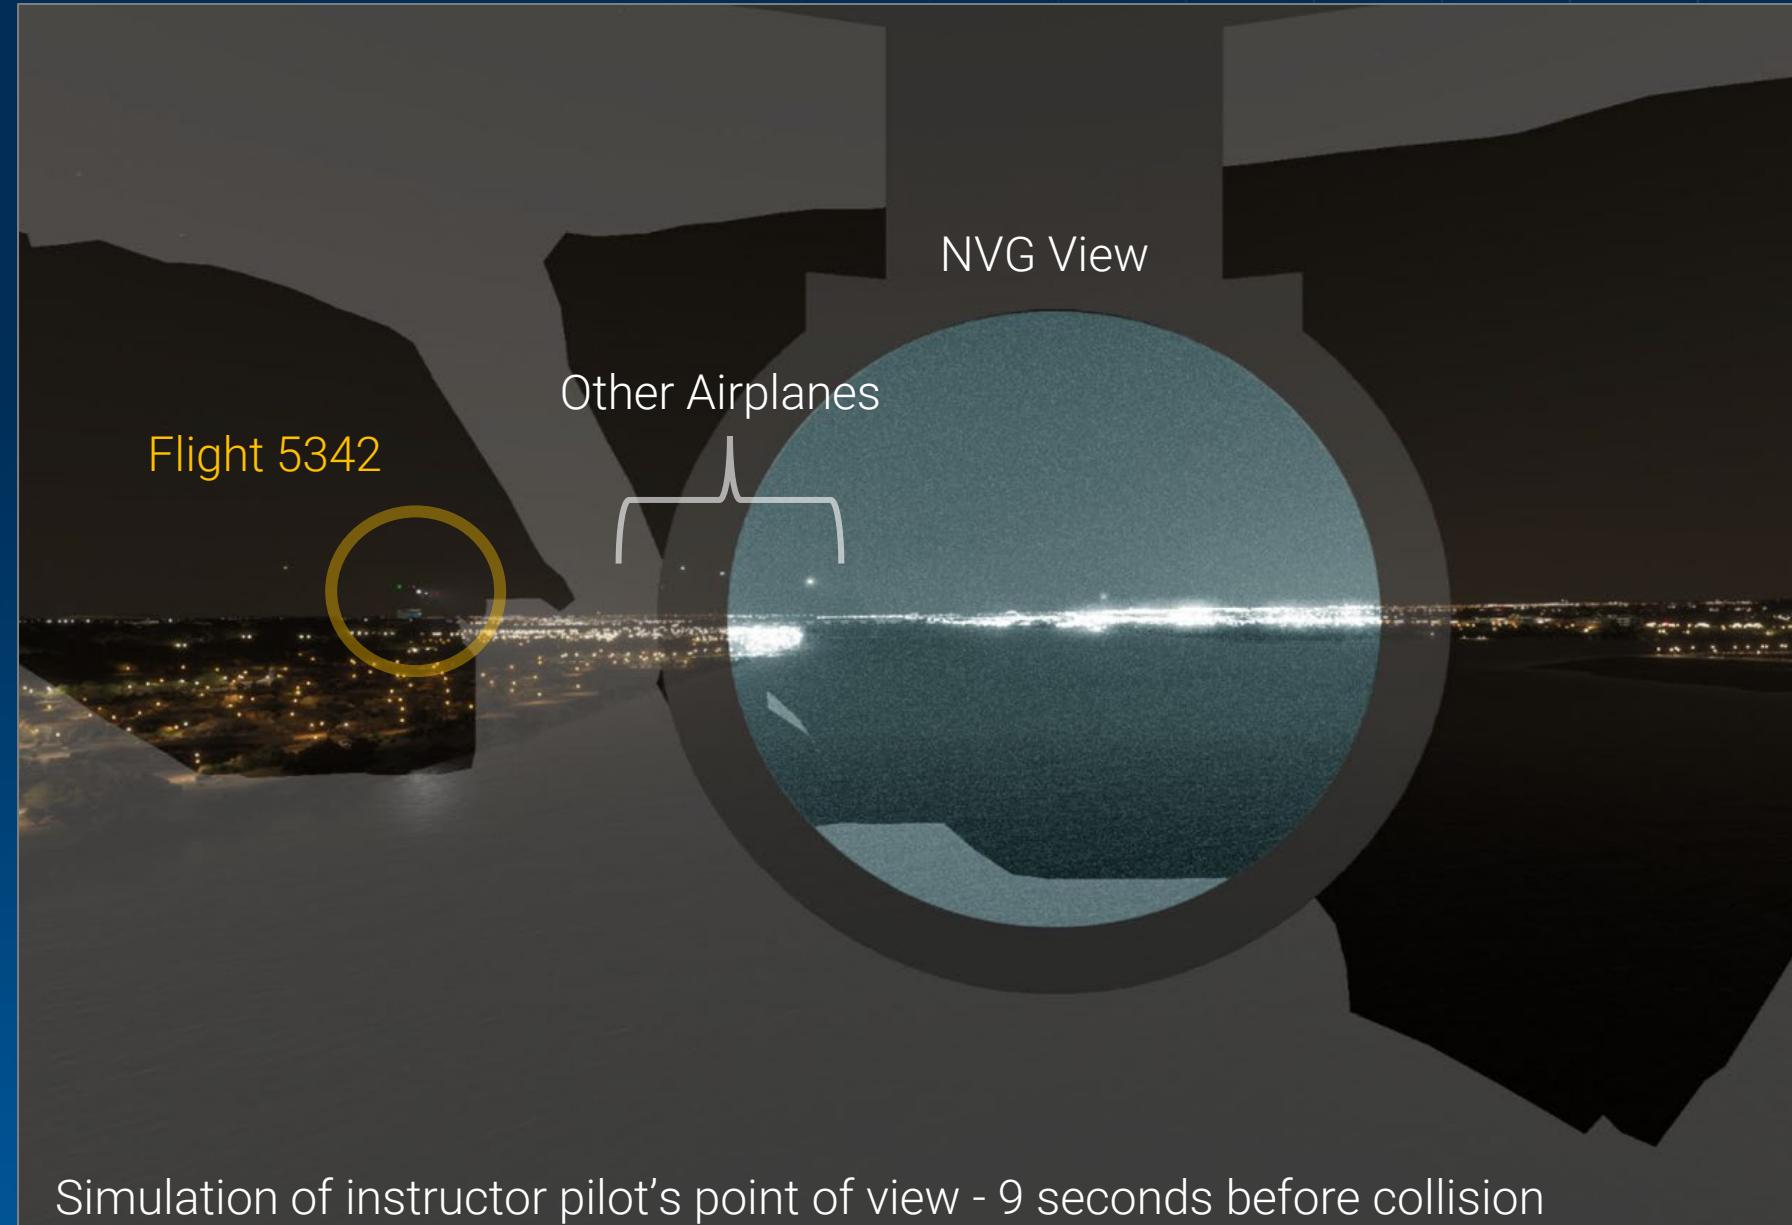
- Local controller asked, “PAT two five you have the CRJ in sight?”
- Did not provide clock direction or distance

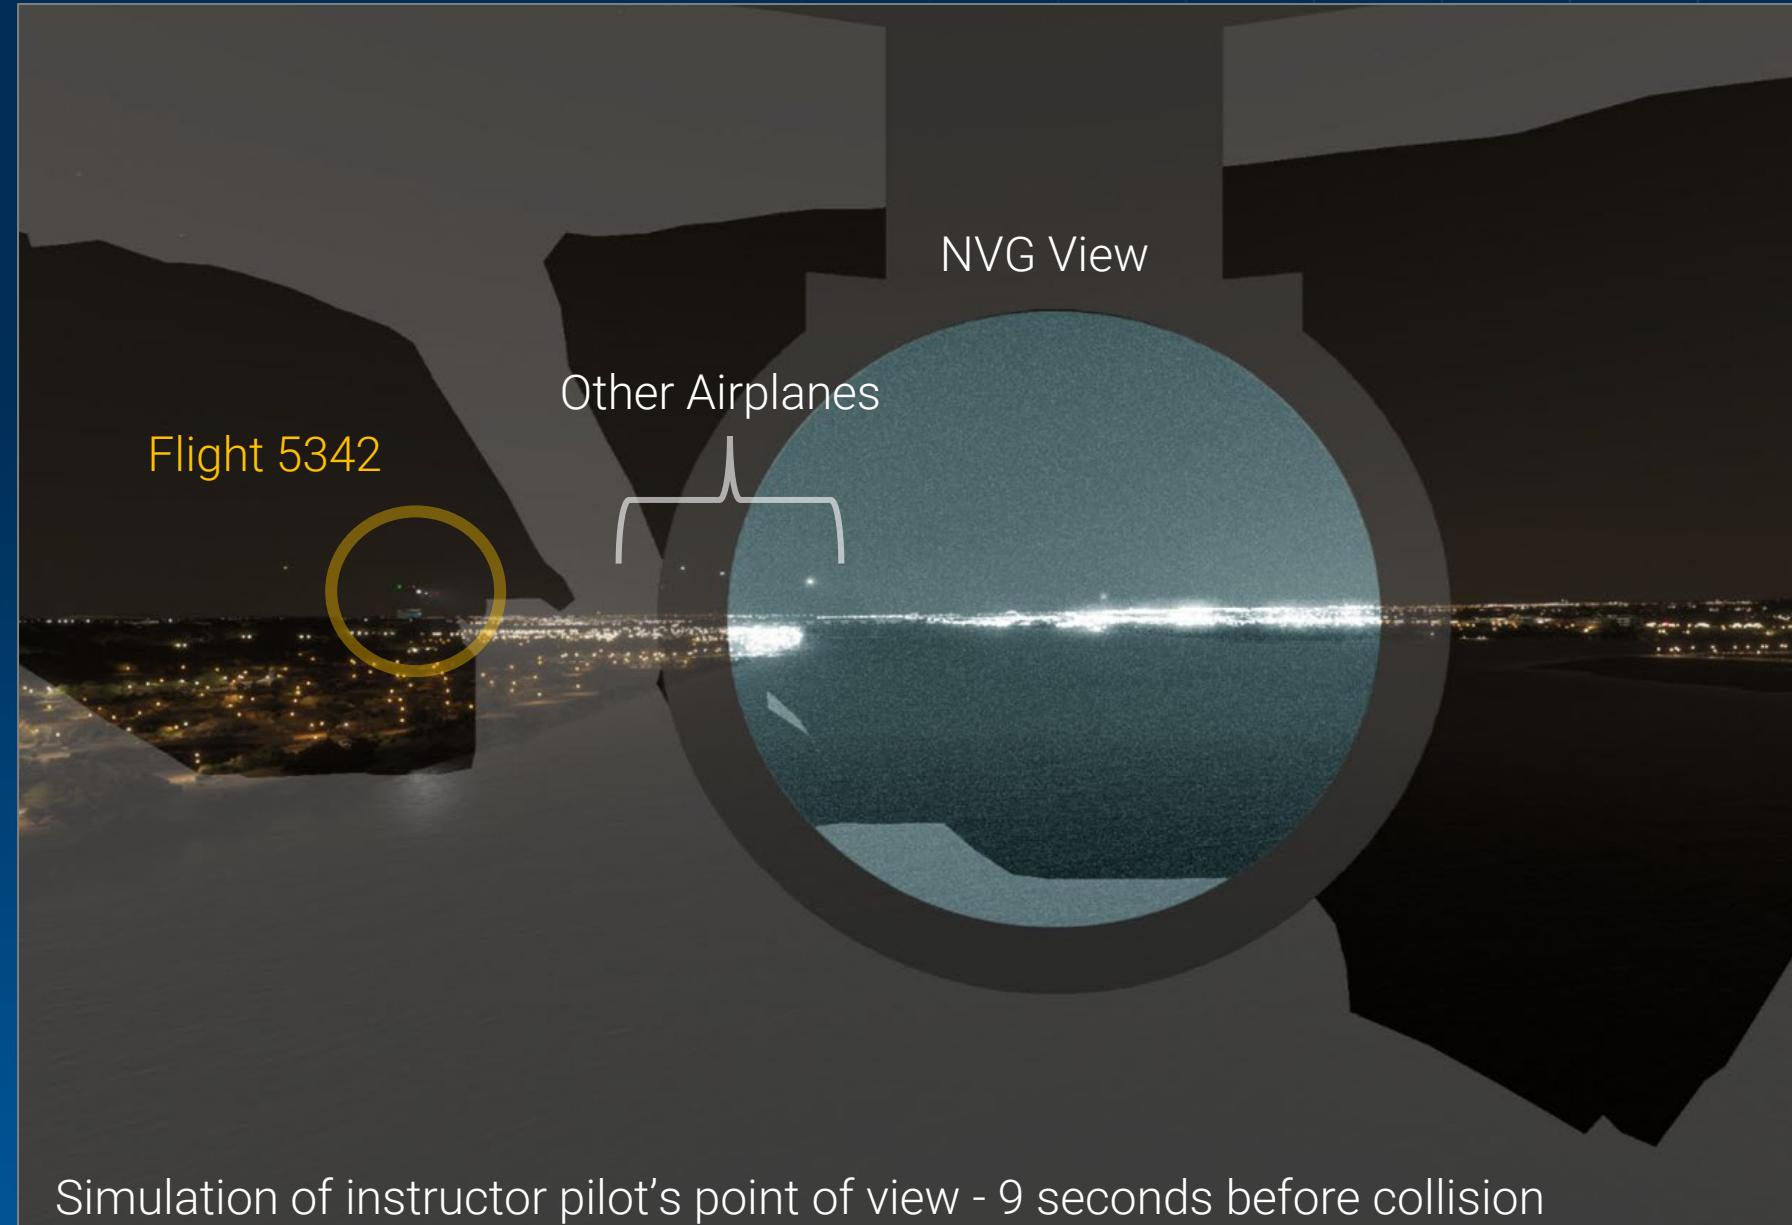
- Helicopter crew did not know where to look for the target
- Multiple other airplanes in view that could have been mistaken for the “CRJ”

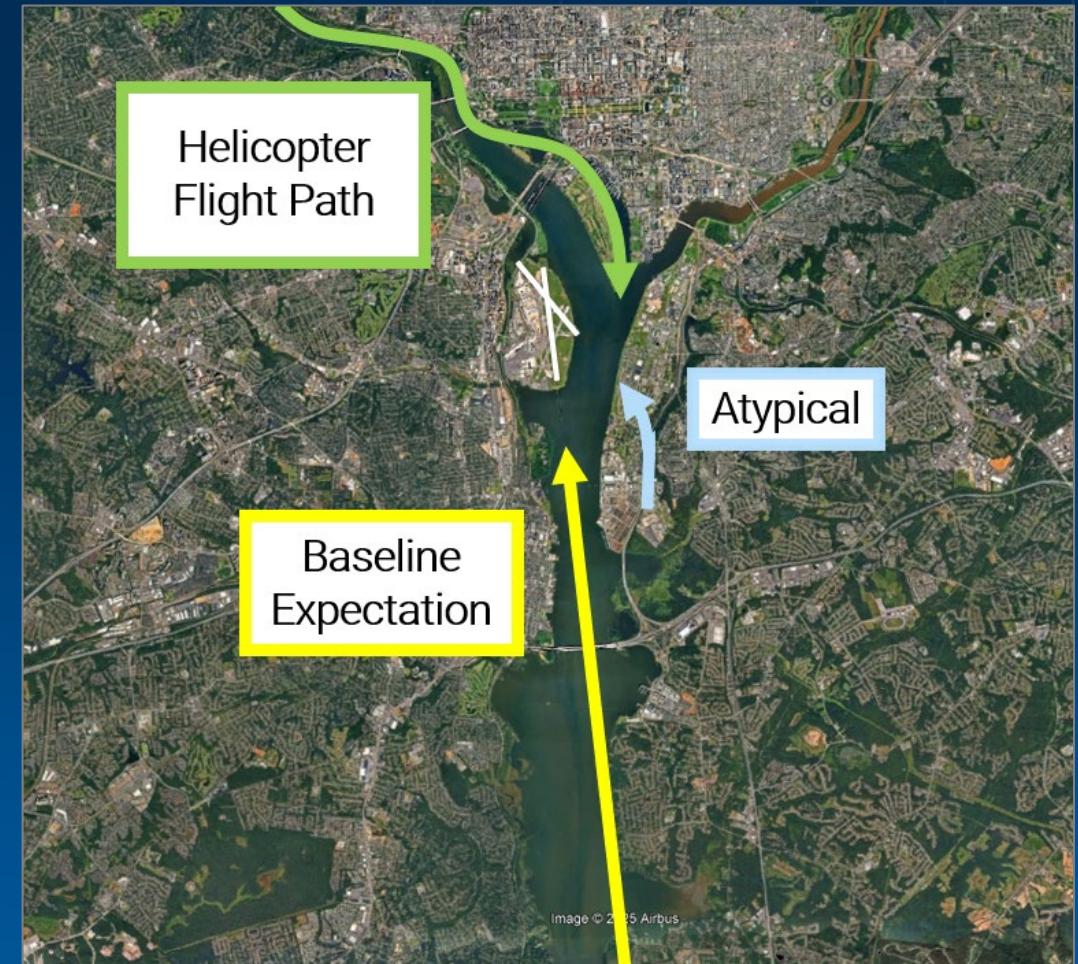
- Flight crew lacked an accurate mental model of CRJ's location and intended flight path
- Baseline expectations likely drove the instructor pilot's visual search
- Only 5 to 7% of northbound arrivals landed on runway 33
- Instructor pilot likely concluded "CRJ" was approaching runway 1

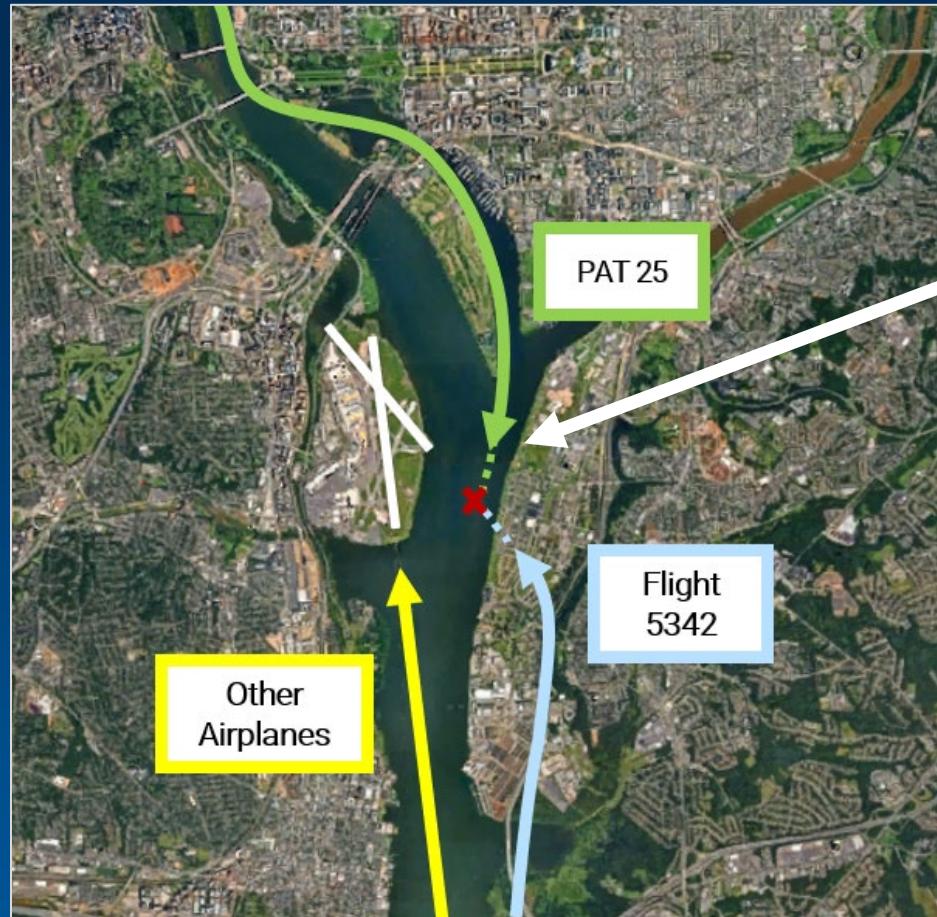
- Instructor pilot: "...Kinda come left for me... I think that's why he's asking"
 - No avoidance maneuver
 - No vocalization of concern

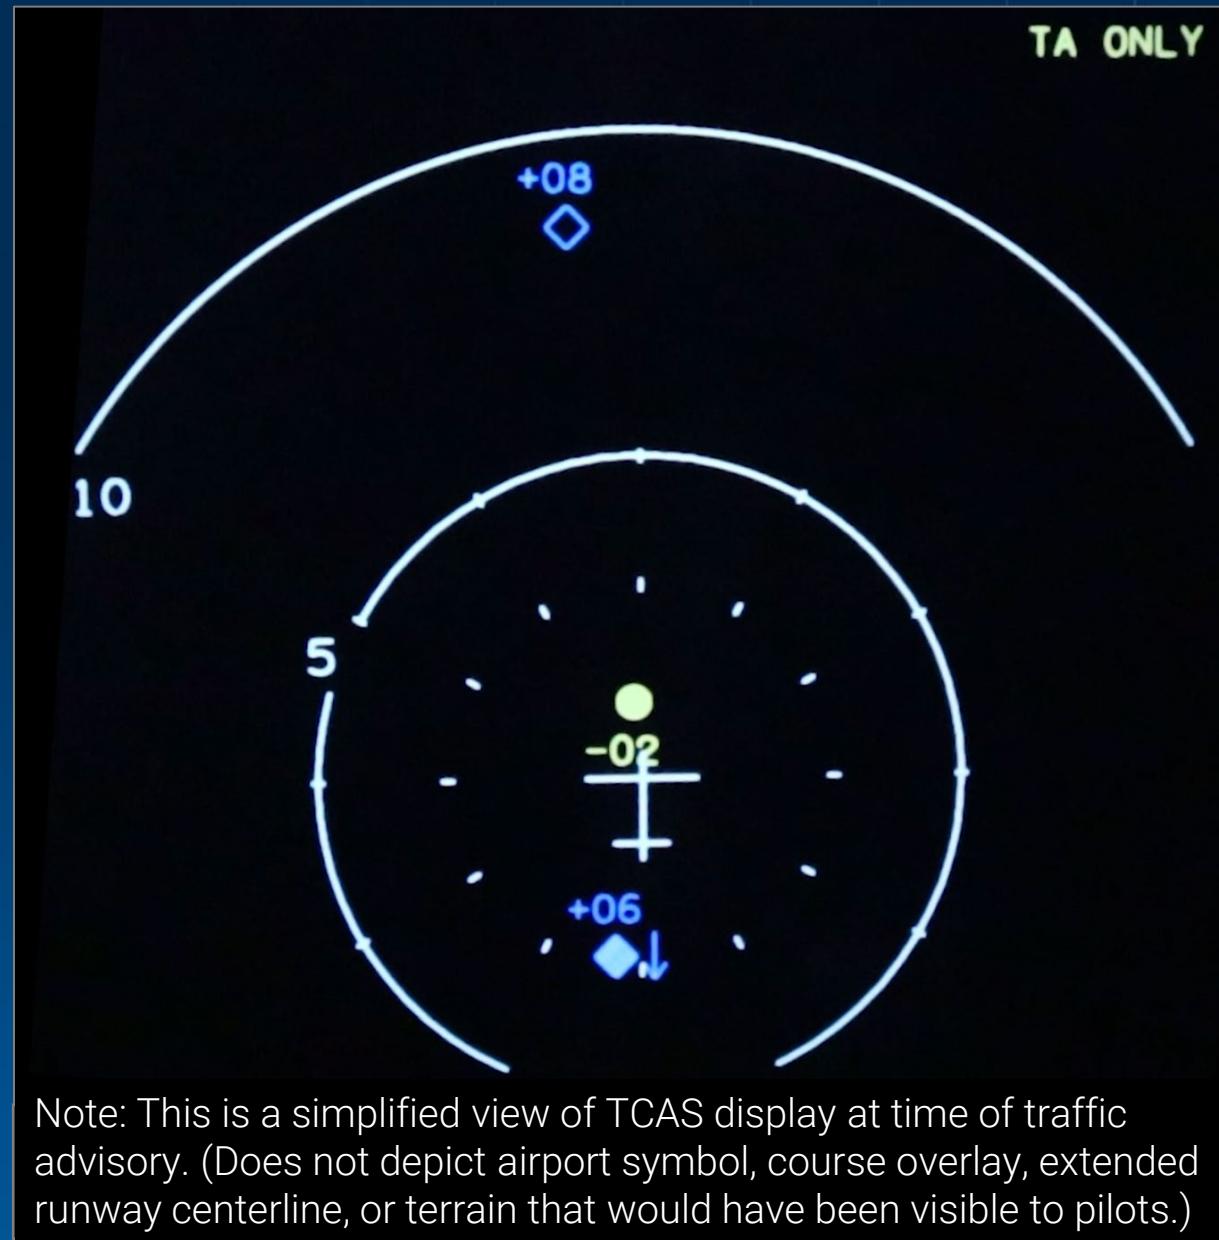
- Flight crew workload was high
- Pilots did not see helicopter until it was too late to avoid
- Pilots likely would have performed avoidance maneuver earlier if resolution advisory had occurred
- Flight crew likely unaware of severity of conflict until just before impact

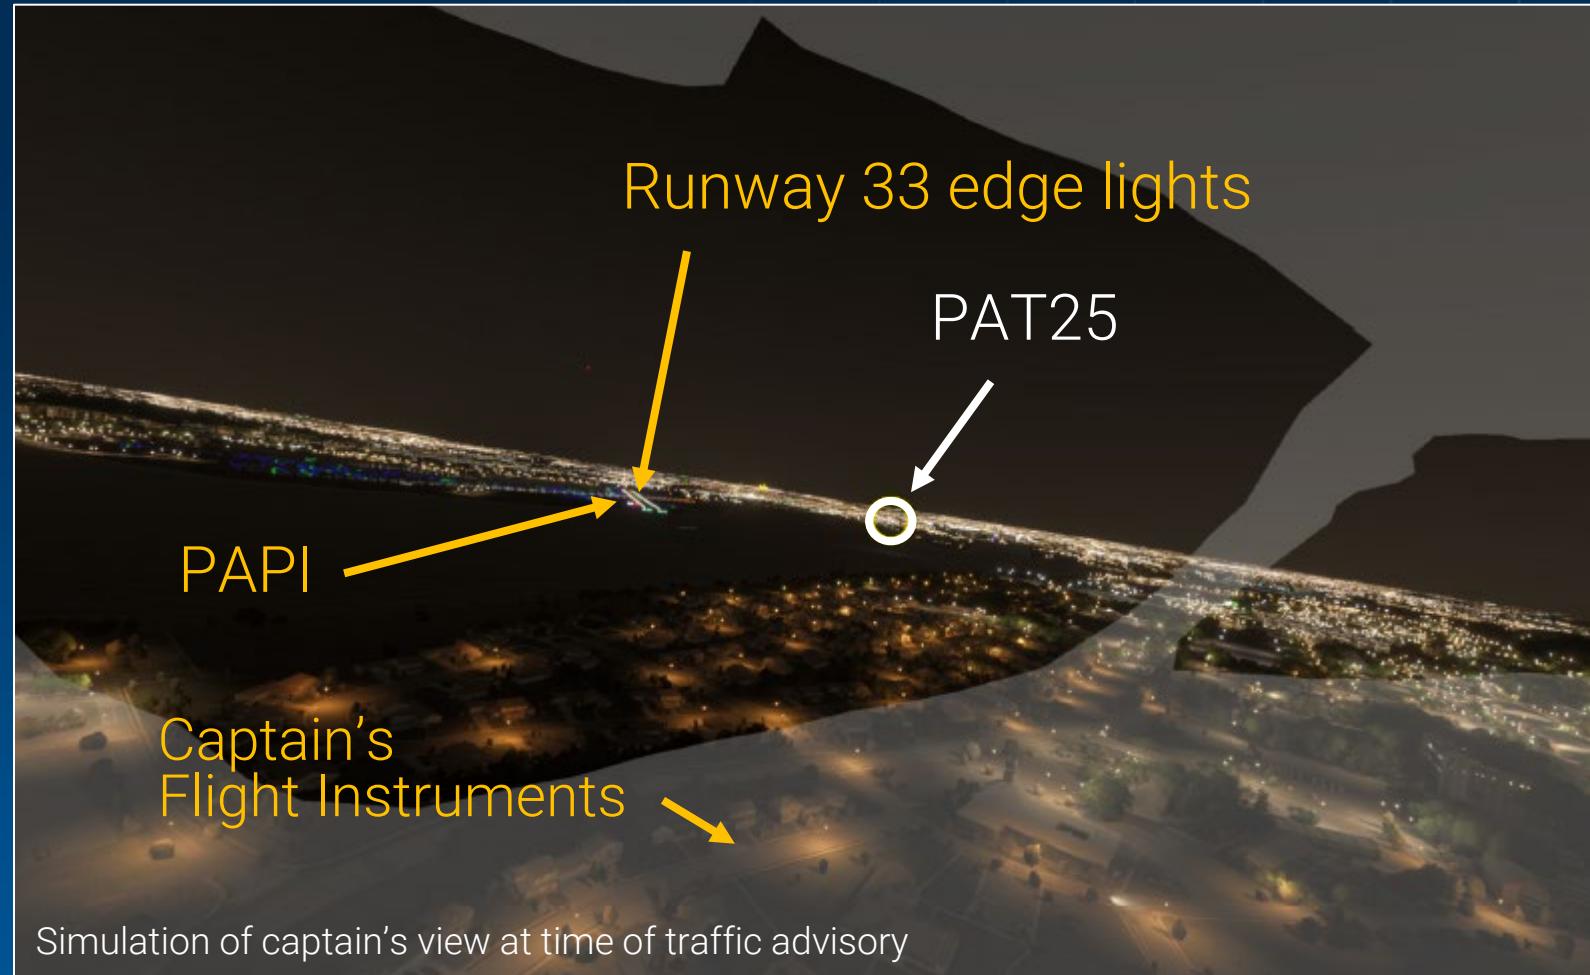
- Captain turning left on final approach to runway 33 when TCAS traffic advisory occurred
- Required control of thrust, airspeed, lateral path, and vertical path
- Referencing flight instruments, runway edge lights, PAPI
- Lacked capacity for extensive visual traffic search

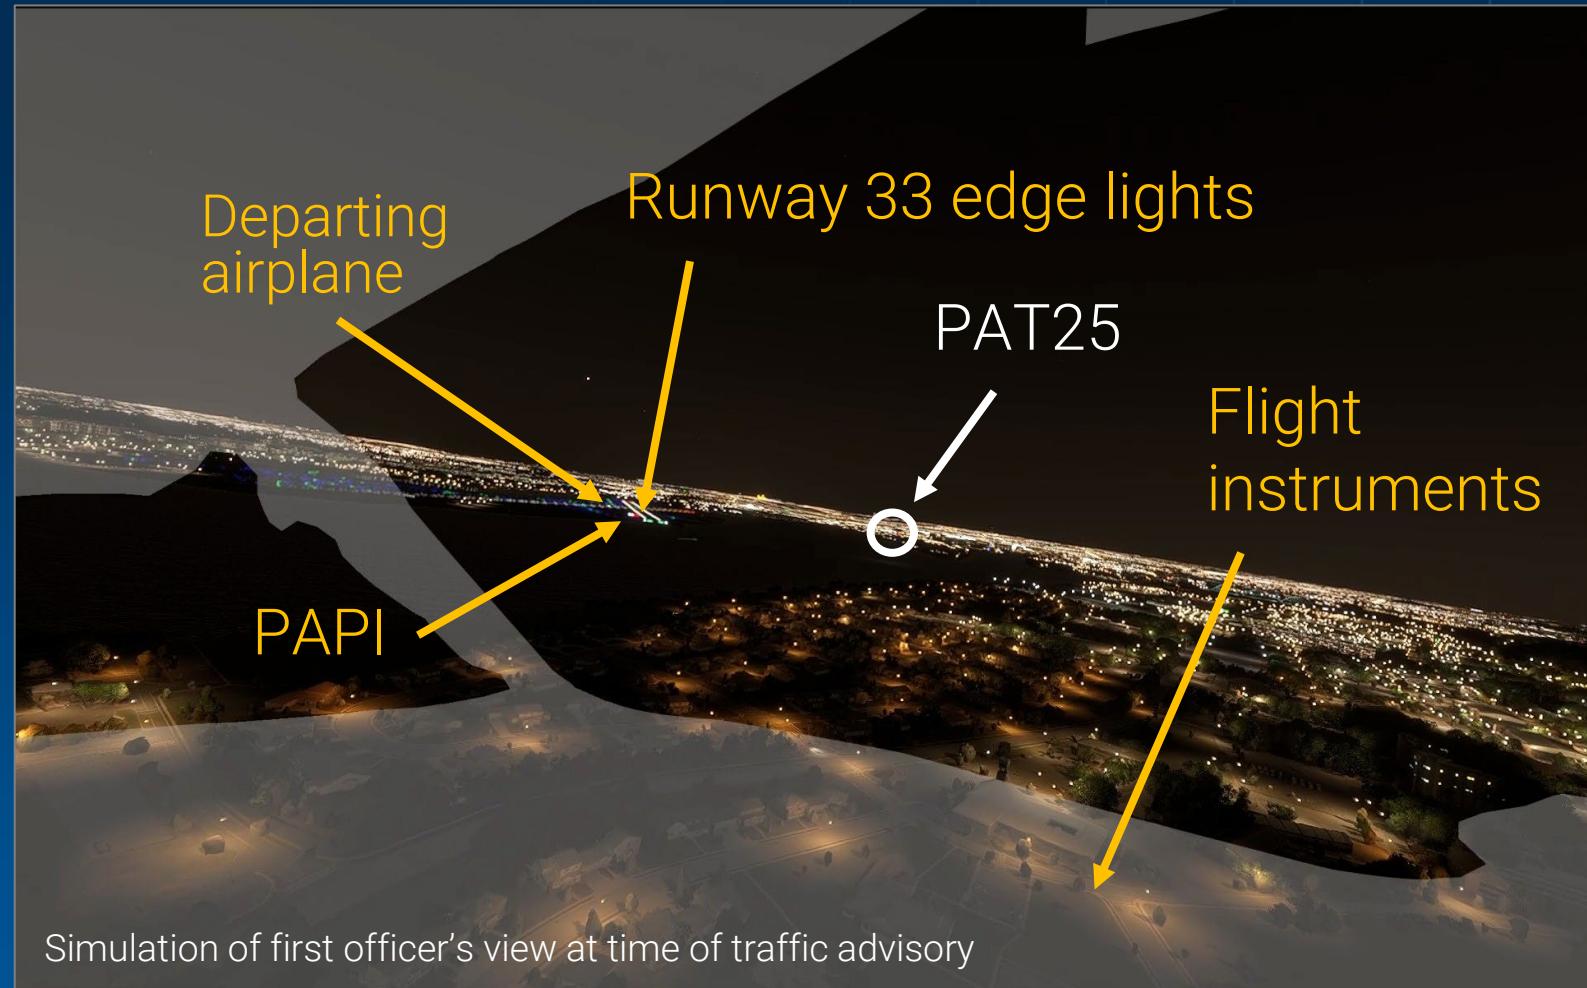
- FO responsible for ensuring approach remained stable
- Watching the flight instruments, runway edge lights, PAPI
- Likely also monitoring airplane taking off on intersecting runway
- Ability to search for traffic also constrained

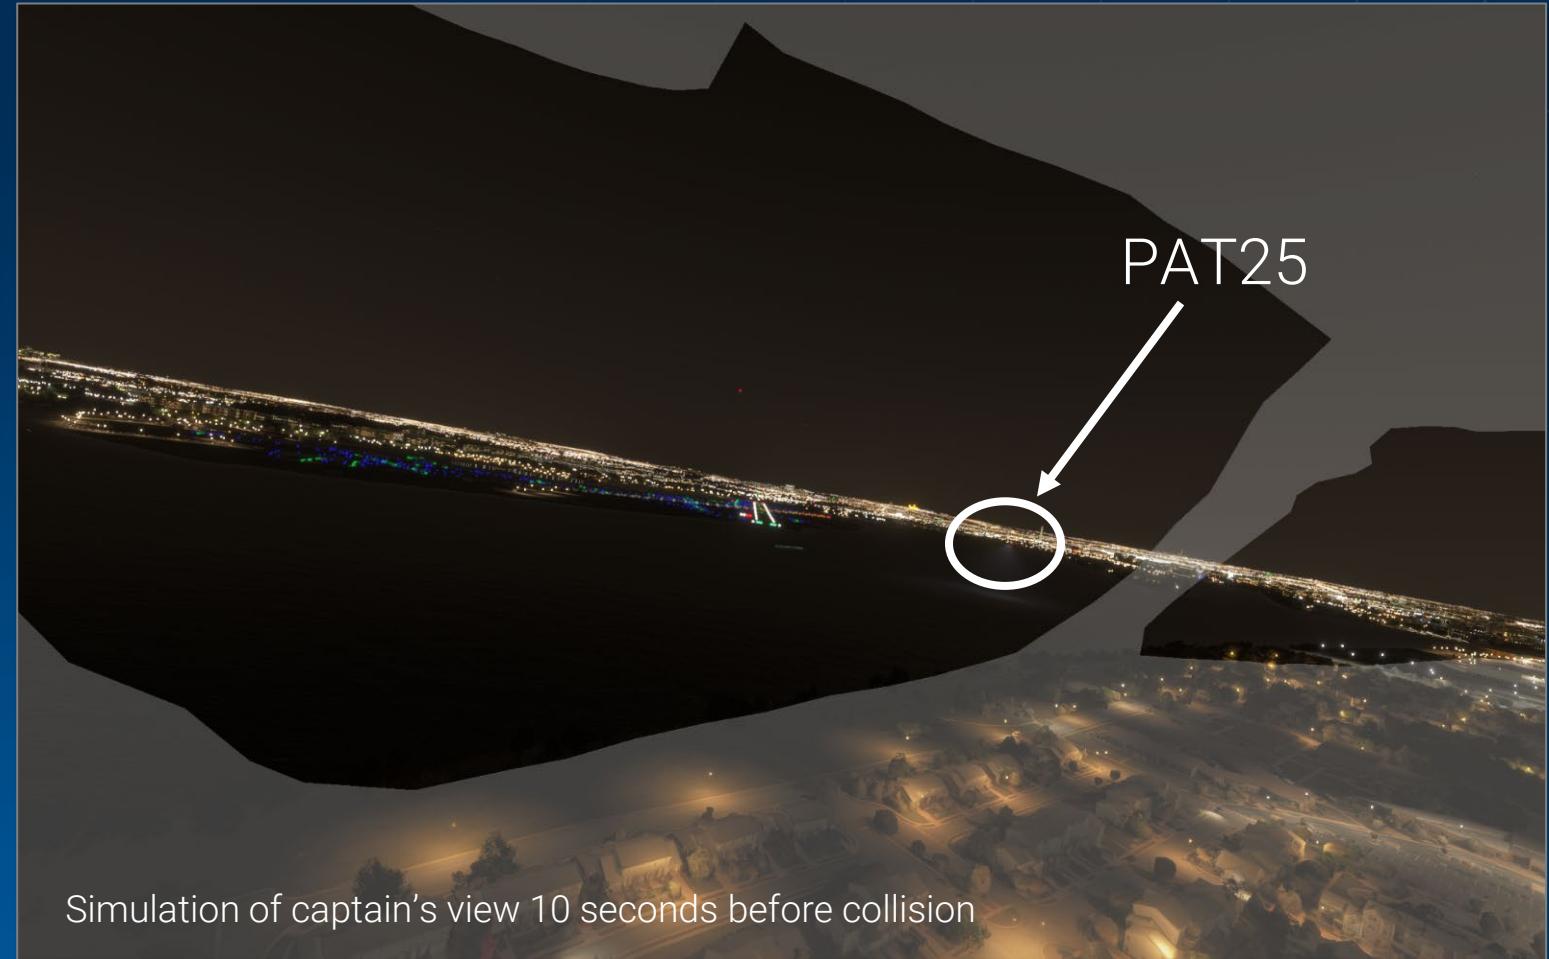
- Helicopter's low conspicuity
- Complex background
- Helicopter's lack of apparent motion
