Collision Between Vehicle Controlled by Developmental
Automated Driving System and Pedestrian
Tempe, Arizona
March 18, 2018

Accident Report

NTSB/HAR-19/03
PB2019-101402

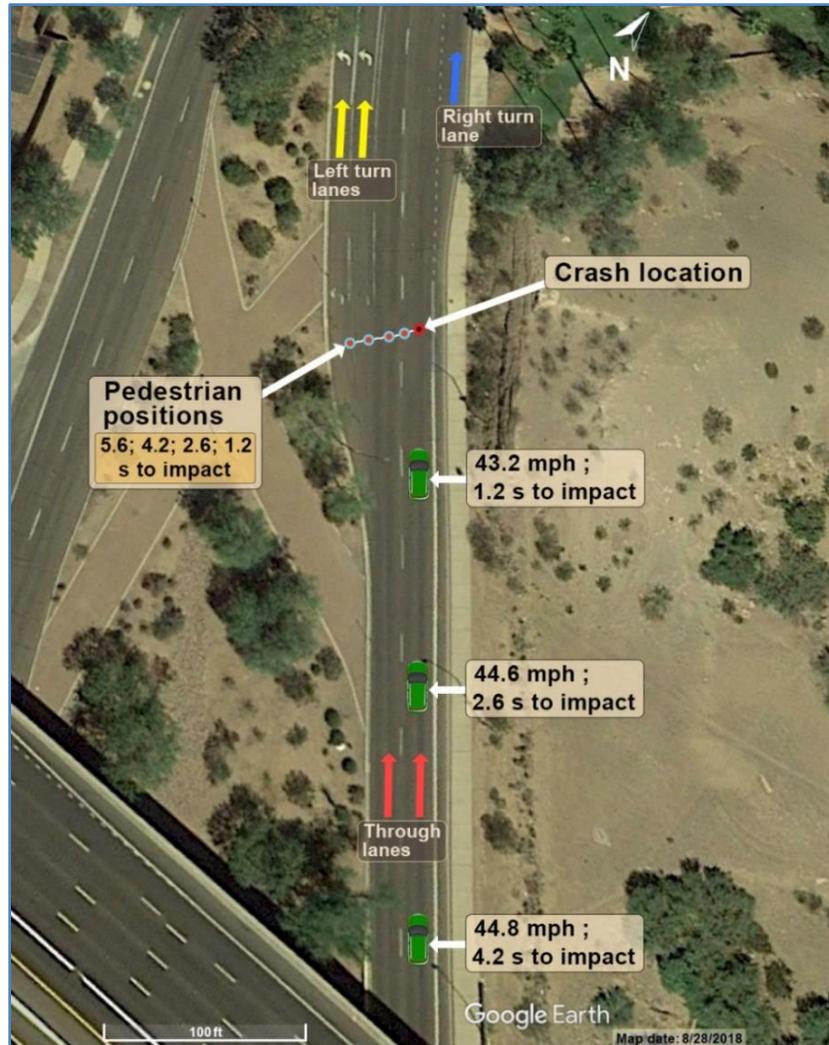
Figure 1. Aerial view of crash location showing path of pedestrian as she attempted to cross N. Mill Avenue and movement and speed of SUV at three points before impact. Pedestrian's path shows her position from initial detection (5.6 seconds before impact) until impact; SUV's position is shown at corresponding times beginning 4.2 seconds before impact. (Source: Adapted from Google Earth)

ADS data show that the operator began steering left 0.02 seconds before striking the pedestrian, at a speed of 39 mph. The video from the ATG-installed forward-facing camera shows that the pedestrian was struck by the SUV's front end at a near-perpendicular angle. The impact pushed the pedestrian under the SUV, which carried her with it. She came to rest 75 feet to the north, in the right-turn lane. The bicycle came to rest 105 feet north of the point of impact. The rest position of the SUV was 189 feet north of the point of impact, in the right-turn lane.

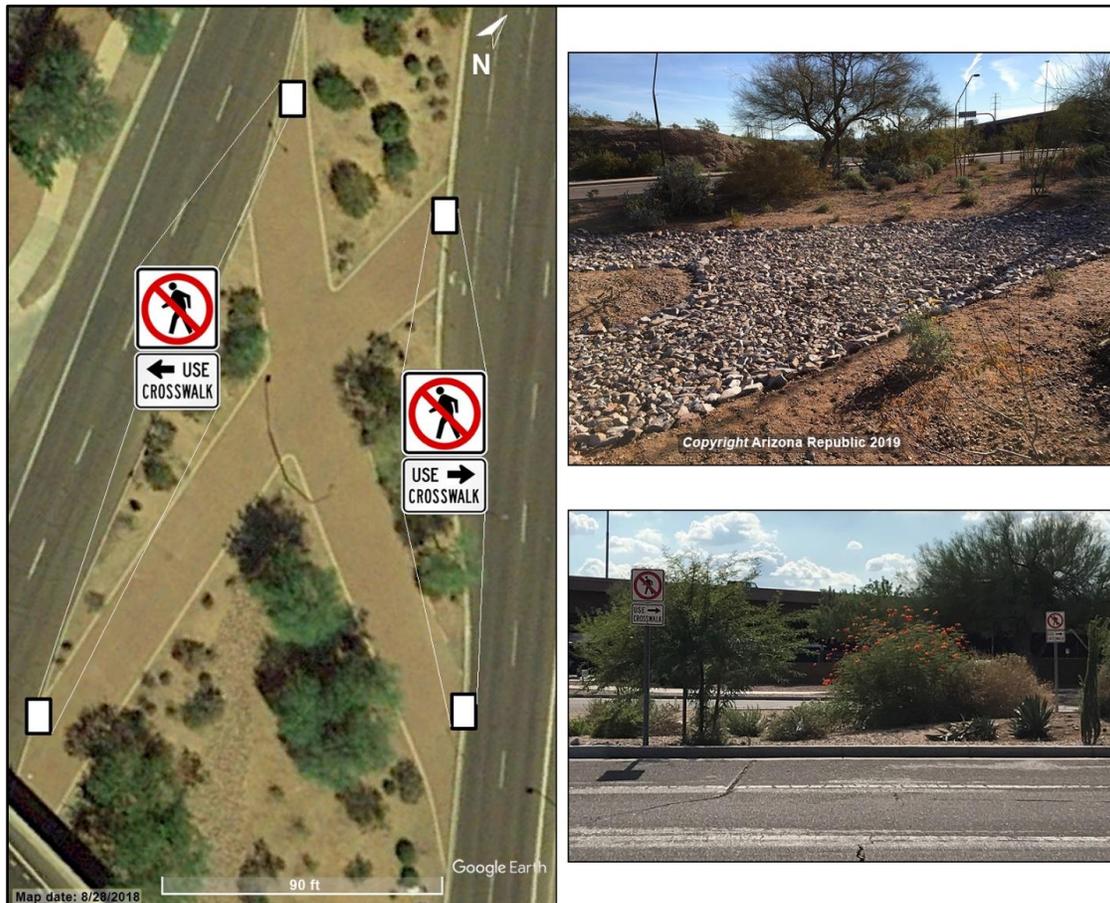
Figure 2. Configuration of median on N. Mill Avenue at time of crash (left image) and postcrash changes (right images). Aerial view in left image shows X-shaped configuration, location of signs prohibiting pedestrian crossing, and insets illustrating signs. Right image shows rocks placed postcrash on median (top) and double-sided signs prohibiting pedestrian crossing (bottom). (Sources: Left image adapted from Google Earth; top right image from *Arizona Republic*; bottom right image from city of Tempe)

The northbound and southbound travel lanes on N. Mill Avenue are separated by a landscaped median. Next to the crash site, the median is about 71 feet wide and includes an X-shaped, red-brick configuration, which at the time of the crash had the appearance of a pathway (figure 2). Also at the time of the crash, the median contained four signs prohibiting pedestrian crossing. Each consisted of a no-pedestrian-crossing symbol with an accompanying USE CROSSWALK plaque (see figure 2).⁹ Two of the signs were on the median's east edge and faced the northbound roadway, about 30 feet north and 130 feet south of the crash site.

After the crash, the city of Tempe added four signs to the existing signposts prohibiting pedestrian crossing, resulting in four double-sided prohibition signs that are visible from both the median and the roadway. The city also removed the X-shaped decorative brick path and replaced it with rocks, creating a terrain unsuitable for walking (refer to figure 2).

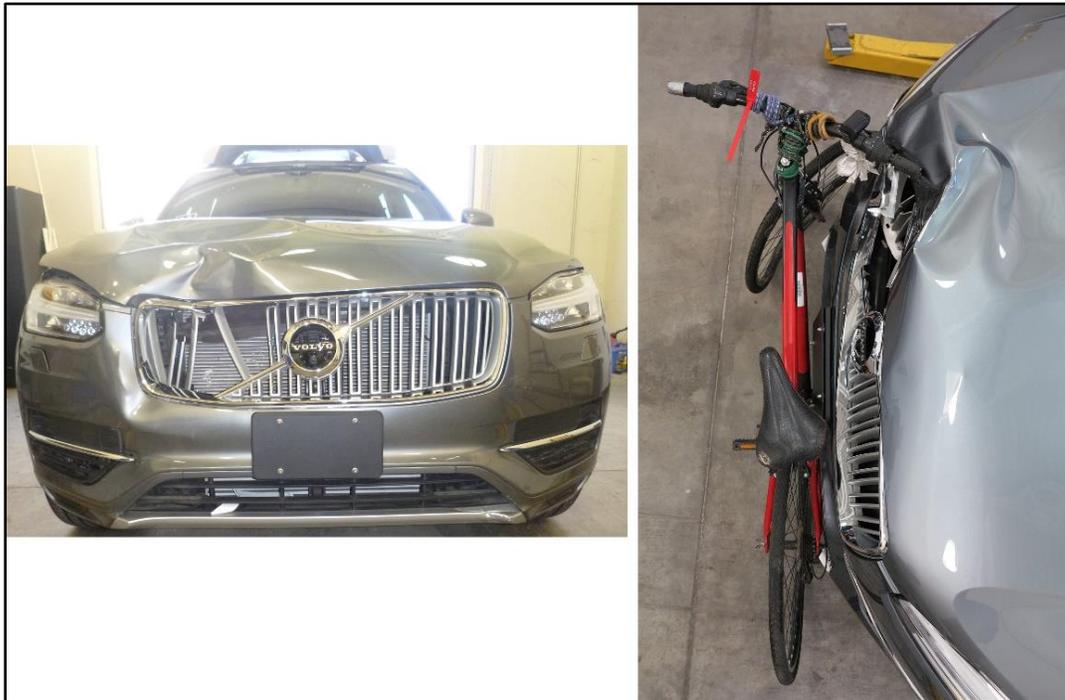
Figure 3. SUV postcrash showing damage to front end (left image) and overhead view of bicycle's position at impact (right image).

1.4.1.2 Damage. The SUV sustained damage to the front end. Contact damage on the front bumper, grille, and hood was concentrated in an area slightly offset toward the passenger side (see figure 3). Both bicycle tires left impressions on the SUV's bumper cover. Scrape marks were visible on the lower left corner of the SUV's front spoiler, caused by the bicycle's rear sprocket assembly. The headlights were intact, and there was no other external damage. The vehicle's interior was unaffected by the crash.

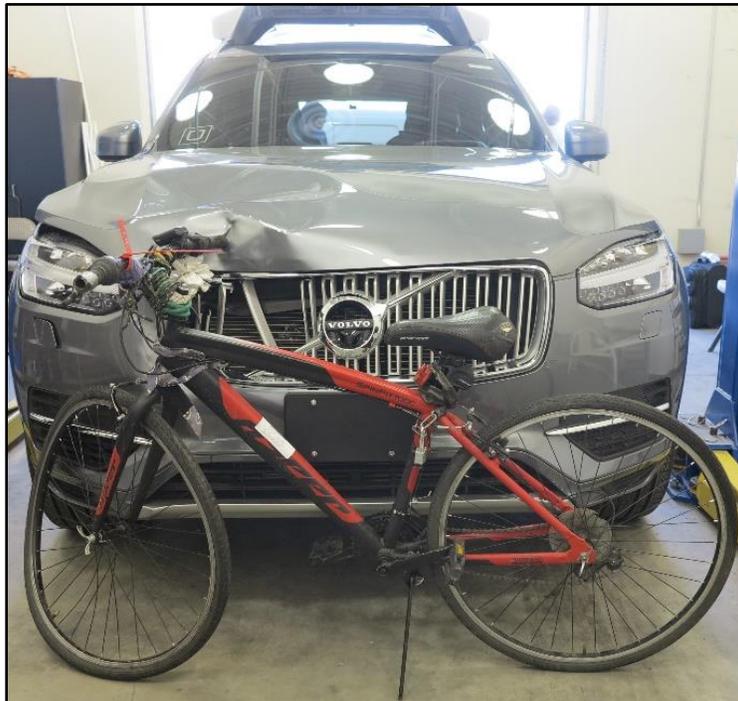
Figure 4. Approximate position of bicycle at impact.

The bicycle was a 2017 700c Hyper SpinFit manufactured by Hyper Toy Company. As a result of the crash, the bicycle’s front wheel was twisted, and the front fork was misaligned with the handle bars (figure 4 shows the bicycle’s position at impact).

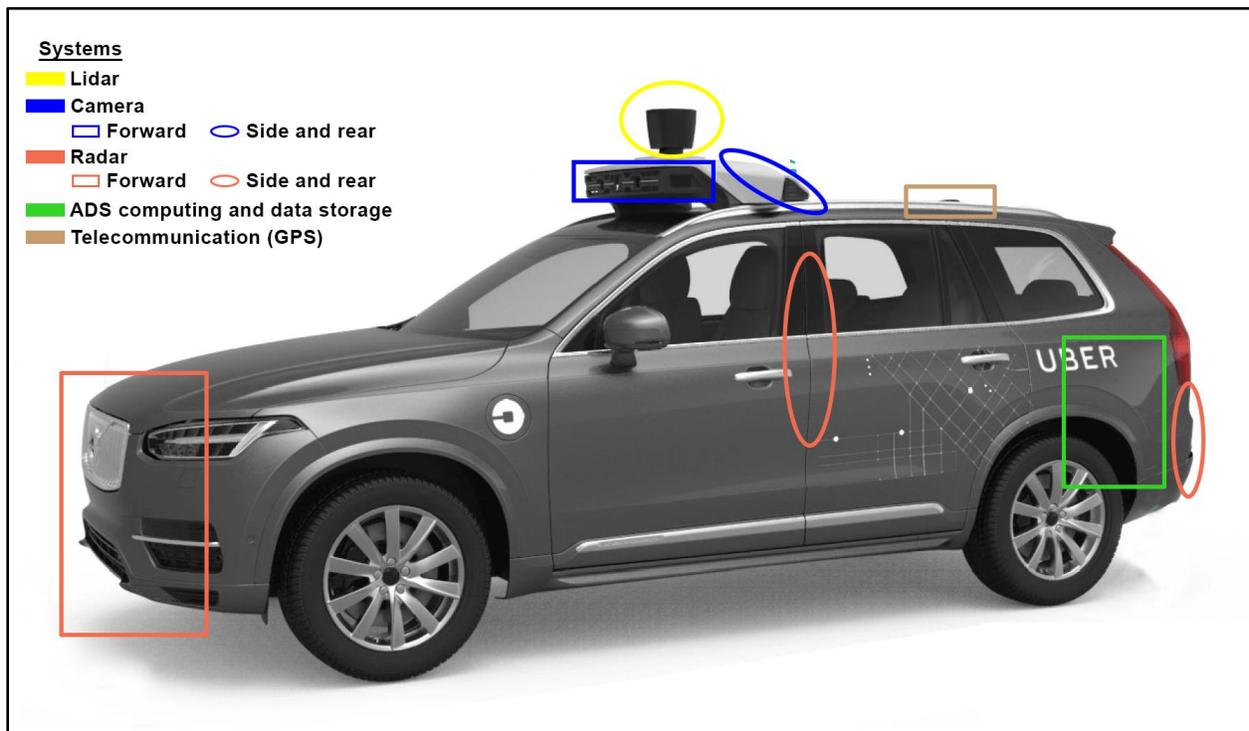
Figure 5. Location of sensor components on 2017 Volvo XC90 equipped with ATG's ADS. (Not all locations of sensor components are shown)

1.5.2.1 Lidar System. The lidar system consisted of a single lidar unit mounted on the forward half of the SUV's roof, as shown above (figure 5).²² The lidar, which was manufactured by Velodyne, had a range of over 100 meters (328 feet) and could detect objects in a 360-degree radius. Initial processing of lidar data was done by the Velodyne processing unit. The ADS then used the data to build a representation of the surrounding environment, which was continually updated as the system detected new objects.

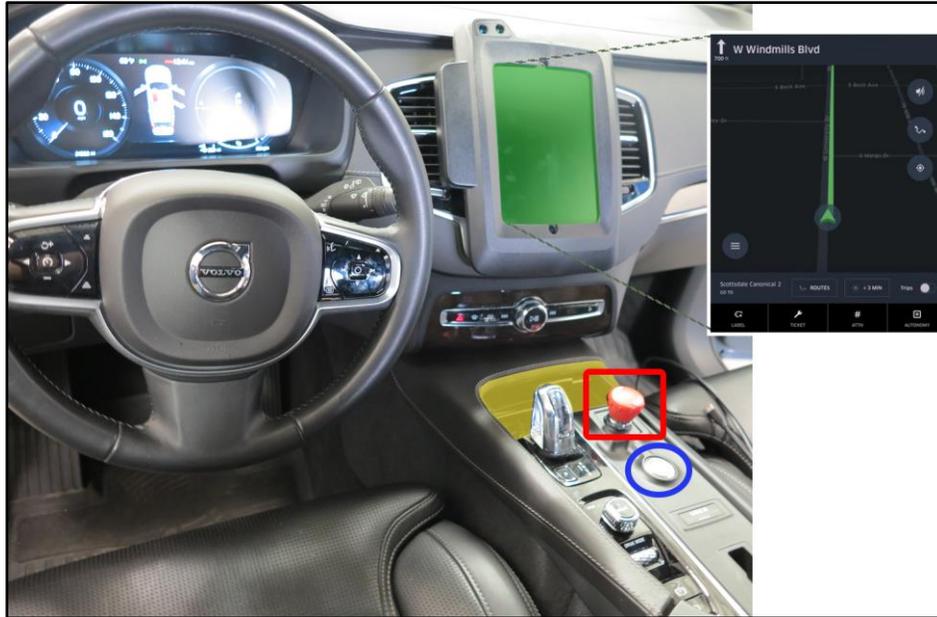
Figure 6. SUV interior showing locations of slot that could mount a cell phone (yellow region in center console), ADS engagement/disengagement knob (red), ADS engagement button (blue), and HMI (with inset illustrating image on tablet).

HMI data show that 19 minutes 25 seconds before the crash, the system alerted the operator that the ADS was disengaging. That prompted the operator, 3 seconds later, to take manual control of the vehicle. ADS disengagement would have followed the process described in section 1.5.4.2.³⁹ The operator tagged the disengagement on the tablet. Ten seconds later, 19 minutes 12 seconds before the crash, the operator reengaged the ADS. For the rest of the crash trip, the operator did not interact with the tablet, and the HMI did not present any information that required the operator's input on the tablet.

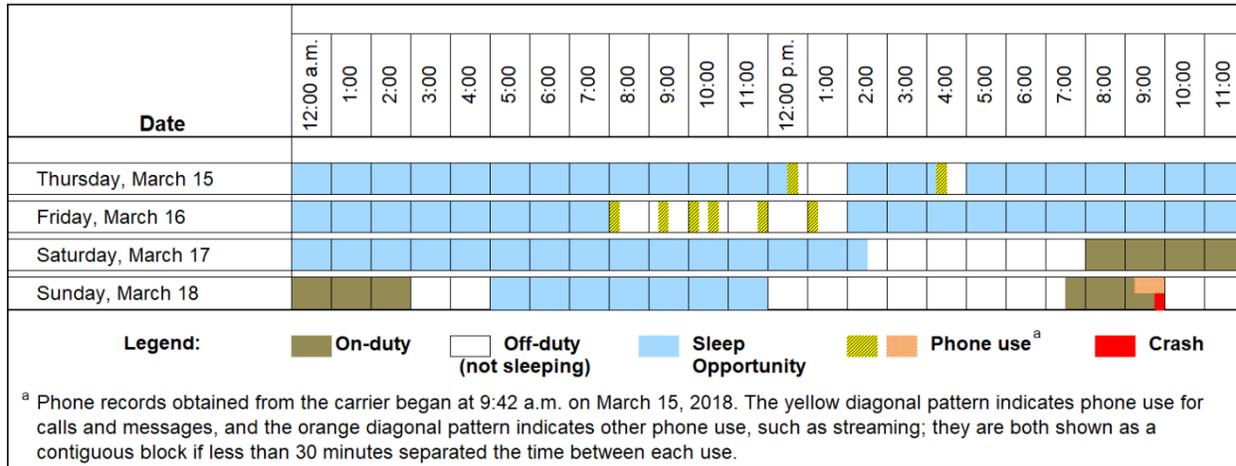
Figure 7. Precrash activities of vehicle operator, March 15–18, 2018.

her shift at 7:30 p.m.⁵³ At the time of the crash, the operator had been on duty driving—manually in the ATG terminal and in autonomous mode on public roads—about 45 minutes.⁵⁴ Figure 7 shows the vehicle operator’s activities in the 3 days before the crash and on the crash day.
