# National Transportation Safety Board

## Chicago Transit Authority Train Collides with Bumping Post and Escalator at O'Hare Station

Chicago, Illinois

DCA14FR007

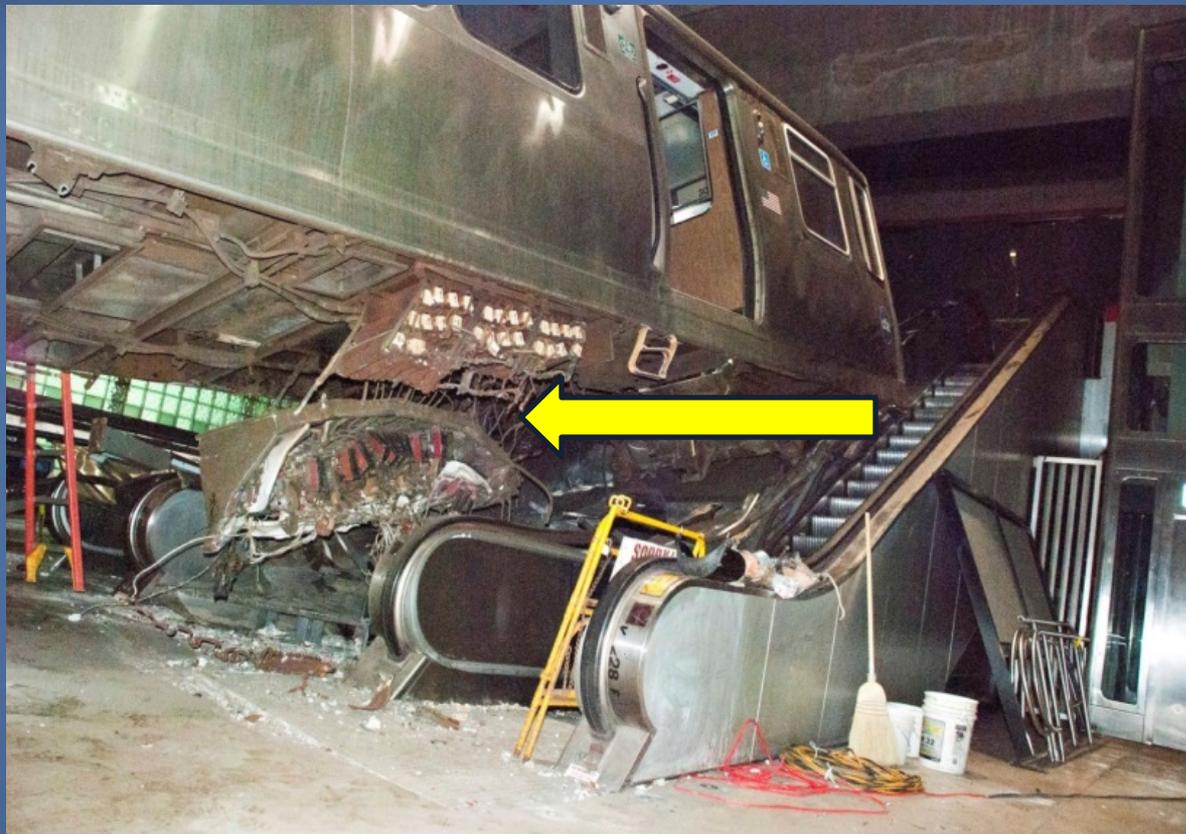
# Location of Fault Logger

- Are not event recorders
- Collect data only after an event
- Limited amount of data
- May not be protected
