National Transportation Safety Board

Occupant Survivability, Emergency Response, and Frangible Structures

Survival Factors presentation

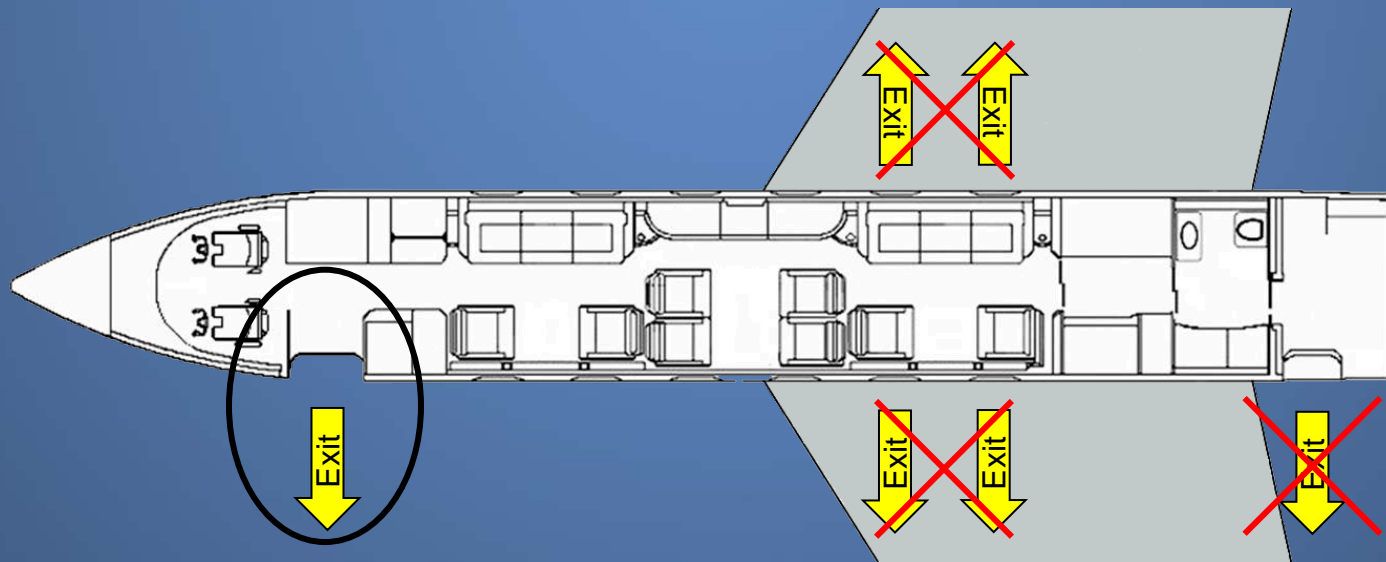
- Fire erupted “almost instantaneously” likely near wing root area

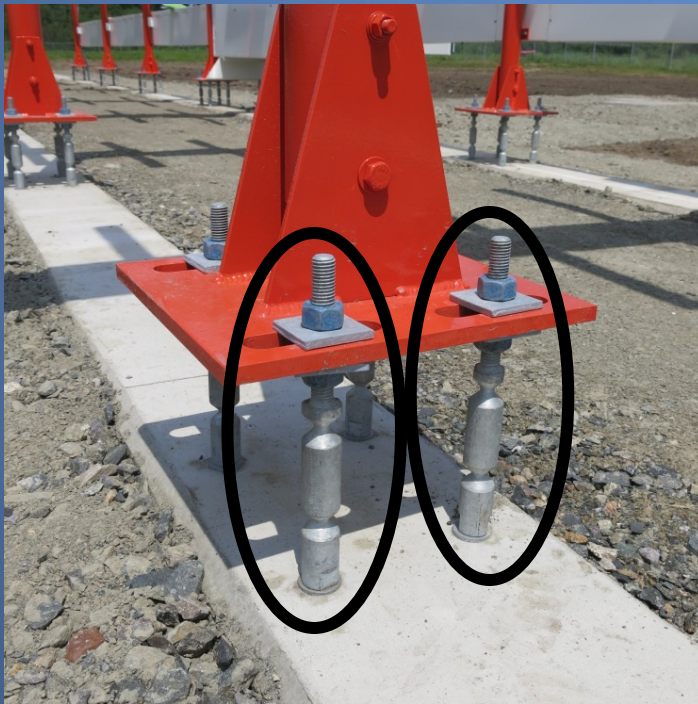
Frangible localizer antenna support

- FAA used frangible fittings for replacement at BED
- FAA encourages incorporation of frangible fittings in areas adjacent to RSAs
- No current method for identifying nonfrangible structures outside RSAs

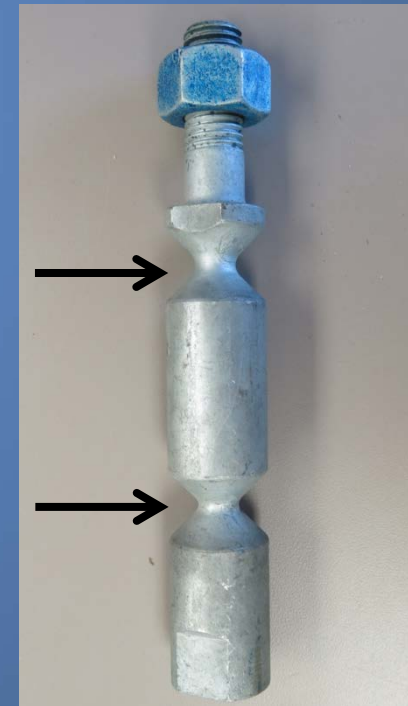
Frangible connector
