# National Transportation Safety Board

Heart of Texas Hot Air  
Balloon Rides  
Kubíček BB85Z Balloon  
Lockhart, Texas  
July 30, 2016  
Paul Suffern  
Meteorology Investigator

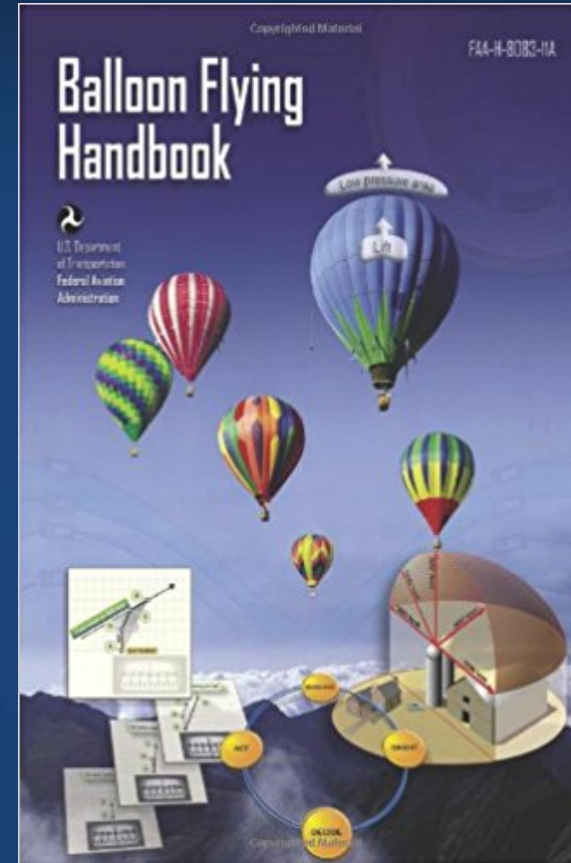
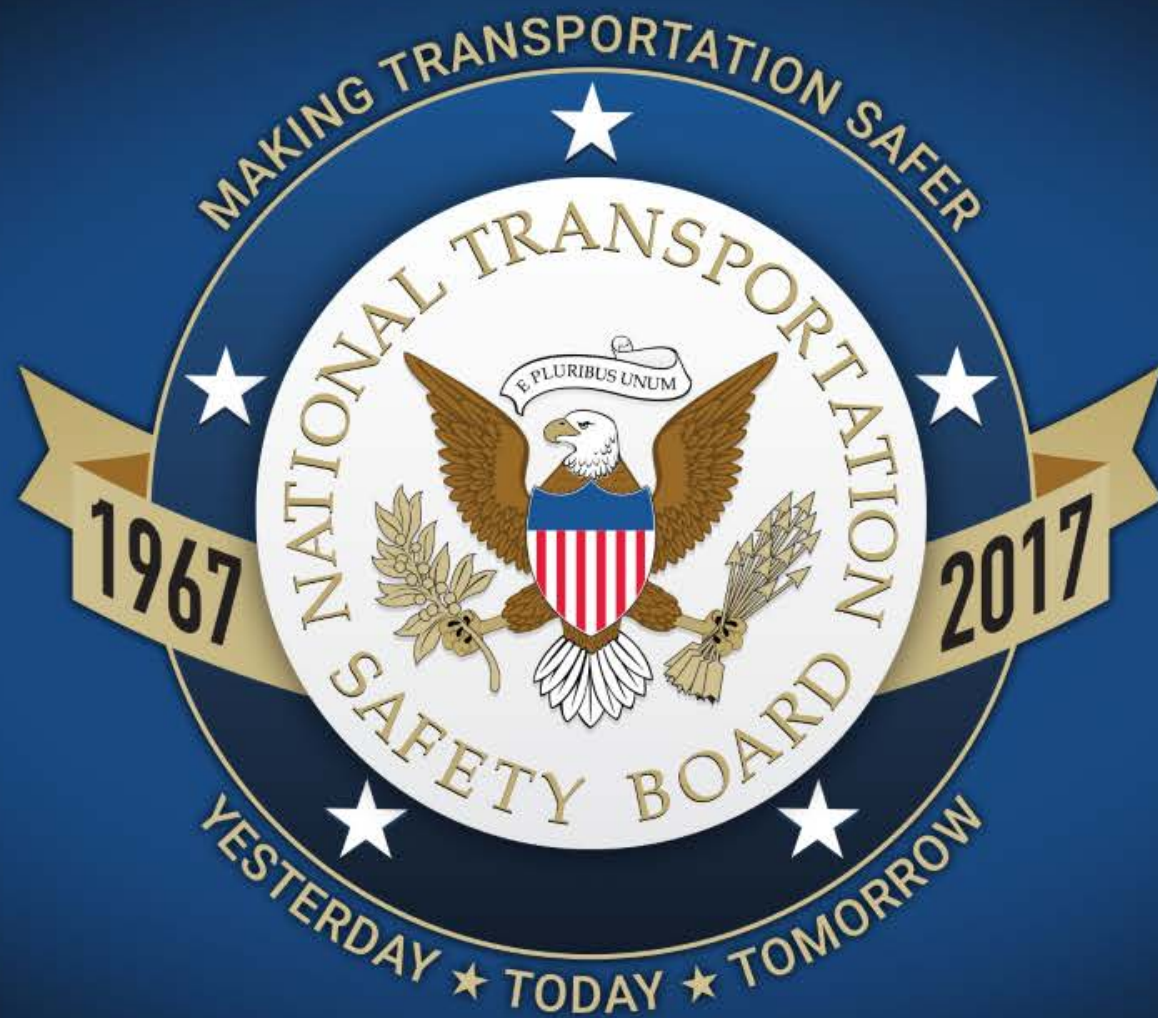
# Low Cloud and Fog Guidance

- Temperature and dew point close together
- FAA *Balloon Flying Handbook* fog information
