National Transportation Safety Board

Agricultural Labor Bus and Truck-Tractor Collision

St. Marks, Florida
July 2, 2016

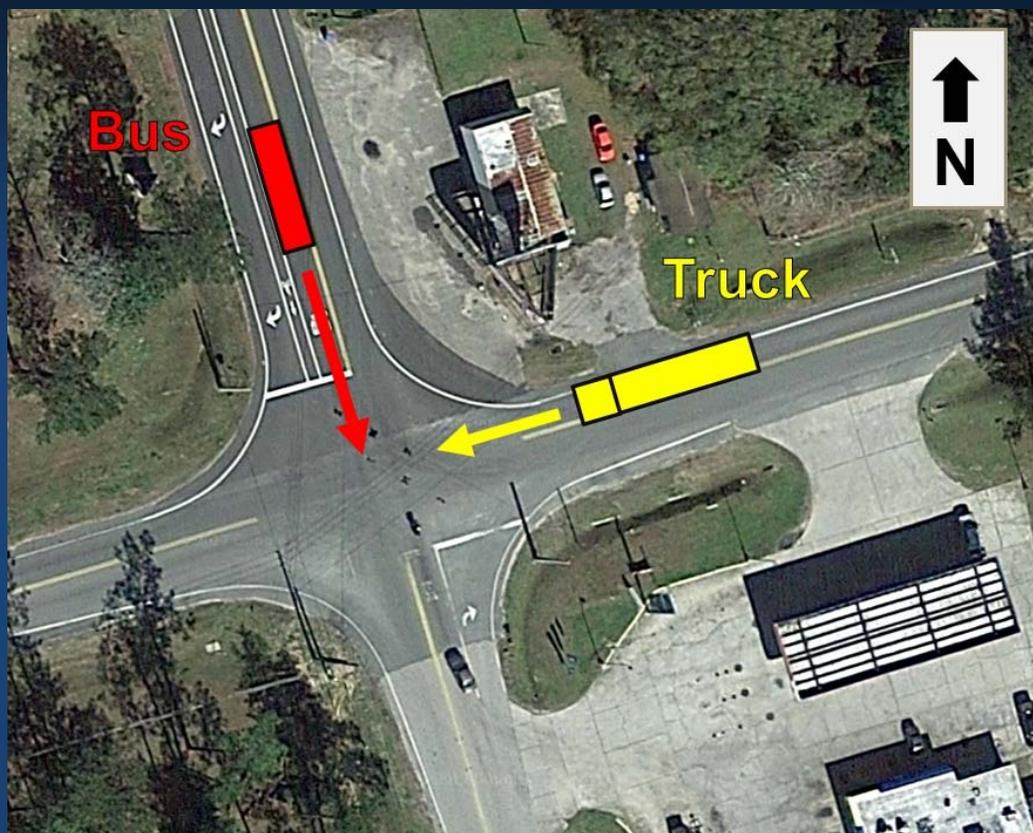
Crash Overview

- Bus heading south on SR-363
- Truck heading west on US-98
- Speed limit 45 mph

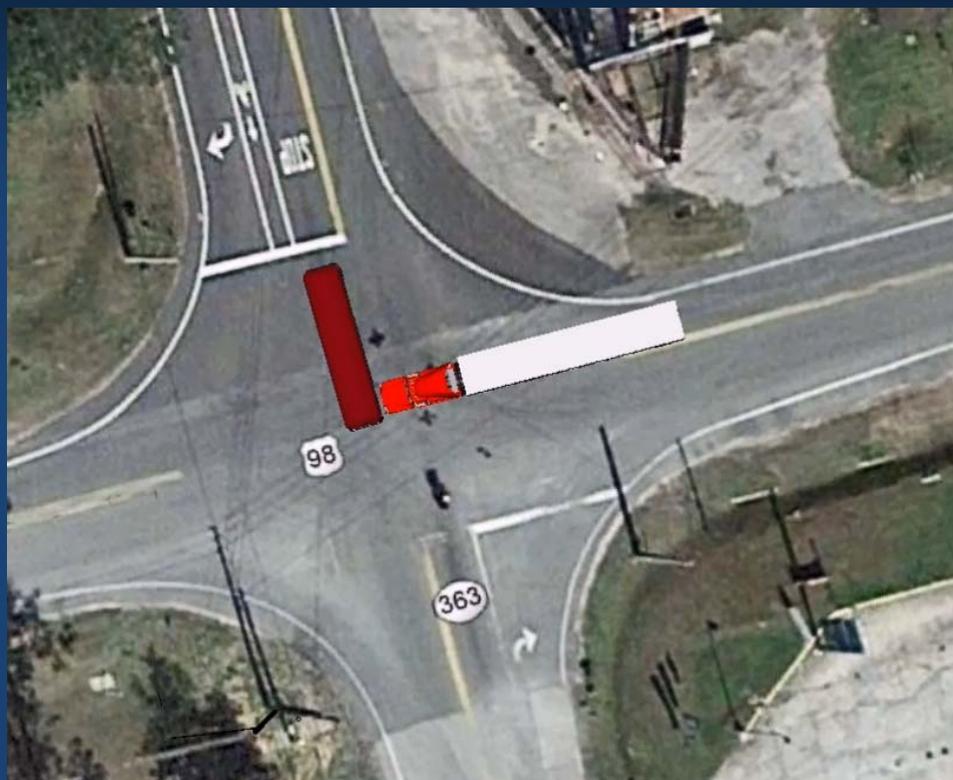
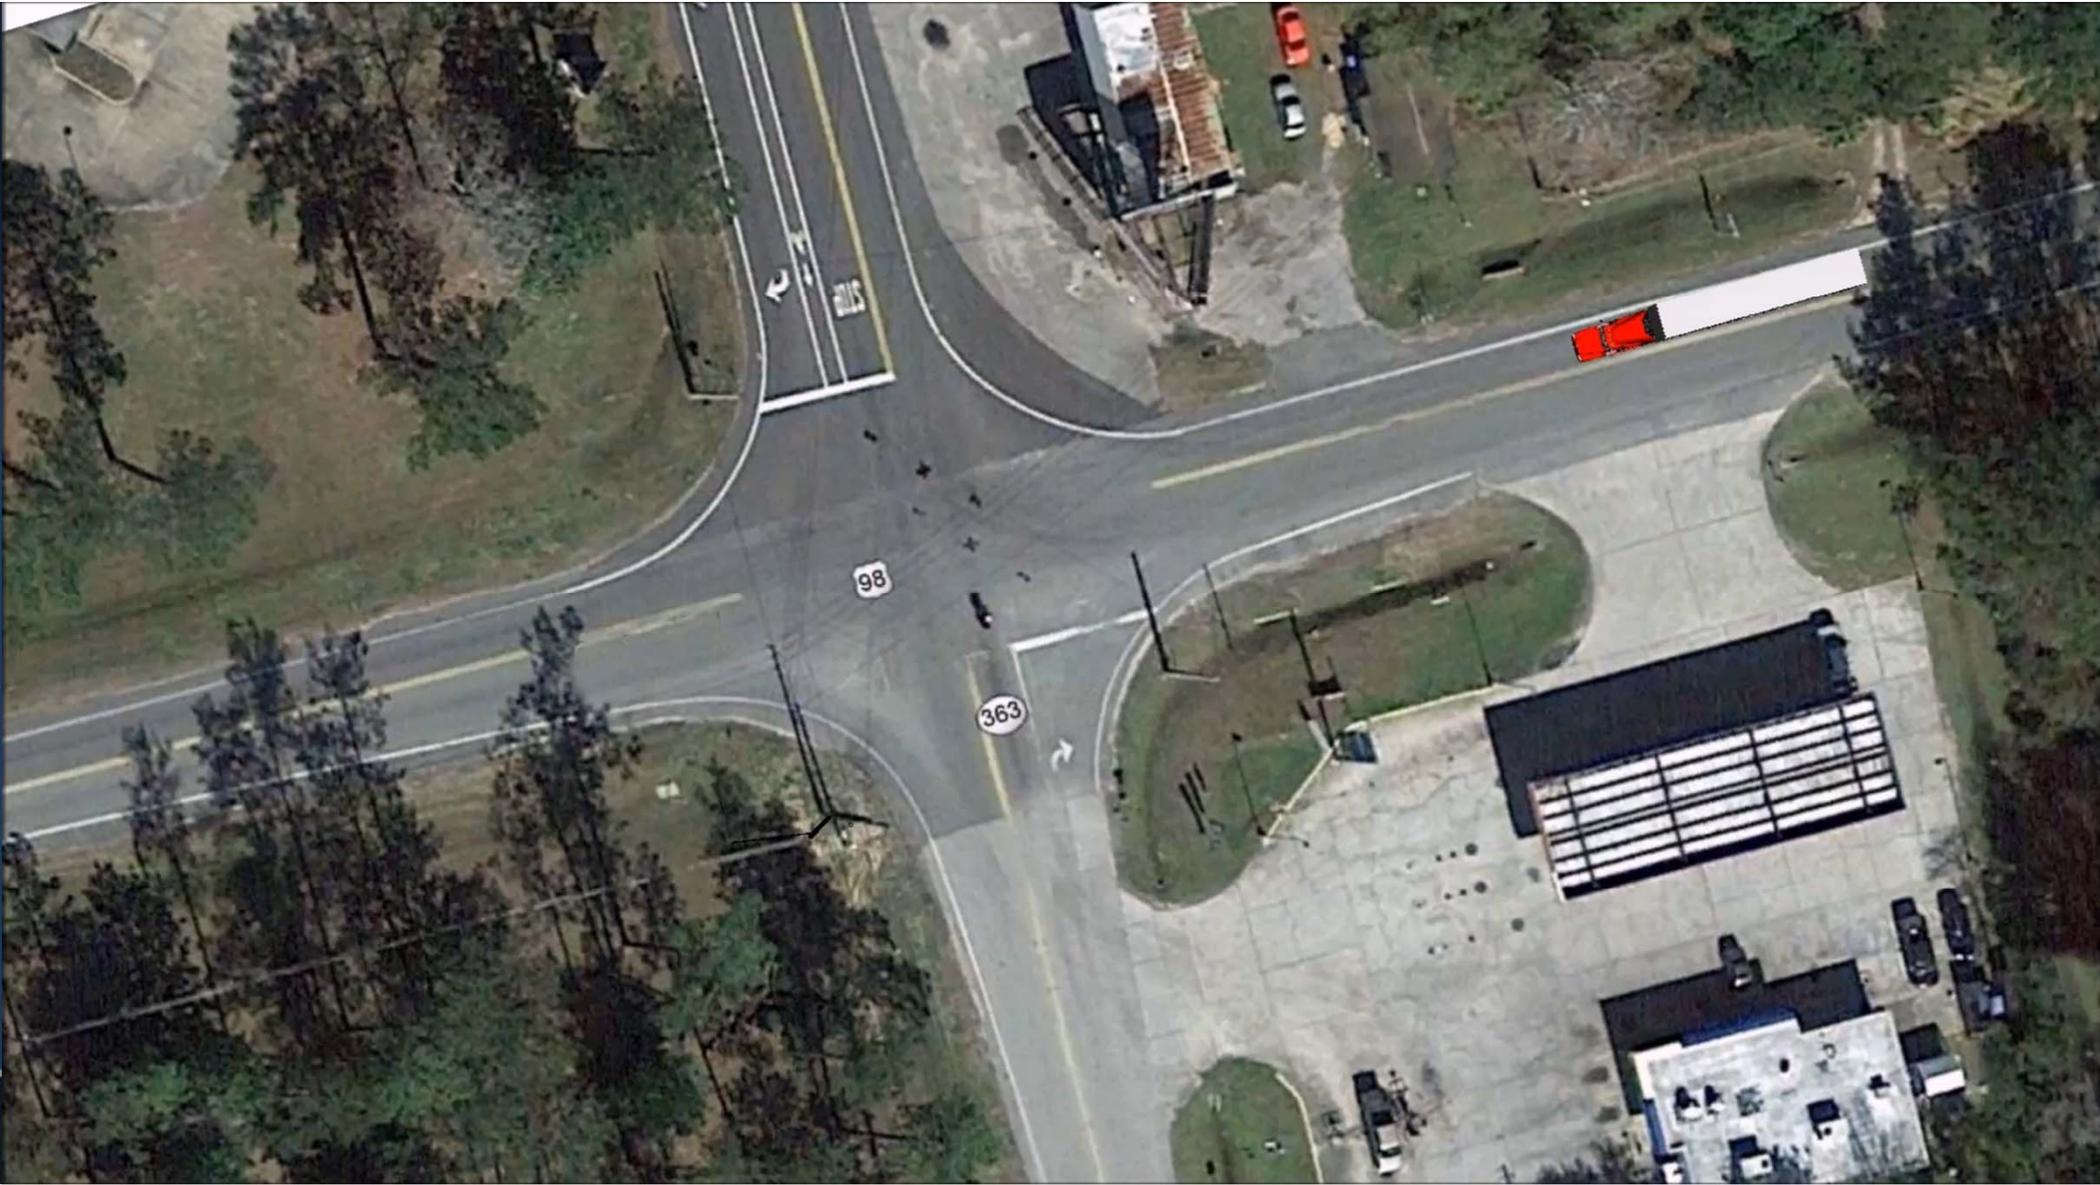
Video Evidence and Crash Simulation

- Bus – 46 mph
- Truck – 44 mph

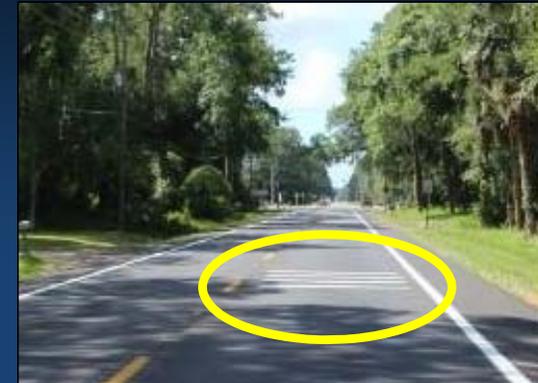
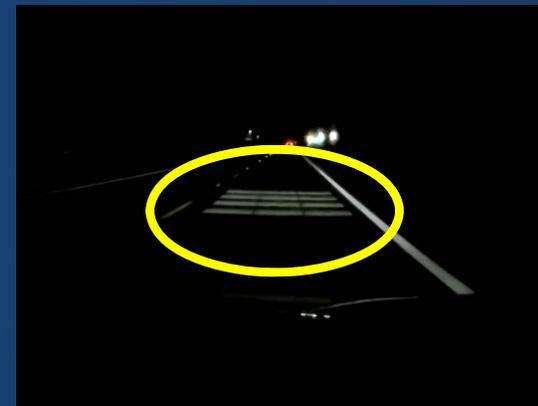
Pavement Improvement Project

- Project timeline:
 - March 23: Transverse rumble strips removed
 - June 3: SR-363 repaved
 - July 2: Crash
 - July 8: Transverse rumble strips reinstalled
- Transverse rumble strips designed to alert drivers to unusual traffic conditions

- Testing of transverse rumble strips:
 - Noticeable increase in vibrations
 - No noticeable increase in sound level
 - Clearly visible retroreflective strips
- Transverse rumble strips may have alerted bus driver if in place at time of crash

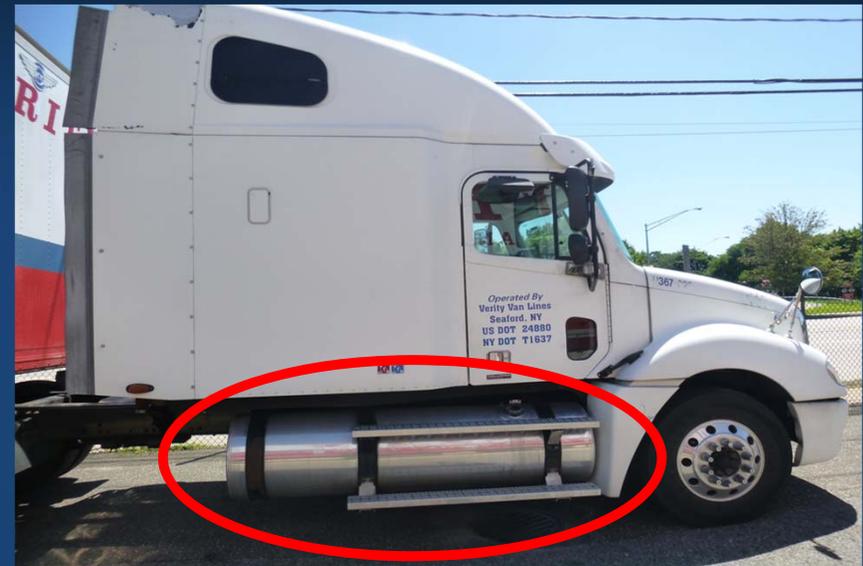
Fuel Tank Specifications

- Side-mounted fuel tanks
- 150-gallon capacity each
- Constructed of 1/8-inch aluminum
- 7 ft long, 2 ft diameter
- Mounted behind front axle
- Held in place by three steel straps

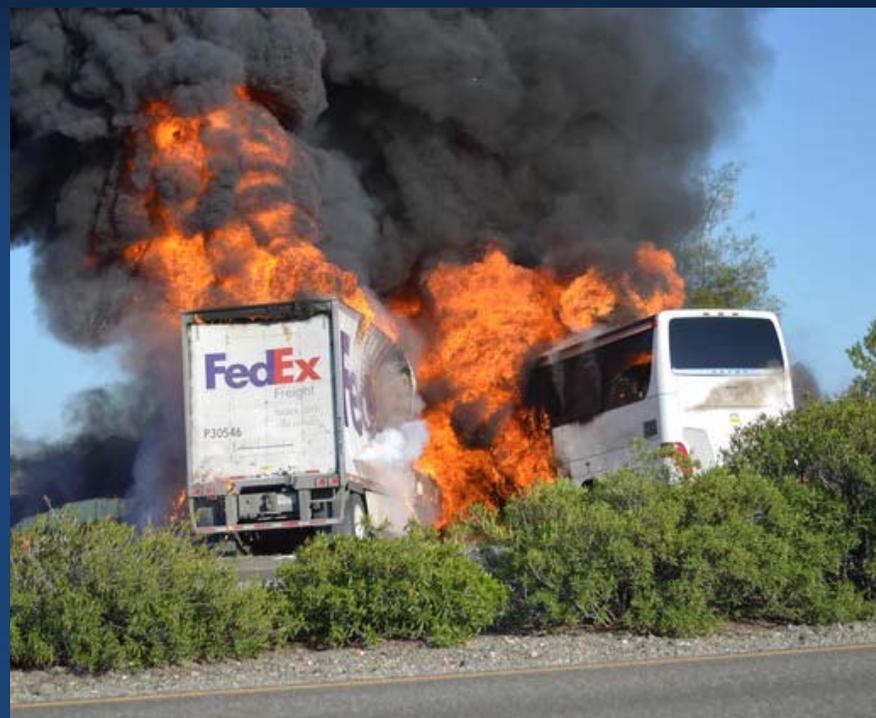
Orland, California

- April 10, 2014
- Truck-tractor collided with motorcoach
- 10 fatal, 39 injured
- Catastrophic rupture of truck tractor's side-mounted fuel tank
