National Transportation Safety Board

Motorcoach Collision With Combination
Vehicle After Traffic Break

Interstate Highway 10 Westbound
Palm Springs, CA
October 23, 2016

Opening Statement

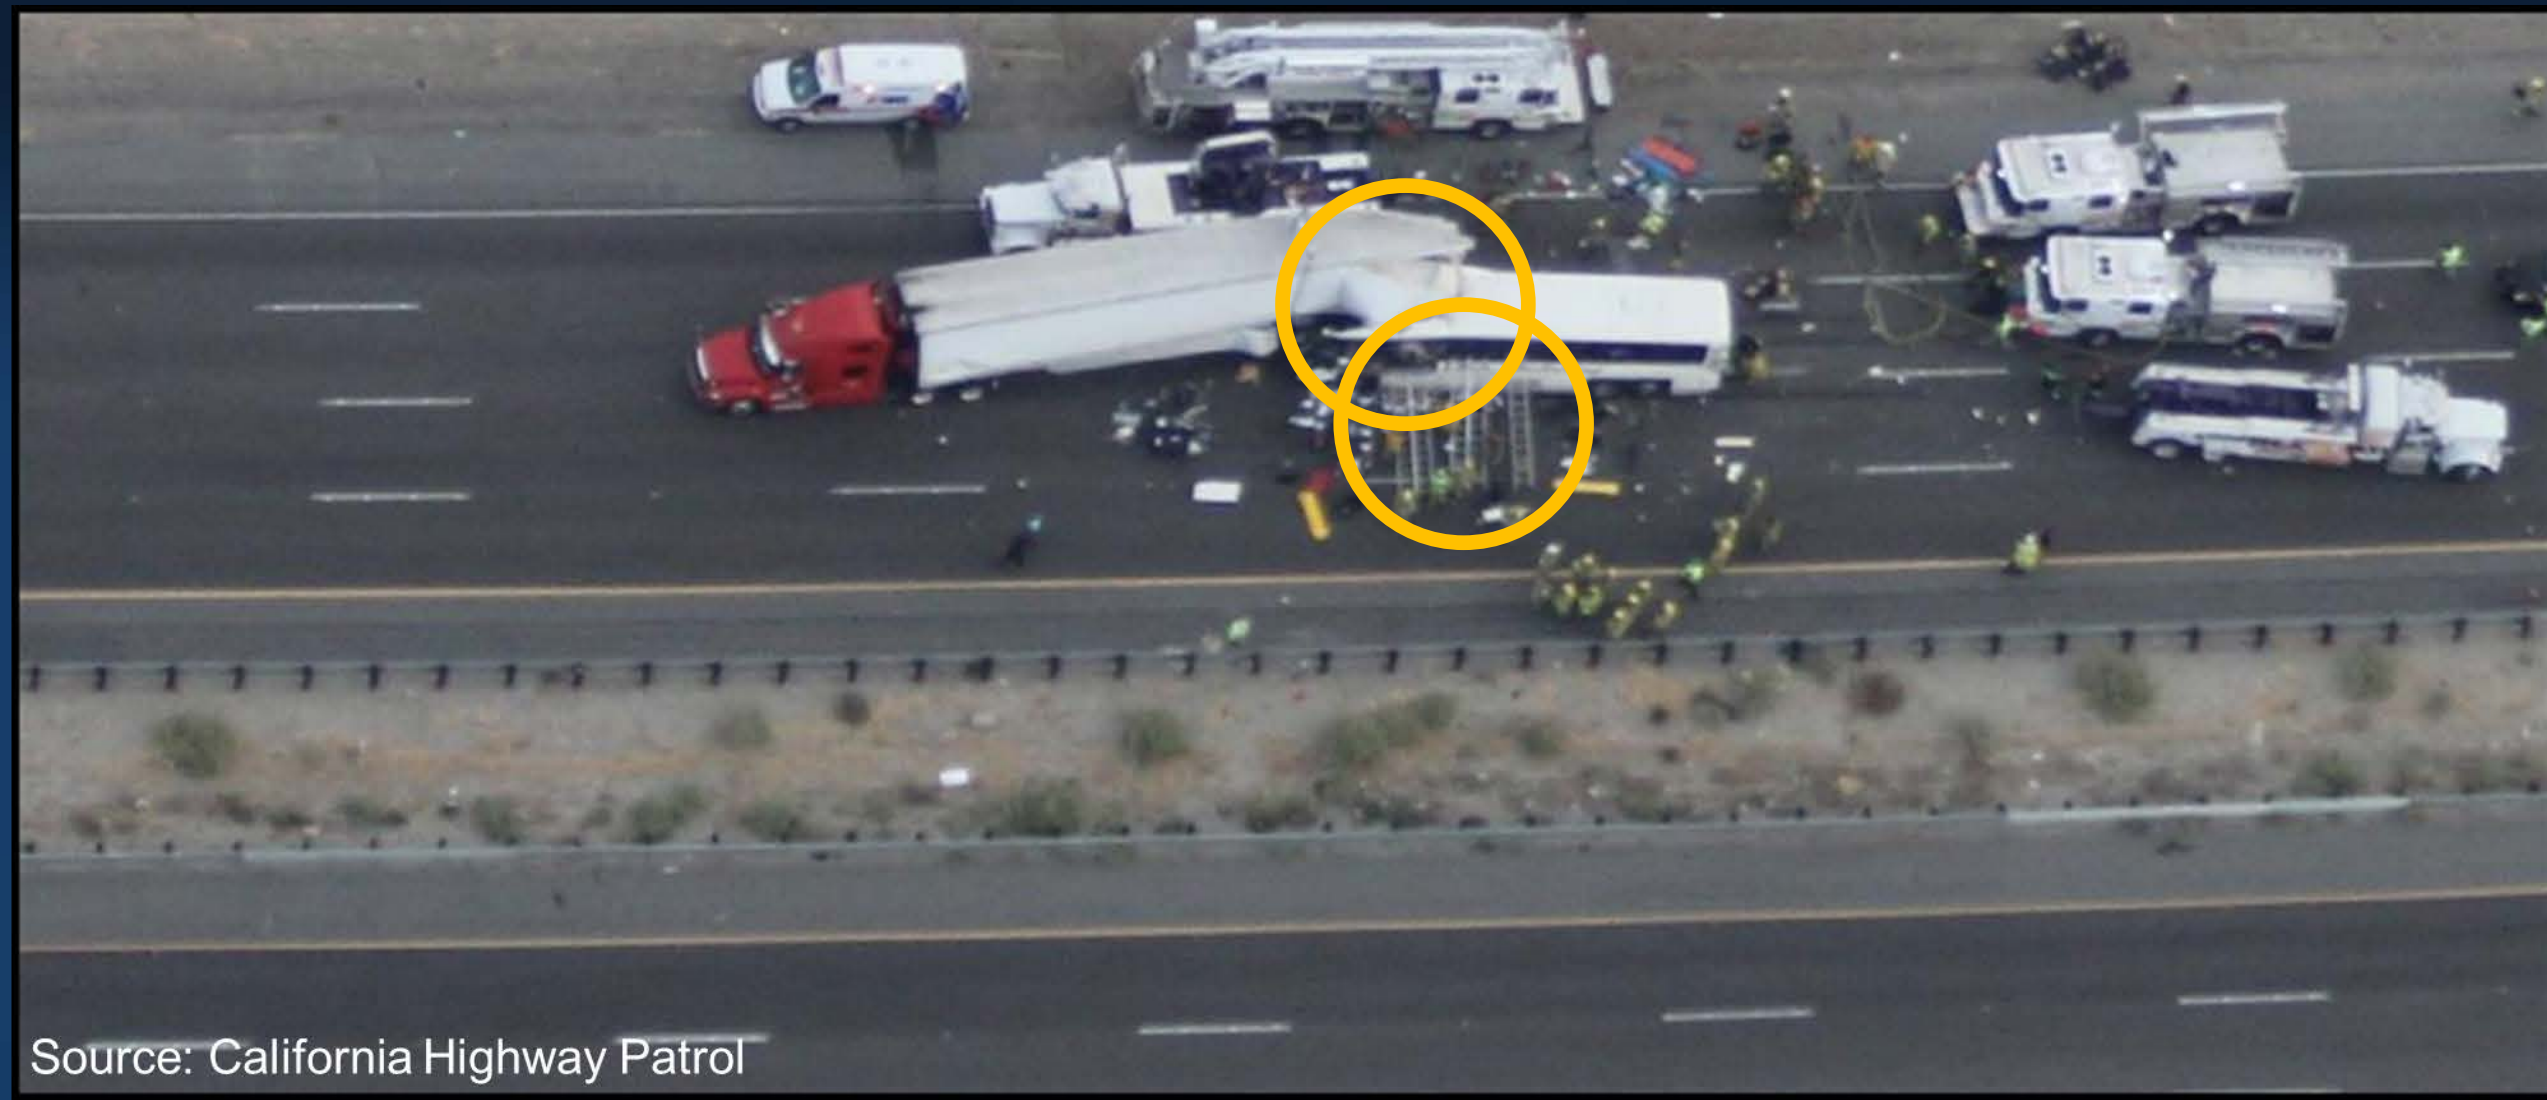
Source: California Highway Patrol

Crash Sequence

- California Highway Patrol (CHP) 5:07
 - Initiated traffic break
- International truck-tractor and Utility semitrailer 5:12
 - Stopped at traffic queue
- Traffic released 5:14
 - Combination vehicle remained stopped
- Motor Coach Industries (MCI) 5:16
 - 47-passenger motorcoach

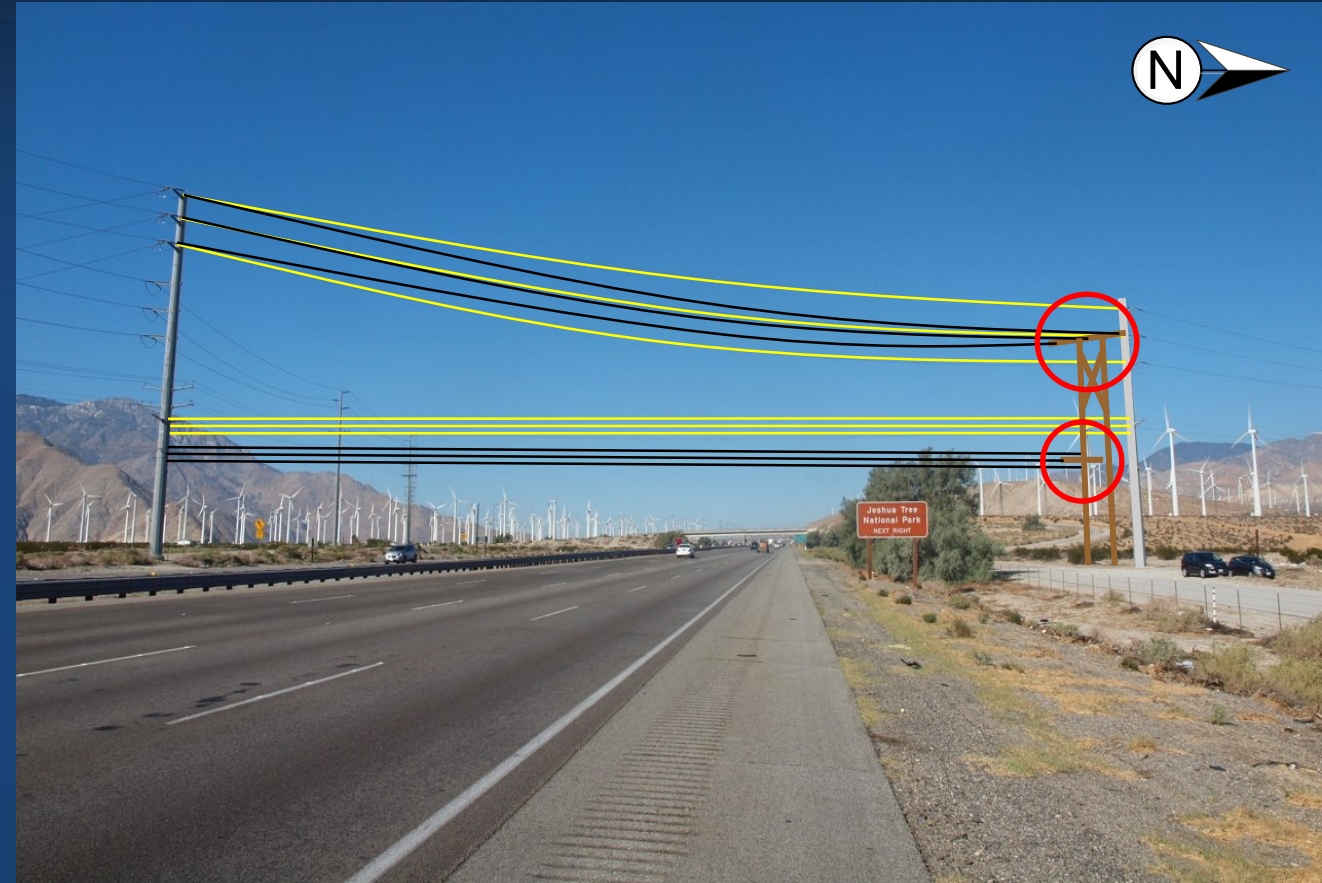
Utility Work – Southern California Edison

- Consisted of transferring 6 transmission lines
- Stage 1 – transferring top 3 lines
- Stage 2 – transferring bottom 3 lines
- Stage 3 – removing wood H-frame structure

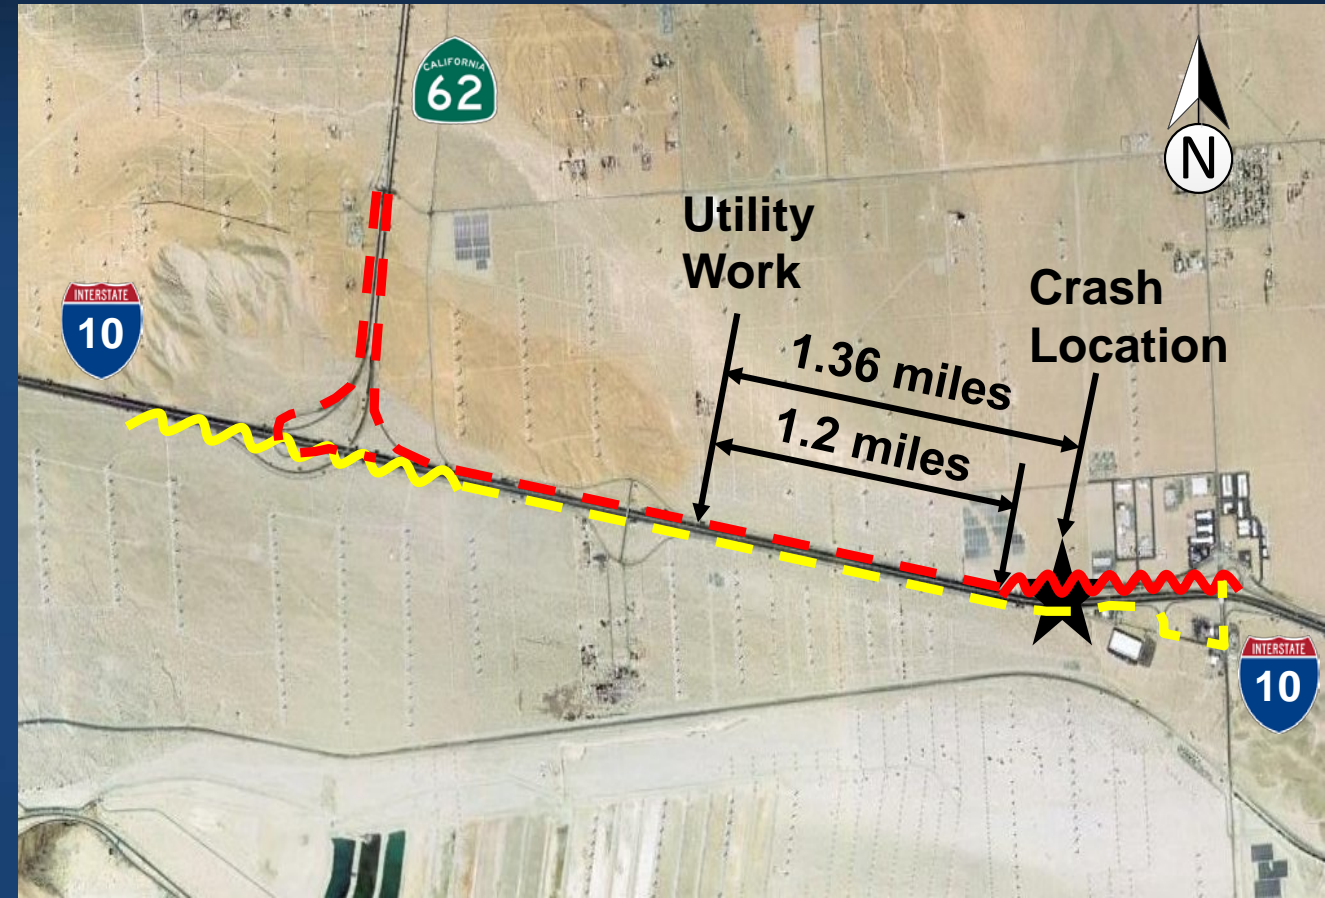
Traffic Break Performed by CHP

- Traffic break in eastbound and westbound directions
- A serpentine maneuver across all 4 travel lanes
- Only traffic break performed before the crash
- No portable changeable message signs (PCMS)

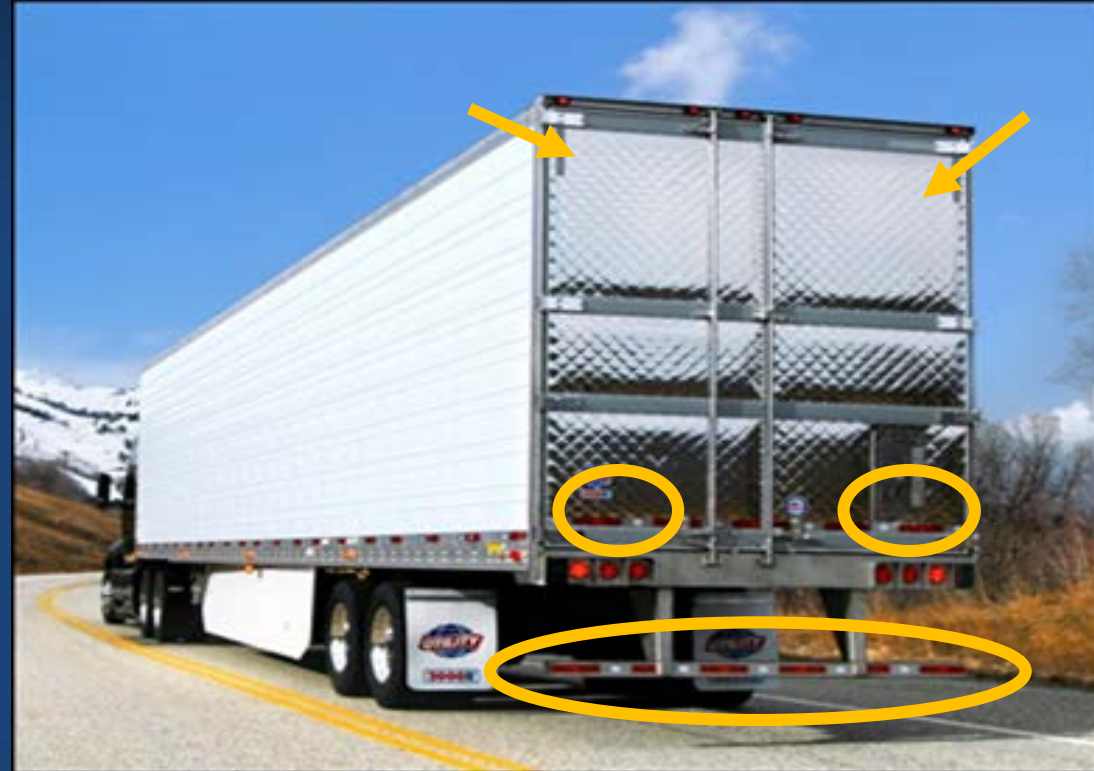
Truck Visibility and Motorcoach Driver Perception

- Truck visibility
 - Retroreflective rear of the trailer
 - Tail and marker lights, no hazard lights
 - Visible for 20 seconds
- Diminished perceptual cues indicating the stopped truck

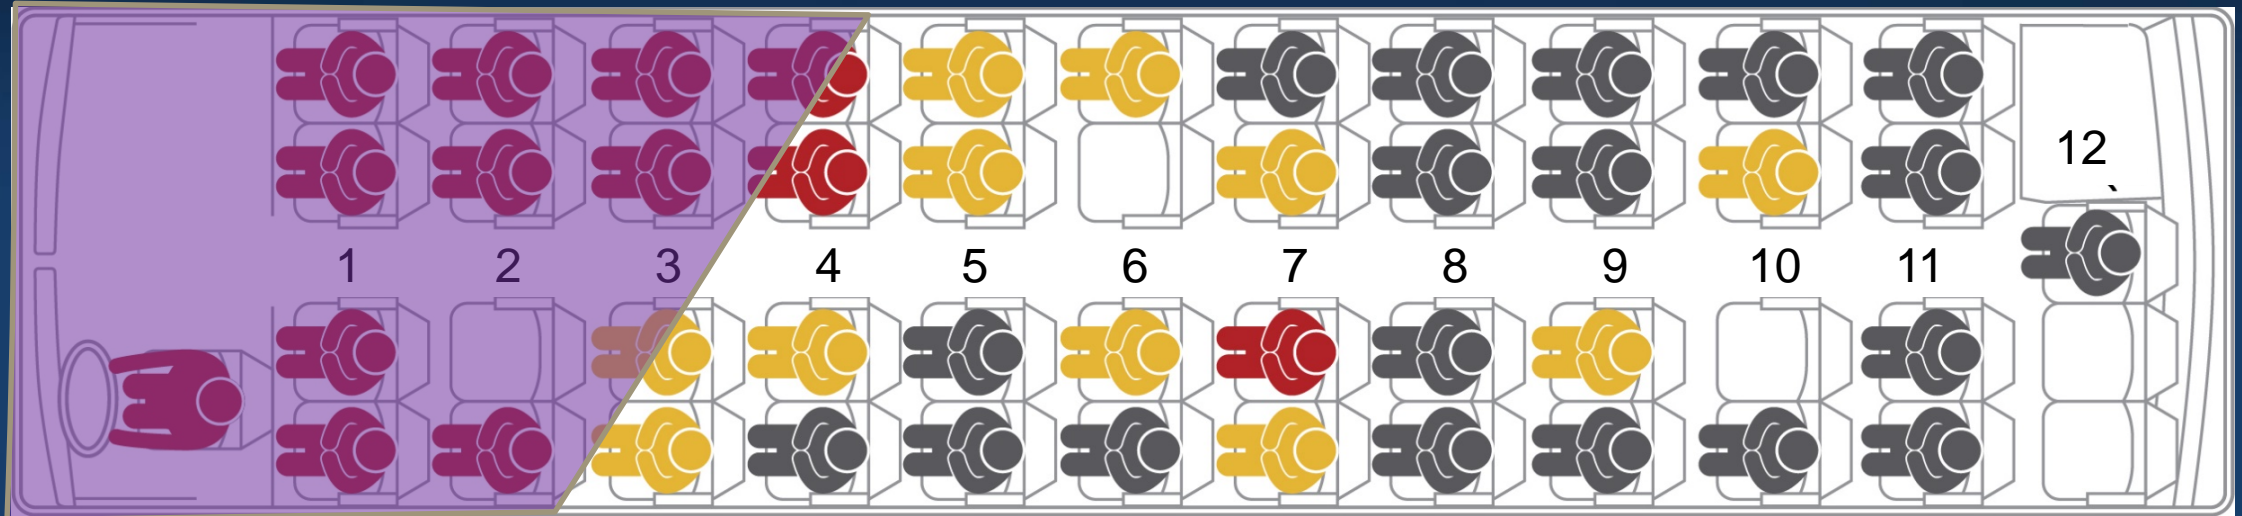
Figure not to scale

Survival Factors

Injuries:

Red: Fatal Yellow: Serious Grey: Minor

- Intrusion of the semitrailer
 - Reduced evacuation points of egress
 - Limited evacuation space
- Emergency exit window challenges
 - Retaining opening for victims and responders
 - Height of windows inside and outside motorcoach

- Secondary service door
 - Applications exist for handicap access and in Europe
 - Permitted under FMVSS
- Use of secondary door for emergency egress
 - Mitigate evacuation challenges
 - NTSB recommendation H-15-13
