Transportation
Safety Board
of Canada

Runway Incursions

A Canadian Perspective

A1700038 – Safety Issues Investigation

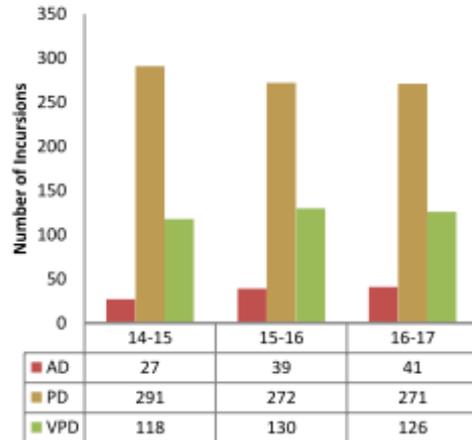
Runway Incursions by Classification

AD – ATS Deviation
 PD – Pilot Deviation
 VPD – Vehicle or Pedestrian Deviation

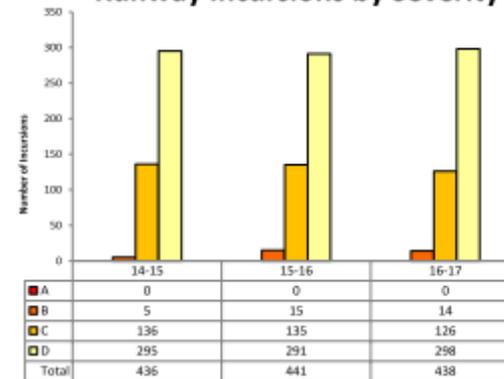
Runway Incursions by Severity

- A - Extreme Risk
- B - High Risk
- C - Some Risk
- D - Minimal or No Risk

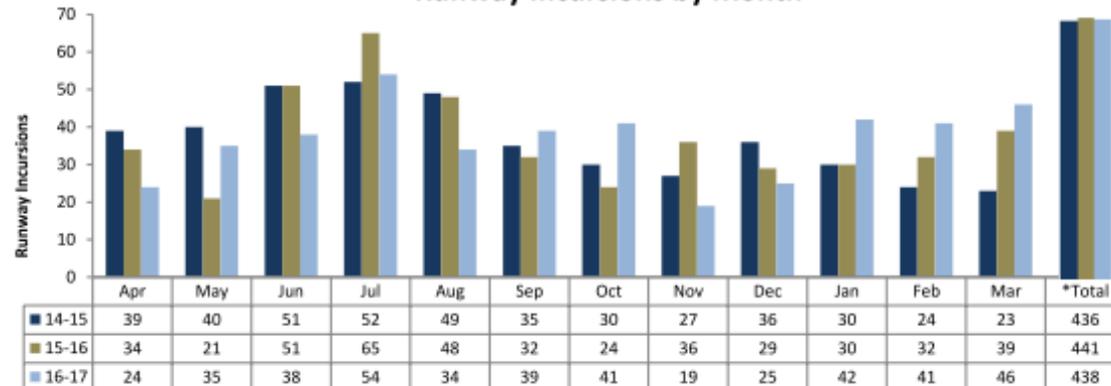
Runway Incursions by Month

*Total not to scale

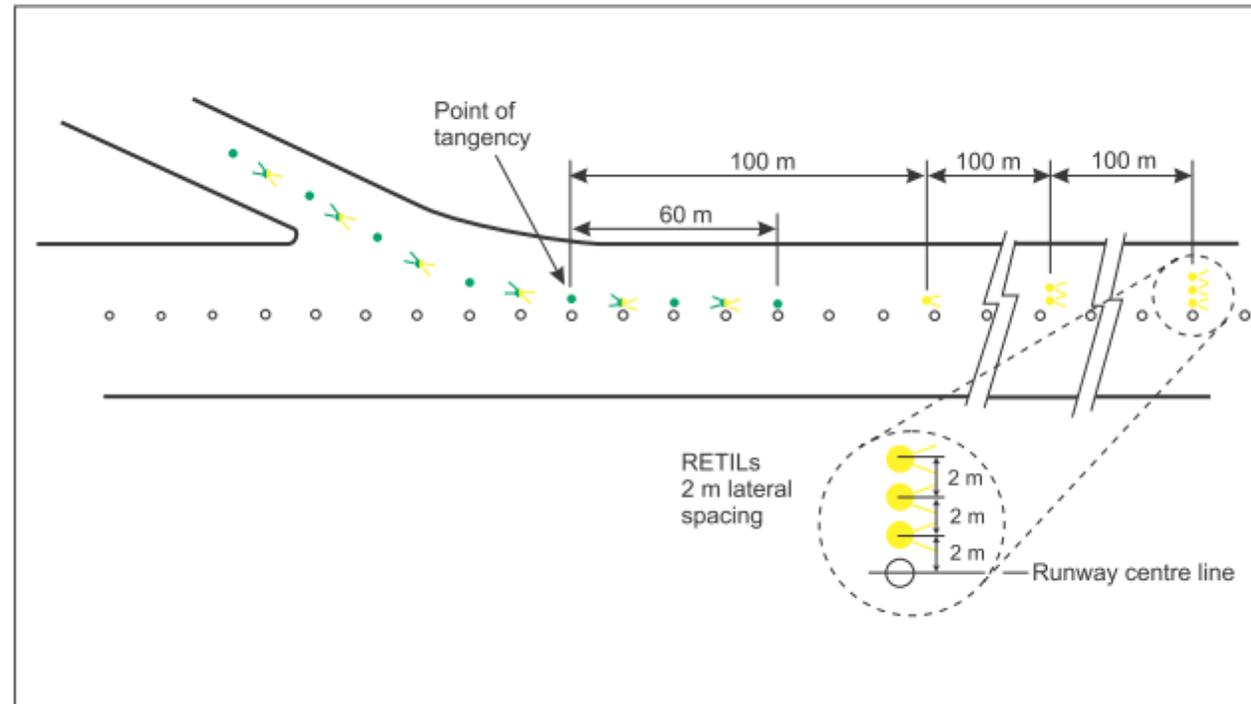
Figure 5-24. Rapid exit taxiway indicator lights (RETILS)

5.3.14	Canada does not use rapid exit taxiway indicator lights.
Remark:	Difference Category C.

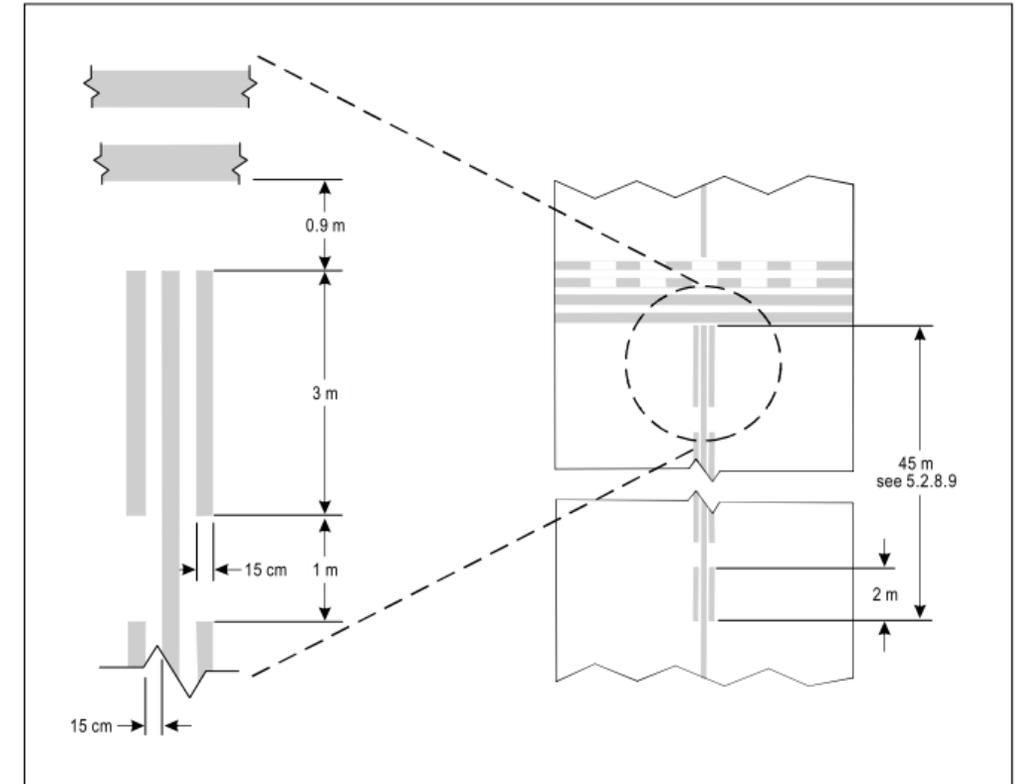
Figure 5-7. Enhanced taxiway centre line marking

5.2.8.9 Where provided, an enhanced taxiway centre line marking shall extend from the runway-holding position pattern A (as defined in Figure 5-6, Taxiway markings) to a distance of up to 45 m (a minimum of three (3) dashed lines) in the direction of travel away from the runway or to the next runway-holding position, if within 45 m distance.

Annex 14, Aerodromes	
5.2.8.5, 5.2.8.9, 5.2.8.11	Canada does not have specifications for enhanced taxiway centreline markings.
Remark:	Pending an amendment to the regulatory requirements, an exemption is in place to permit the positioning of the enhanced taxiway centreline marking. Difference Category C

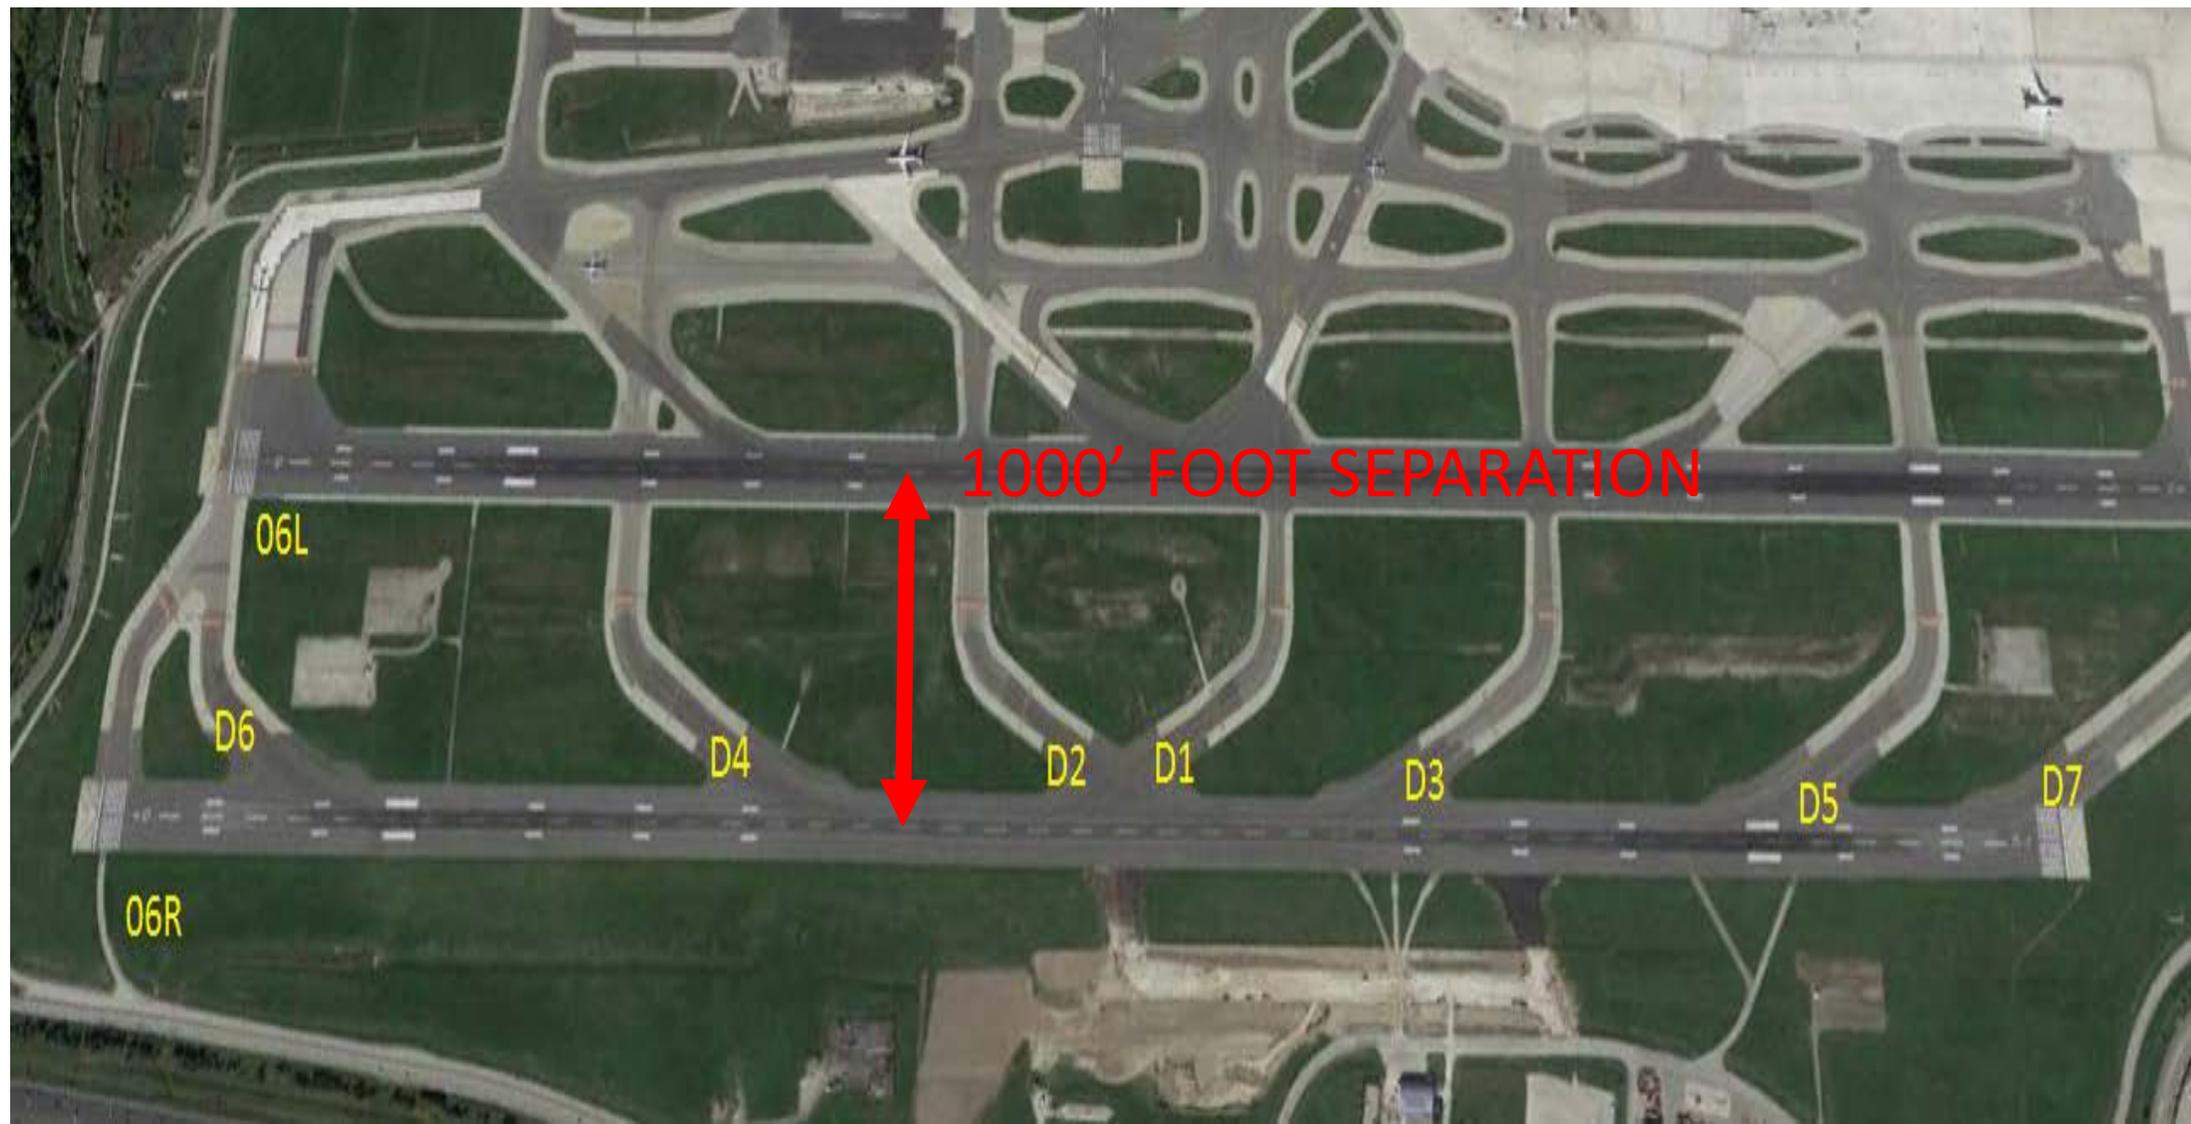
CYYZ South Complex Layout

- In May 2017, the Transportation Safety Board of Canada (TSB) launched a safety issues investigation (SII) that will examine in depth multiple runway incursions that have occurred between runways 06L/24R and 06R/24L at Toronto/Lester B. Pearson International Airport (CYYZ) from June 2012 to June 2017.
- 25 Incursions between the south parallel runways since the beginning of 2012 of varying severity.
- Of the 25 incursions 76% were US Regional carriers operating E175 and smaller aircraft

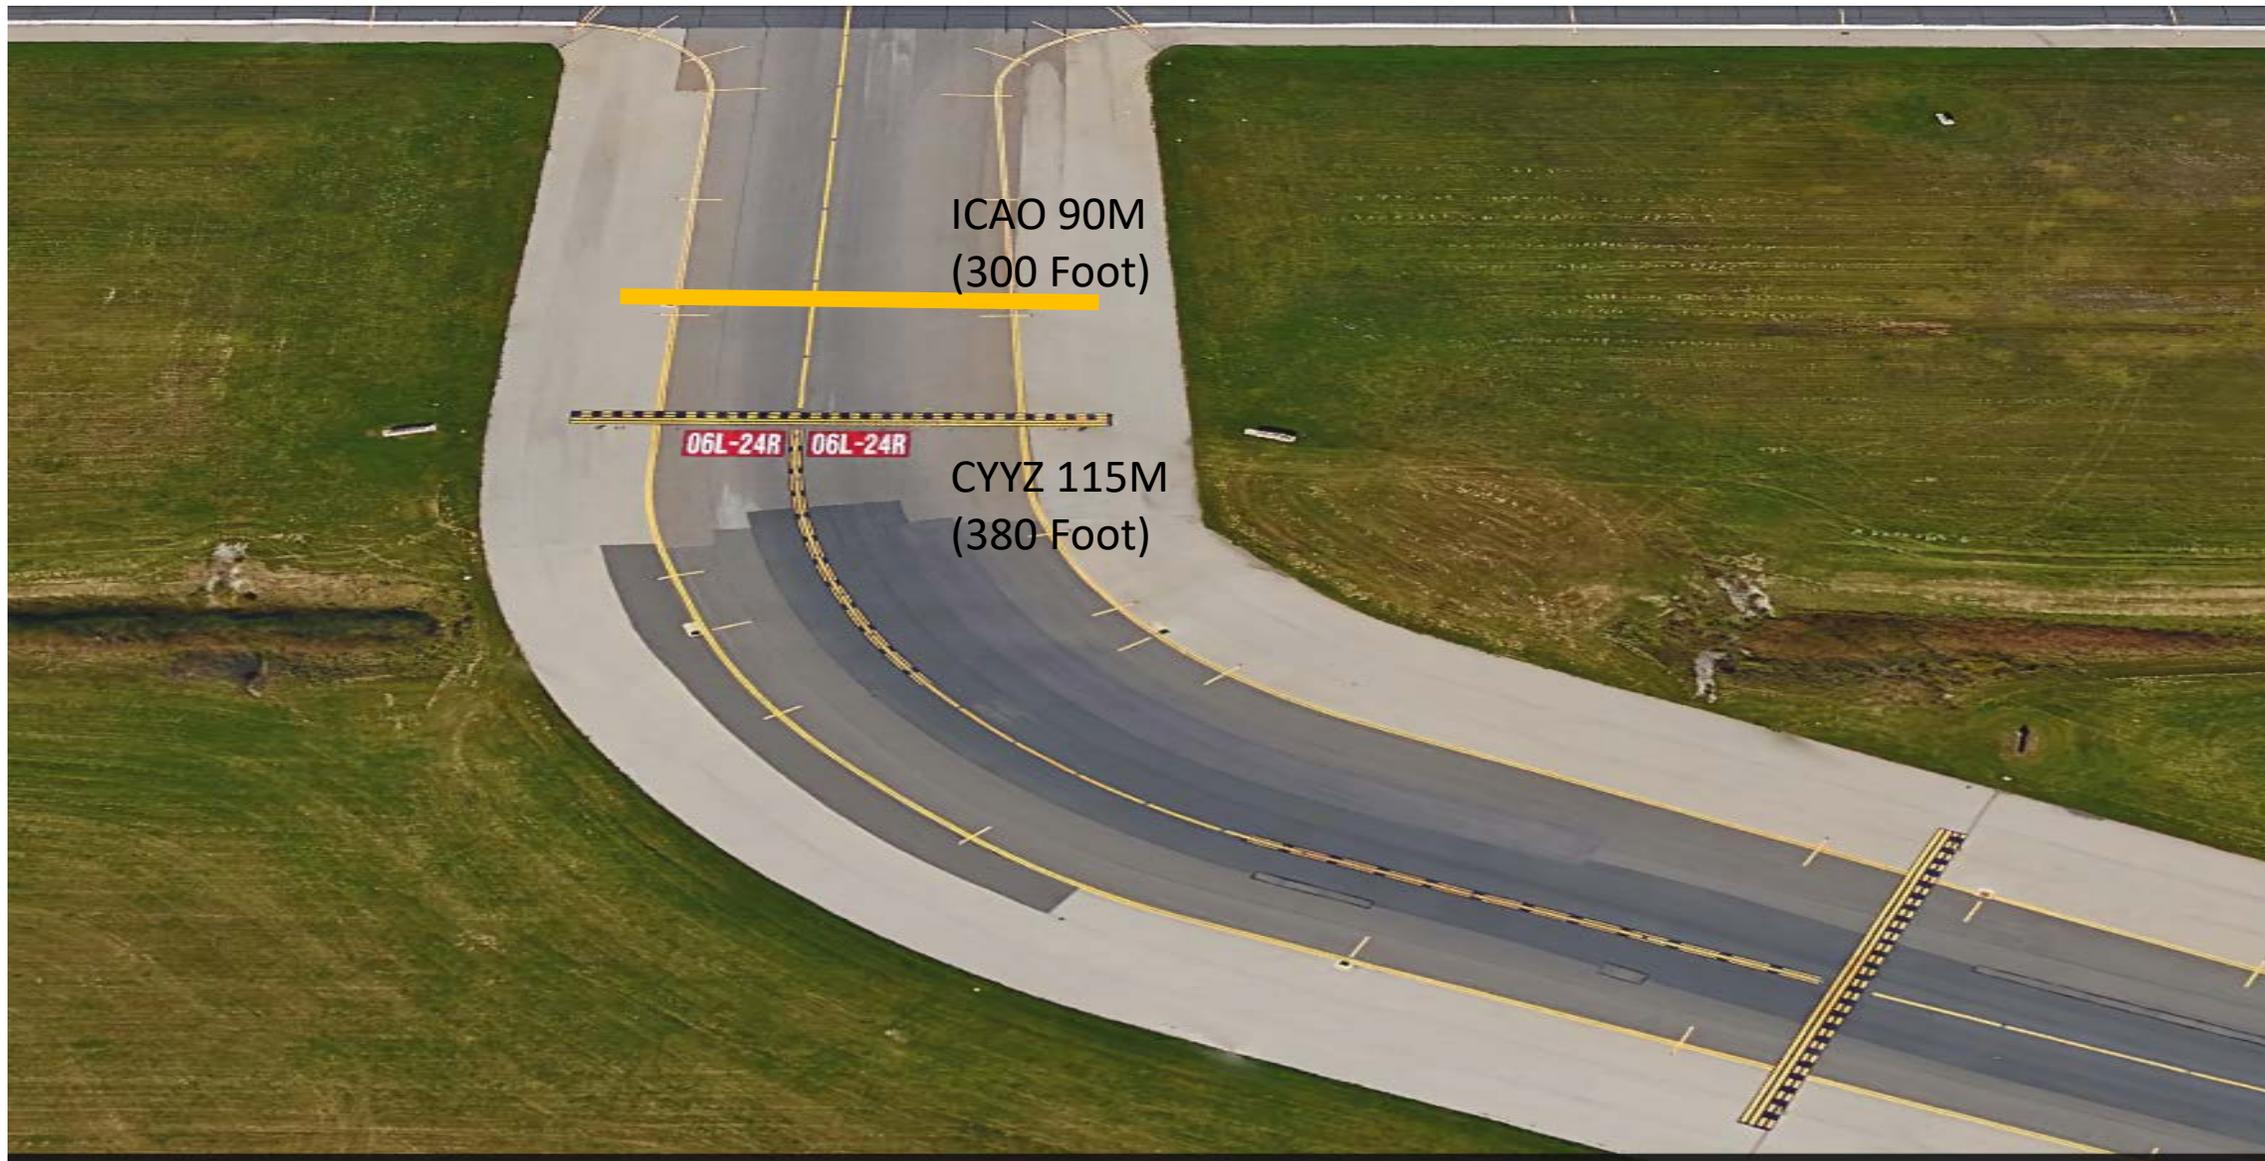
CYYZ Differences from US airports

06L-24R 06L-24R

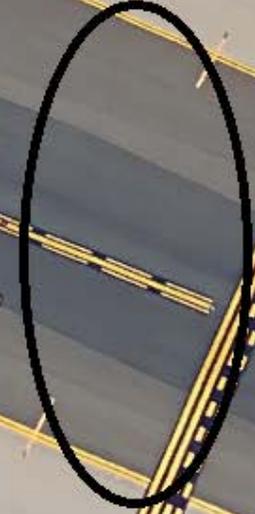
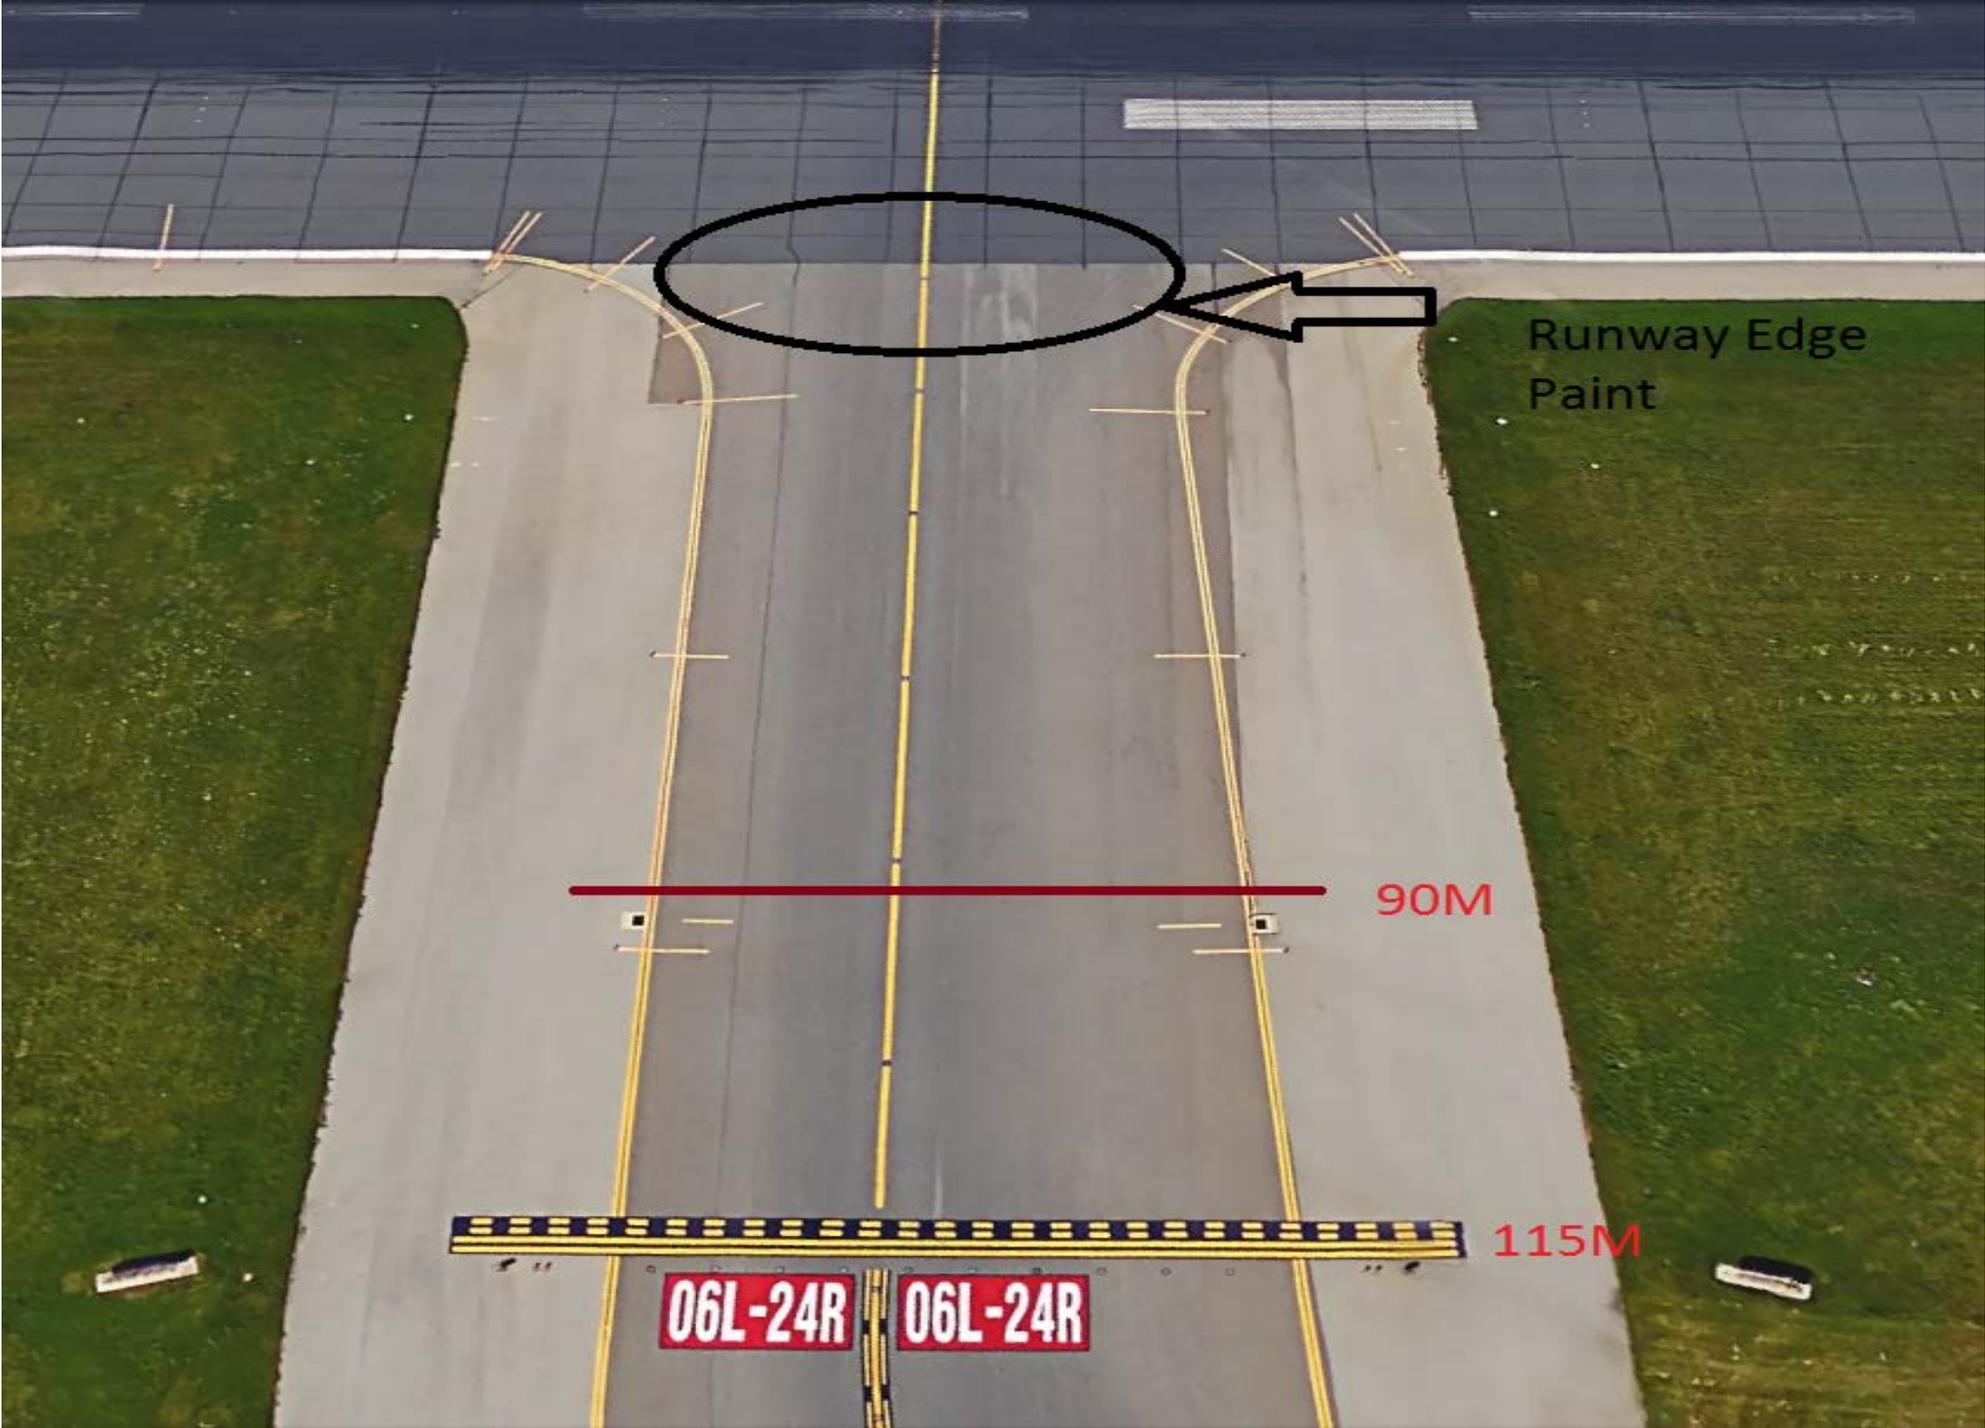
No Runway Exit Markings

Runway Edge
Paint

90M

115M

06L-24R 06L-24R
