National Transportation Safety Board

Grain Car Axle Failure Analysis

Erik Mueller, Ph.D., P.E.

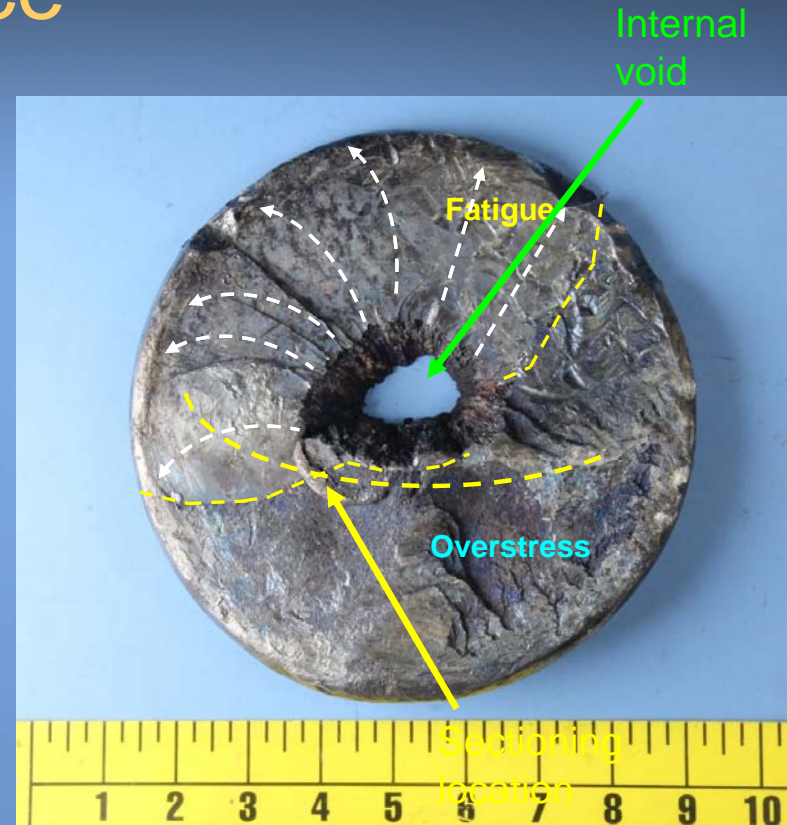
Axle Fracture Surface

- Two distinct fracture regimes
 - Fatigue
 - Overstress
- Crack propagation from inside void to outside
- Heavy batter and post-fracture damage

- The wheelset axle fractured from fatigue
 - Crack initiated at an internal solidification void
 - Crack propagated toward outside surface of axle
- Void was created during initial ingot casting
- Proper ultrasonic testing should have detected void
 - Performed at manufacture
 - Performed at rework

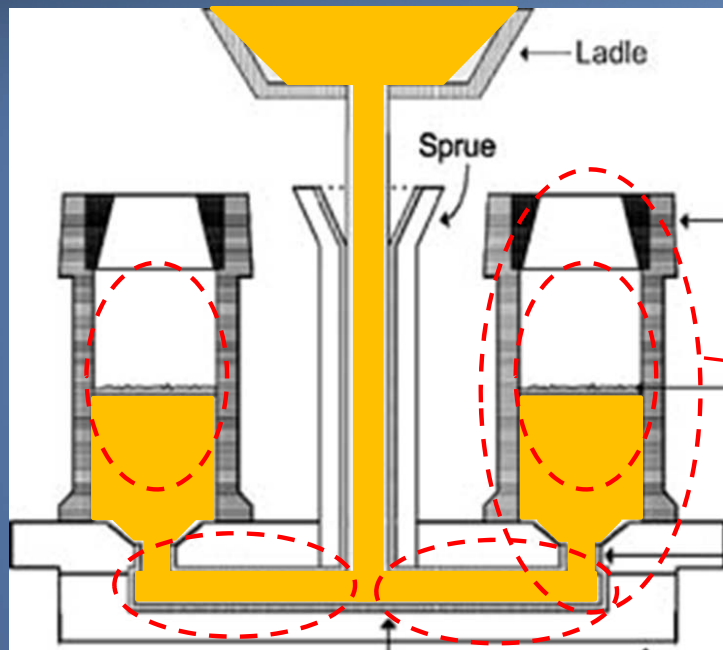
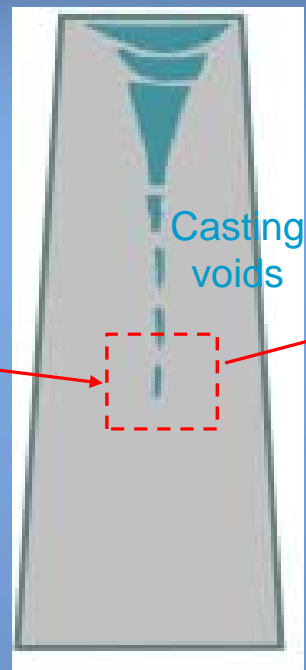
Steel ingot

Formation of Internal Voids
