National Transportation Safety Board

Bridge Design Errors

Overview

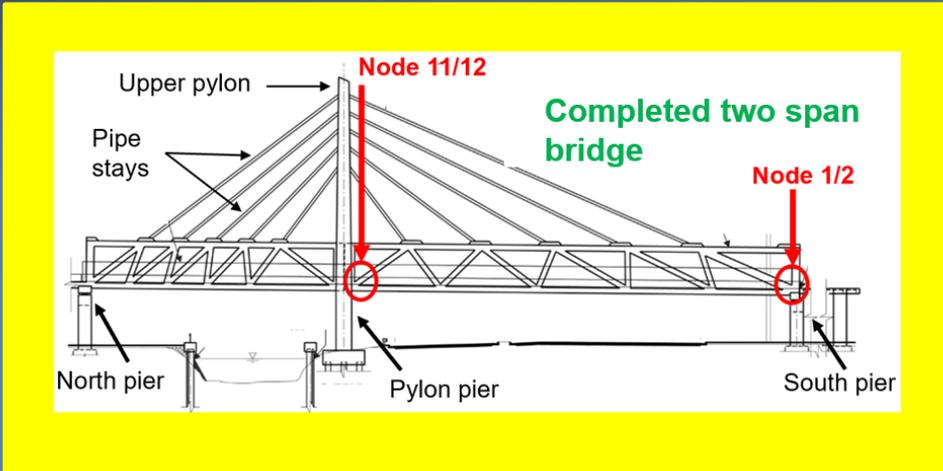
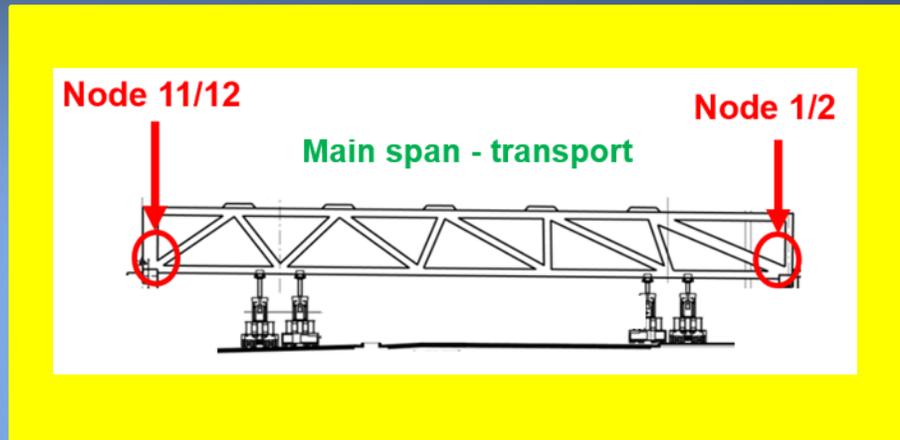
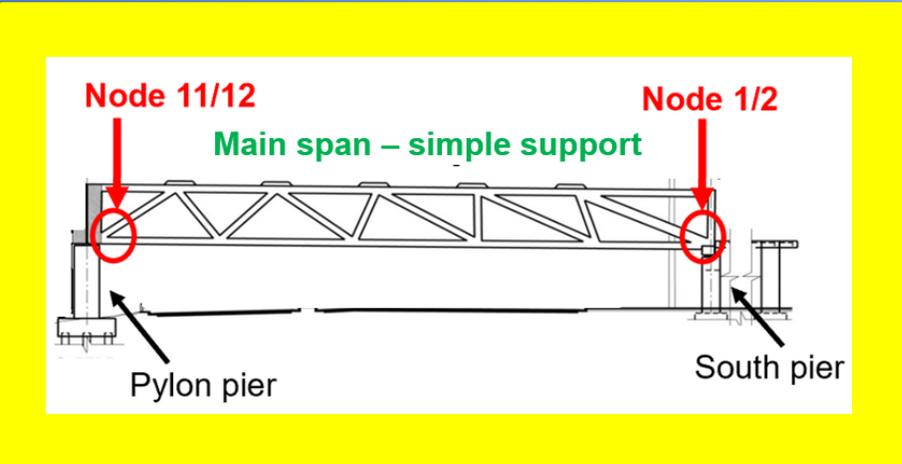
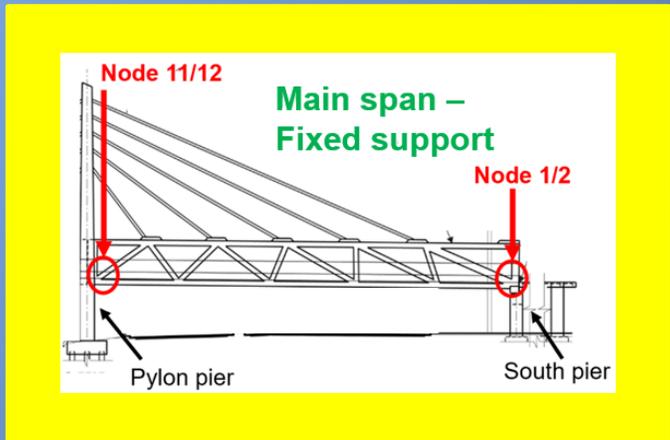
FIGG's Demand Models

Source: FIGG, annotated by the NTSB

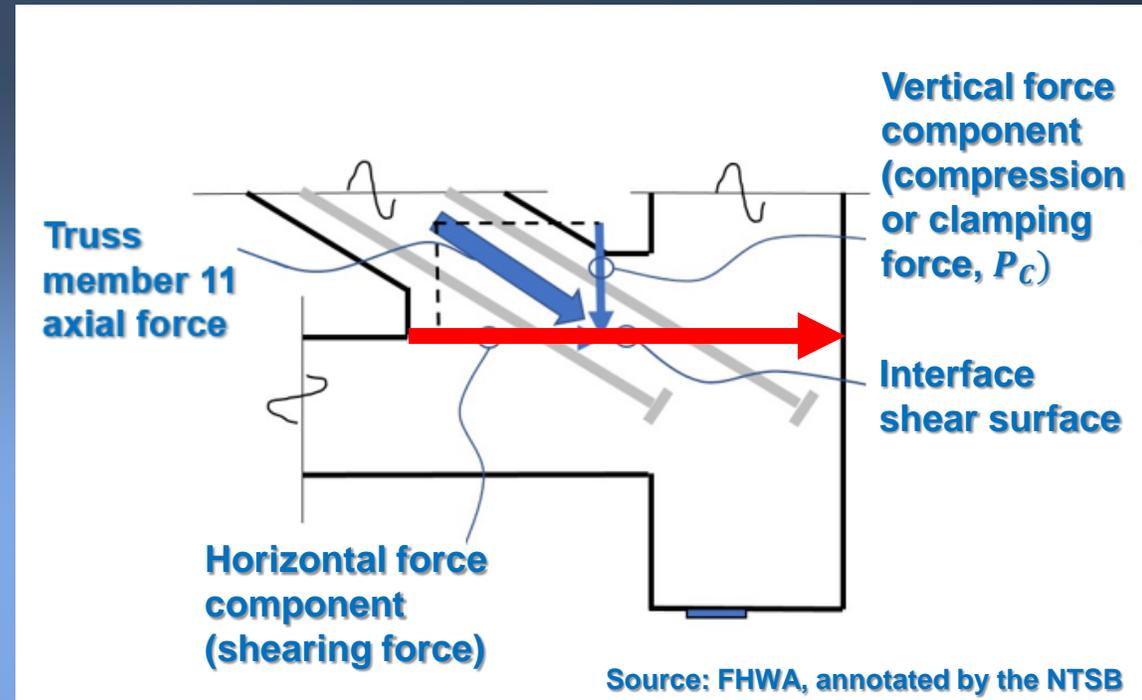
Demand Errors

- Vertical component is compressive or clamping force
- Horizontal component is shearing force on the interface shear surface

Model	Shear Demand
FIGG's fixed support model	978 kips
FIGG's completed two-span model	1,990 kips
FHWA model	1,835 kips

1 kip = 1,000 pounds
