**Truck-Tractor and Cargo Tank Semitrailer
Rollover and Fire
Interstate Highway 69
Indianapolis, Indiana
October 22, 2009**

Opening Statement

Truck-Tractor and Cargo Tank Semitrailer Rollover Animation

HWY-10-MH-001

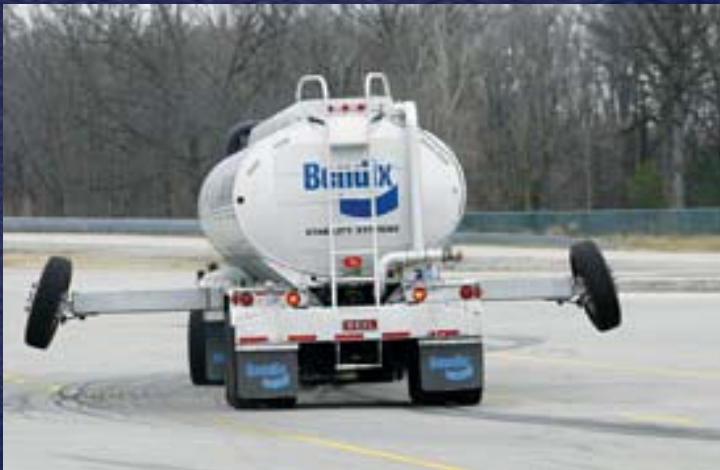
With ESC

Stability Control Systems

- Roll Stability Control (RSC)
 - Tractor or trailer based
- Electronic Stability Control (ESC)
 - Tractor based

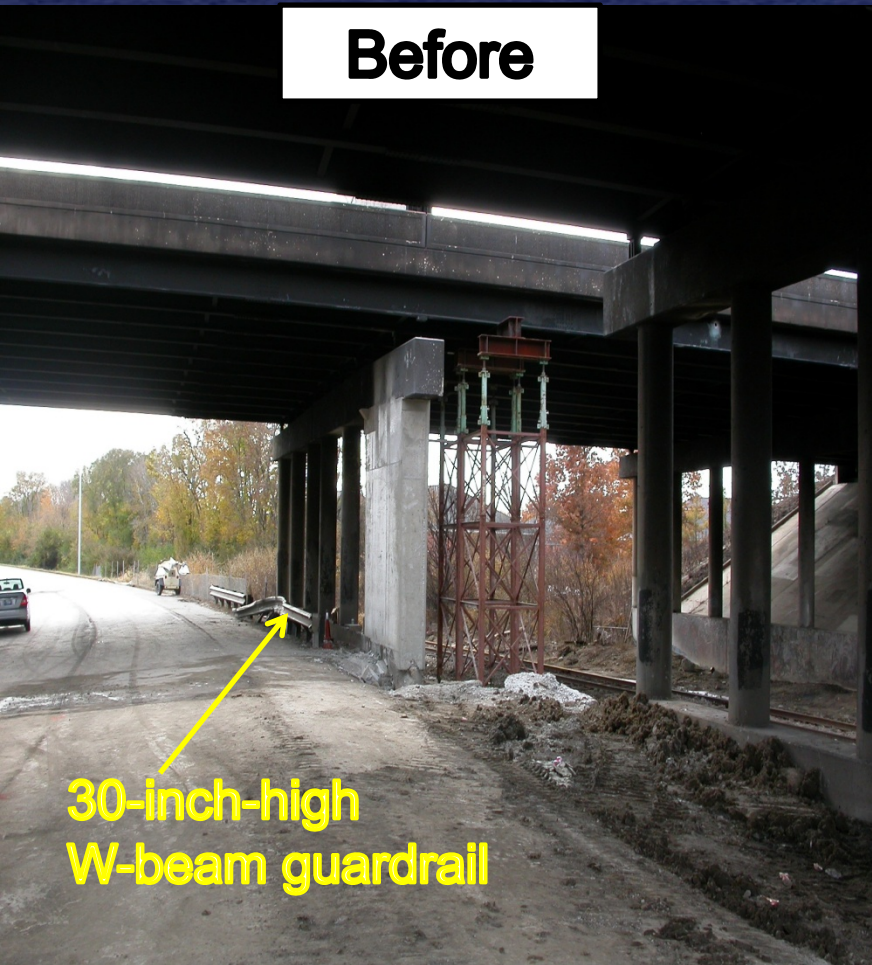
- Primarily designed to redirect passenger cars and pickup trucks
- Overall height – 30 inches
- Bridge columns located within clear zone
 - 14 feet from the edge of traveled way
 - 6 feet from the guardrail

Before and After Condition

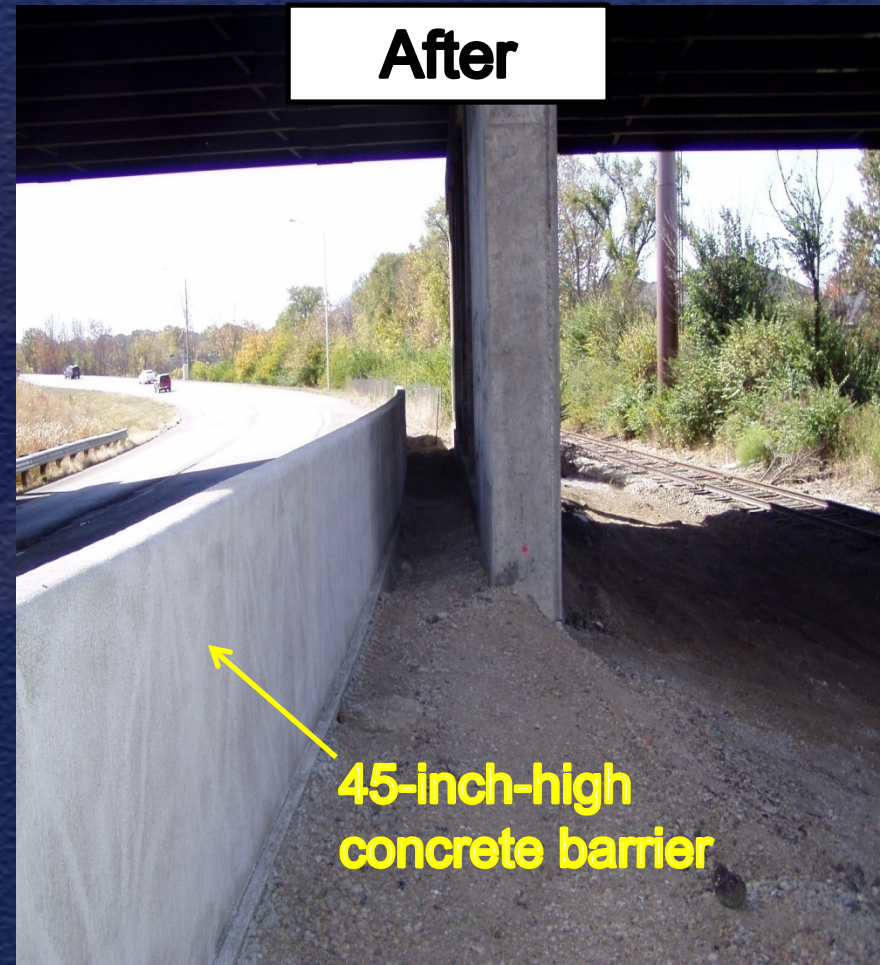
After

- Level of protection had not changed in 40 years
- Upgrading existing roadside barriers generally not high on list of priorities
- If new bridge, 42-inch-high concrete barrier would be required
