NTSB National Transportation Safety Board

Motorcoach Braking

1993 MCI DL-3 Motorcoach

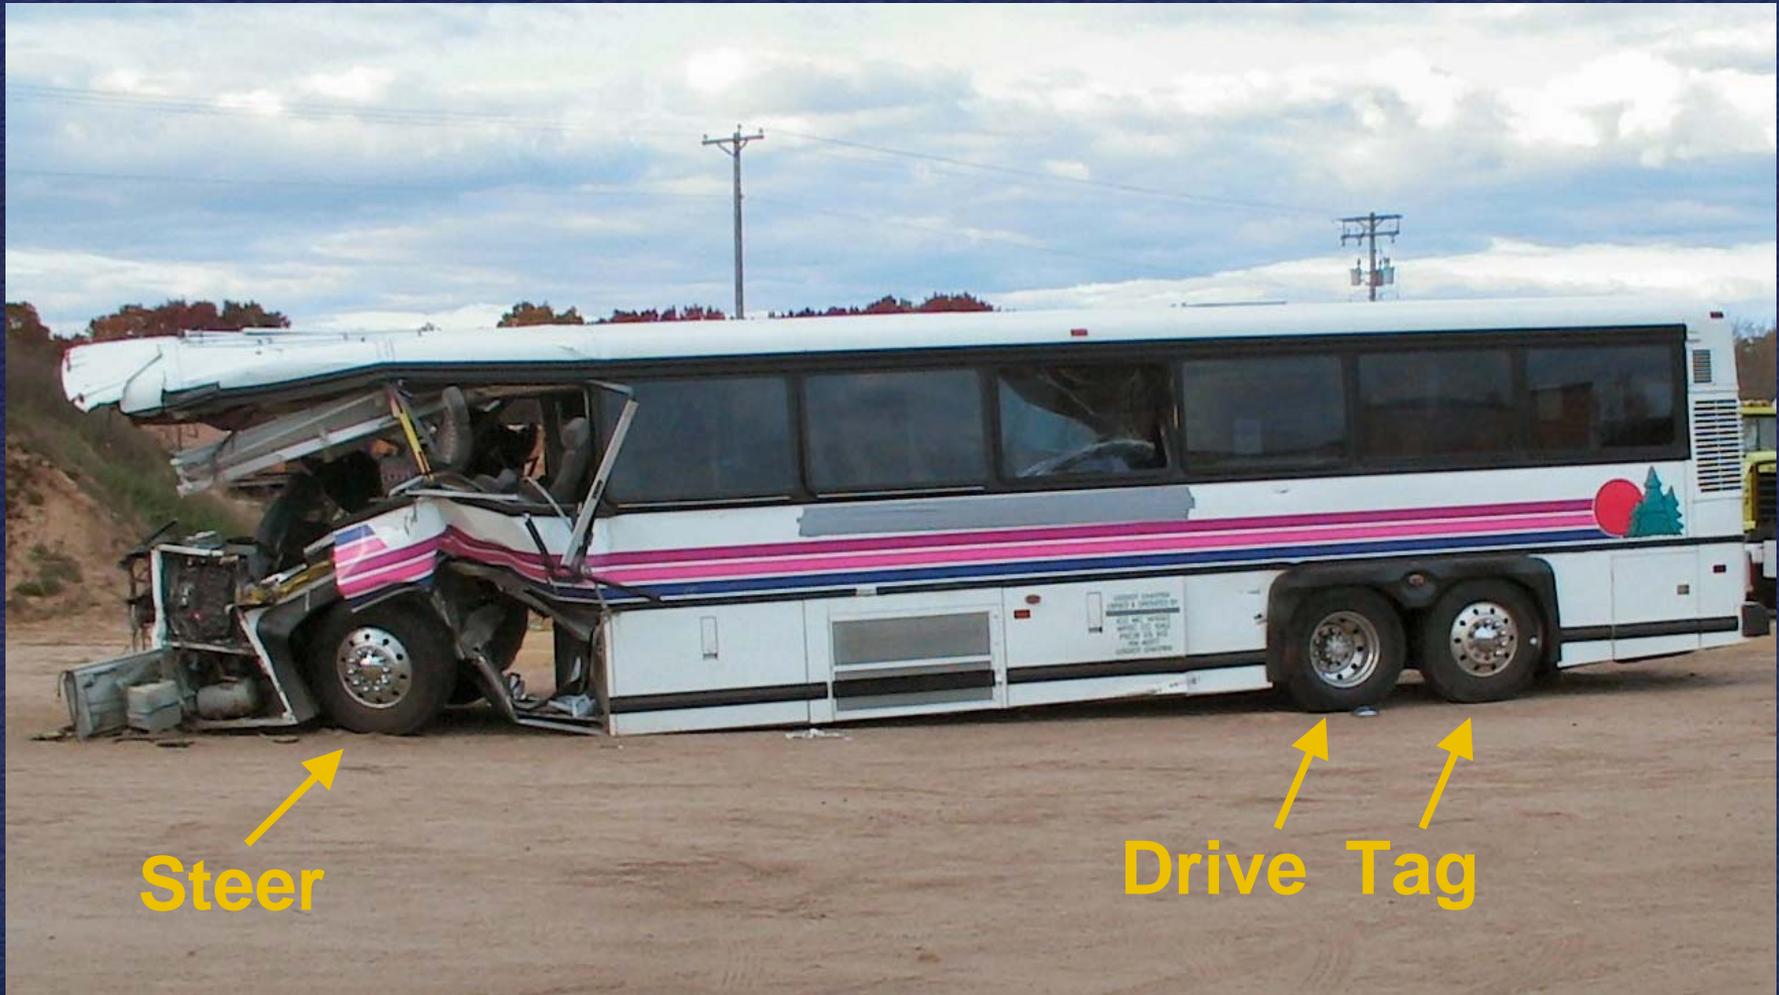
Brake Adjustment

Brake Chamber Type

Automatic Slack Adjuster Length

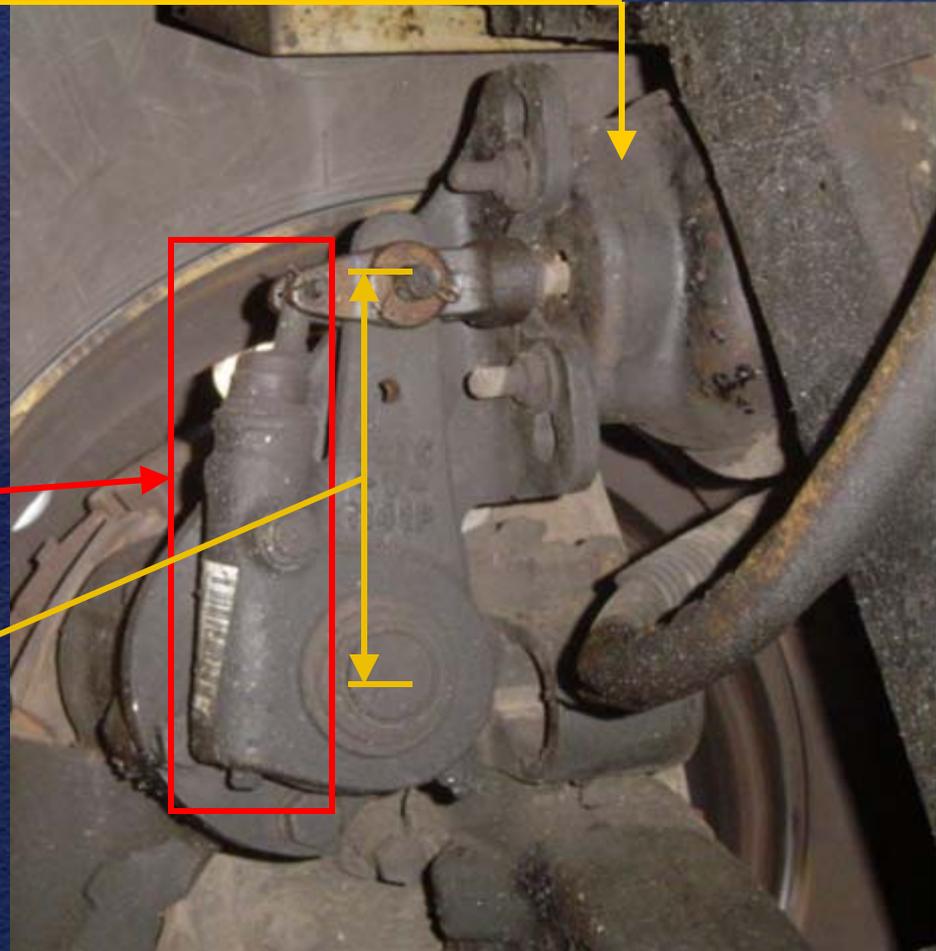
Brake Adjustment, Cont'd.

Axle	Push Rod Travel (inches)	Adjustment Limit (inches)
Left steer	1 1/2	1 3/4
Right steer	1 3/4	1 3/4
Left drive	2 7/8	2 1/4
Right drive	2 3/4	2 1/4
Left tag	1 3/4	1 3/4
Right tag	1 5/8	1 3/4
