NTSB National Transportation Safety Board

Office of Highway Safety

Truck Wreckage Visibility

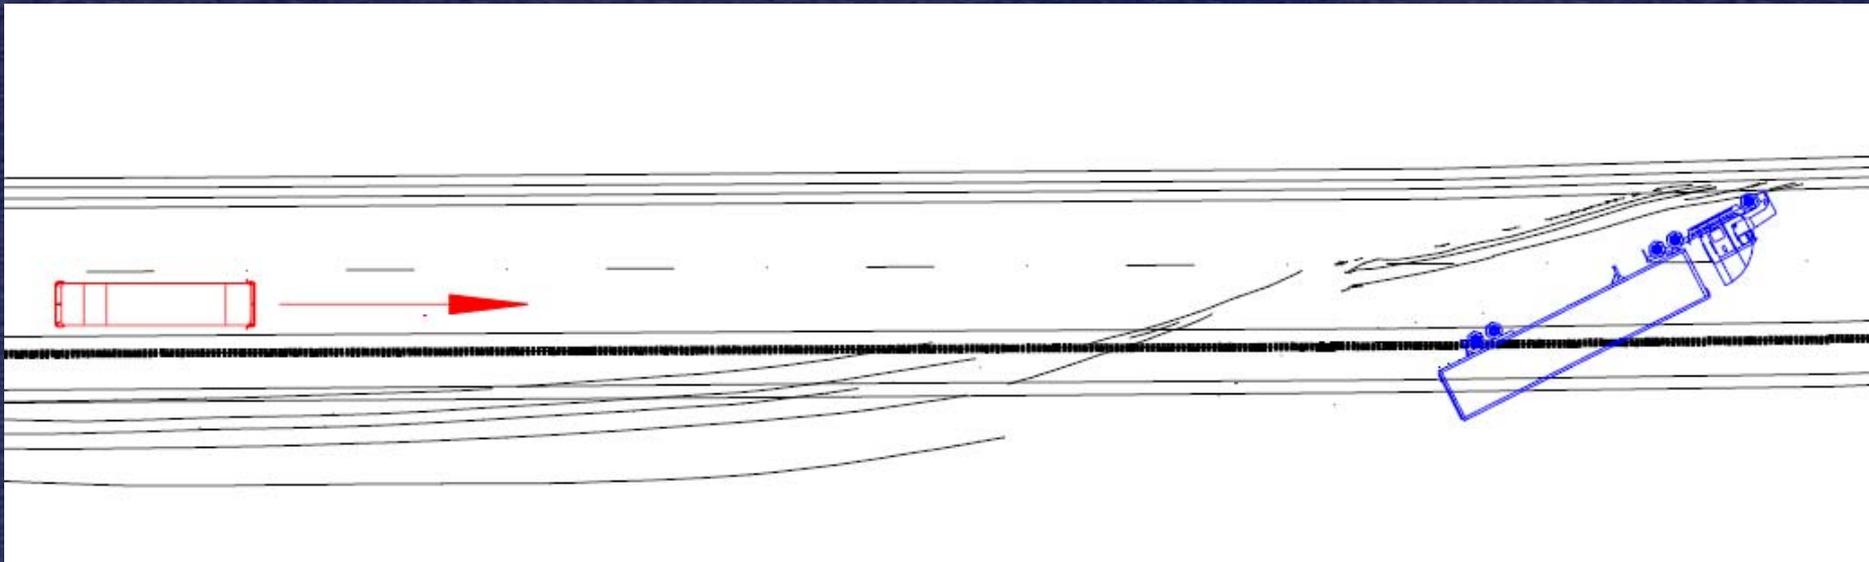
Postaccident Visibility Study

- Slow approach
- Frequent stops
- Expectation of looking for truck wreckage

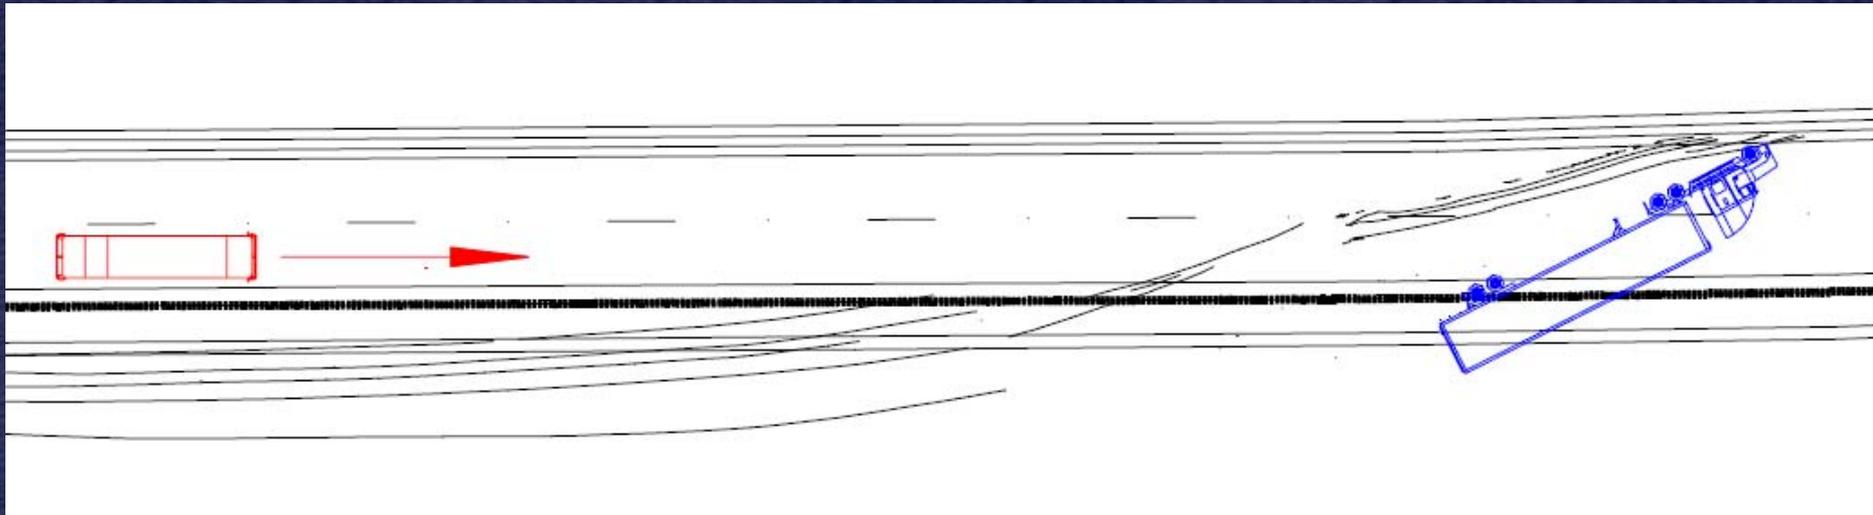
227 feet

Postaccident Visibility Study, Cont'd.

- Low-beam detection of hazard in lane
- Emergency braking
