NTSB National Transportation Safety Board

*Office of Railroad, Pipeline &
Hazardous Materials Investigations*

Emergency Response

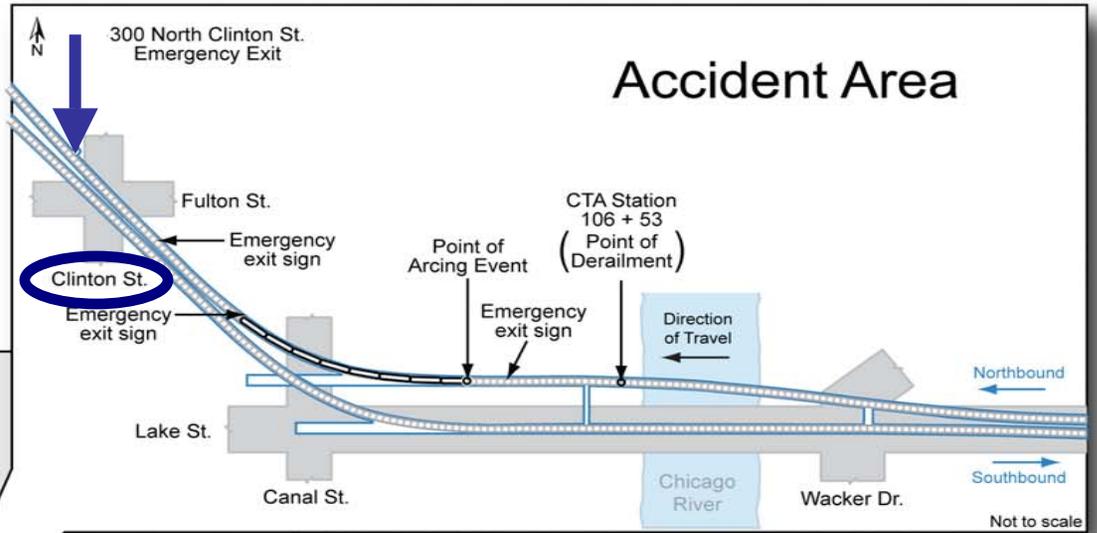
Accident Area

- Emergency responders did not have specific information about the location of the train
- Emergency responders were directed to the following locations:
 - Clark/Lake station
 - Grand/Milwaukee station
 - 300 North Clinton Street emergency exit
- Tunnel station numbers were spray painted onto the tunnel walls

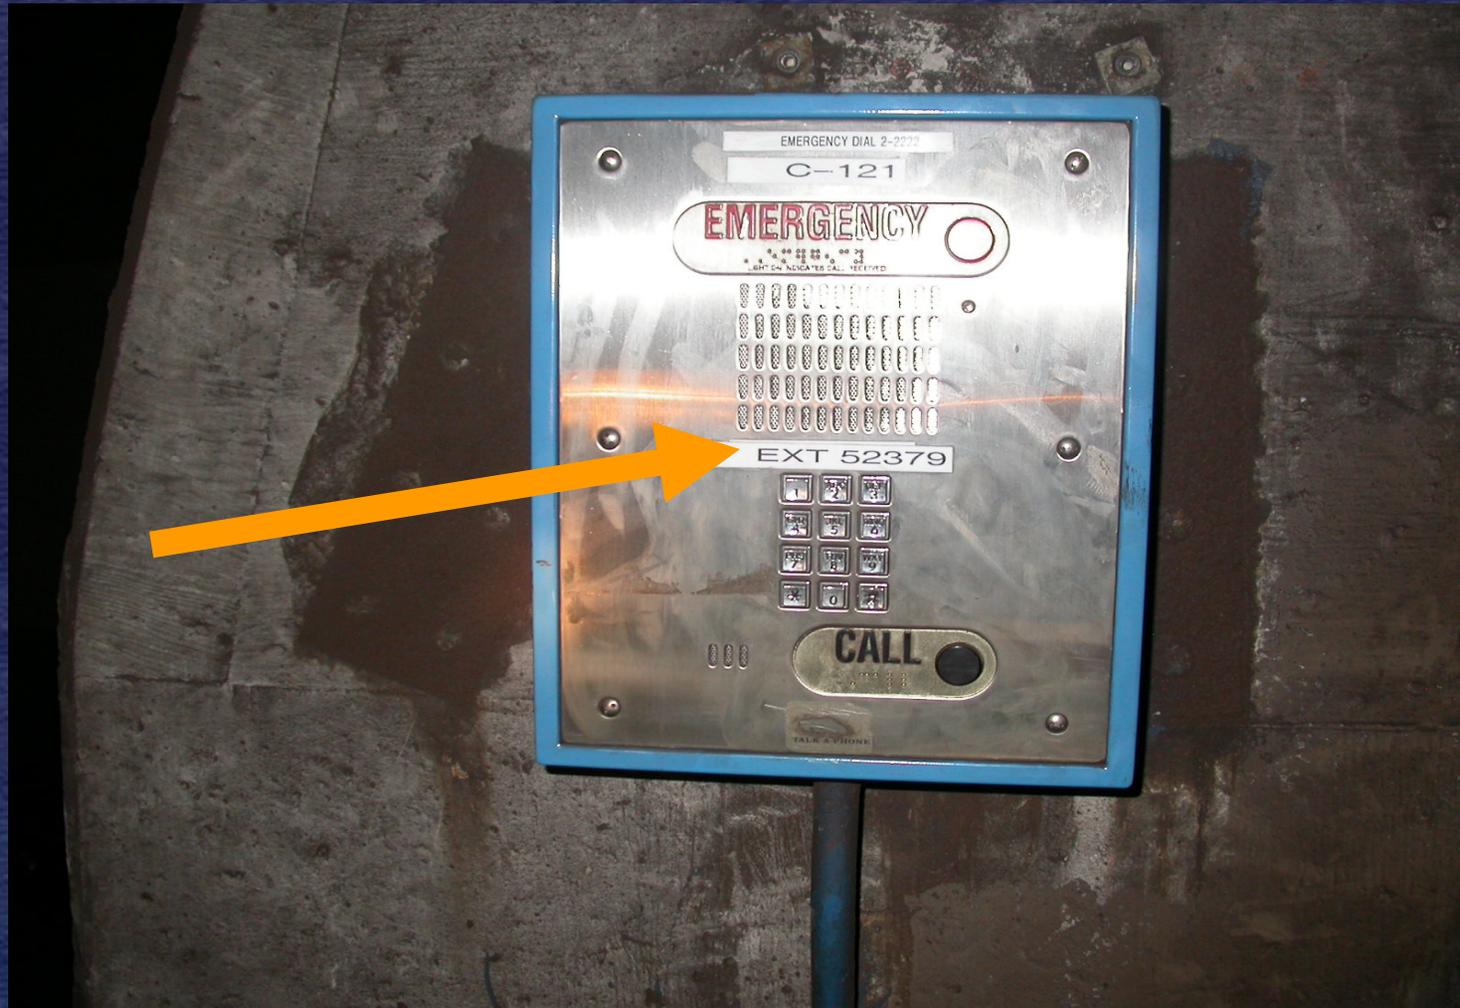
Emergency Call Boxes

- Because a train indication system had not been installed on the Dearborn Subway and the Chicago Transit Authority's control center could not identify the location of an emergency call box used to report the accident, the specific location of train 220 could not be determined, which delayed the emergency response and the activation of emergency exit lights and announcements at the closest accessible emergency exit.

- The CTA had installed a train indication system on some of its lines
- Revised emergency response maps have been distributed
- Reflective station signs displaying the track station number are being installed
