NTSB National Transportation Safety Board

*Office of Railroad, Pipeline &
Hazardous Materials Investigations*

Operations

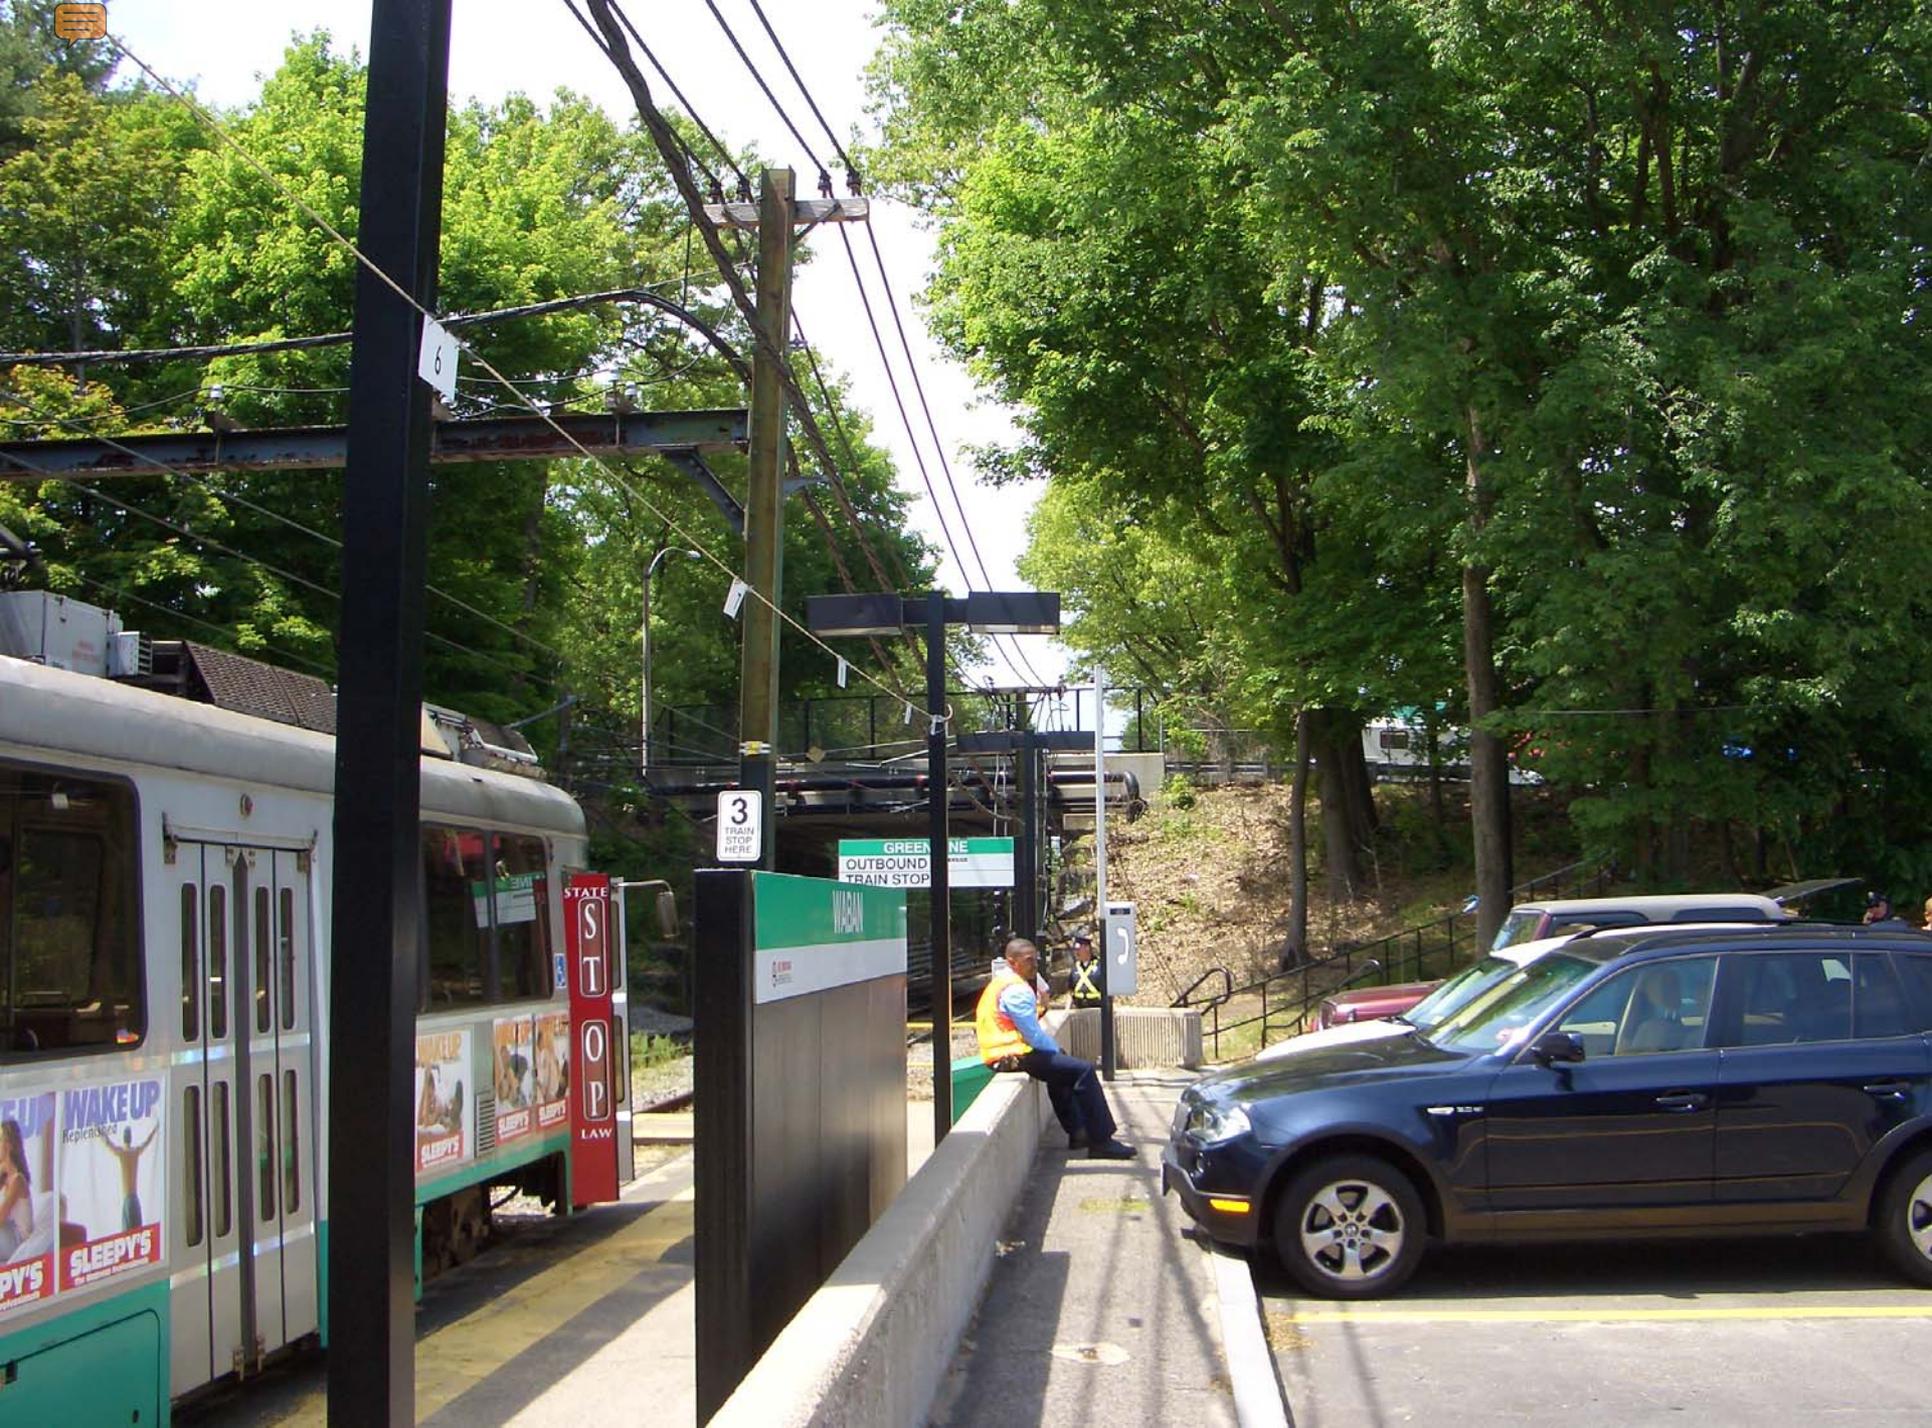
6

3
TRAIN
STOP
HERE

GREENLINE
OUTBOUND
TRAIN STOP

STATE
STOP
LAW

WAKEUP
SLEEPY'S
