NATIONAL TRANSPORTATION SAFETY BOARD

SAFETY REPORT

GENERAL AVIATION CRASHWORTHINESS PROJECT, PHASE ONE

NTSB/SR-83/01

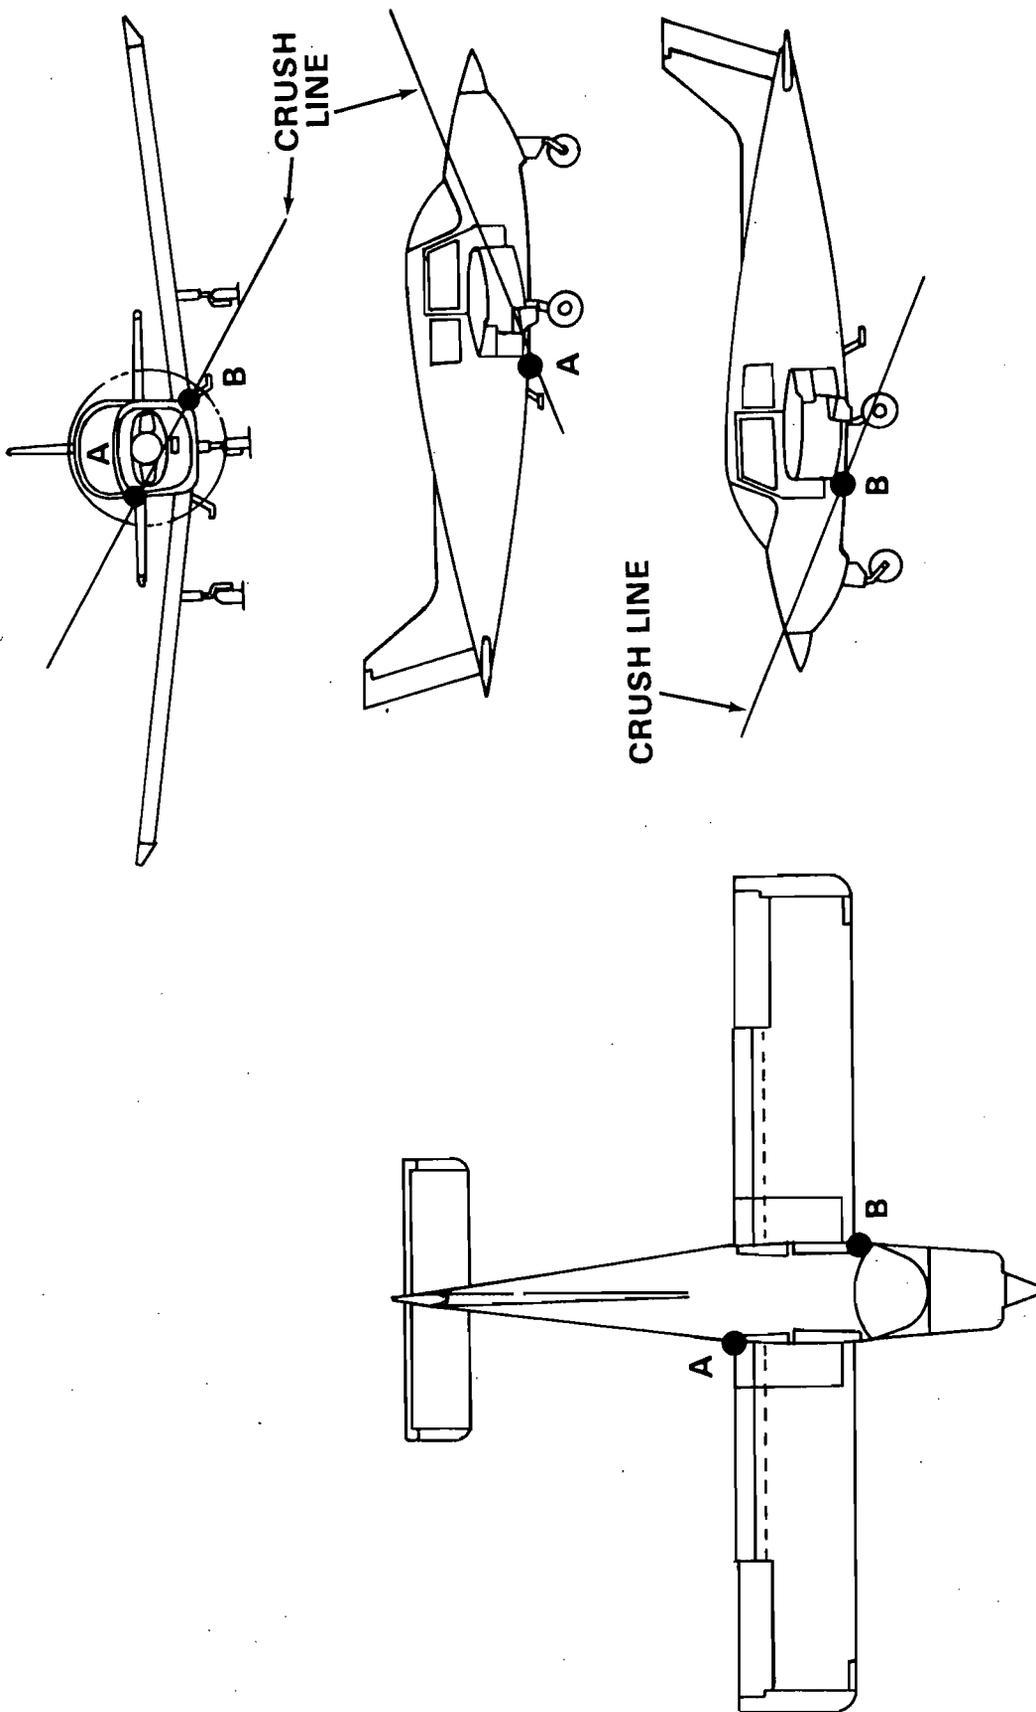
Figure 1.—Crush line documentation.

airframe. In general, the crush line can be identified by small, tight wrinkles in the skin, or by deformation of the airframe surfaces around longerons or stringers. This type of damage is caused by direct contact between the airplane and the ground. Points representing the edges of the damaged areas are plotted on an airplane three-view drawing and straight lines are drawn between these points. (See figure 1.) Several lines intersect to create an imaginary plane or flat surface, i.e., crush line. The impact attitude can be determined graphically by relating the crush line to the impact surface. The rotation required to place the crush line on the impact surface defines the airplane's pitch, roll, and yaw attitudes at impact relative to that surface. Correcting for surface slope will yield these attitudes relative to the horizon.

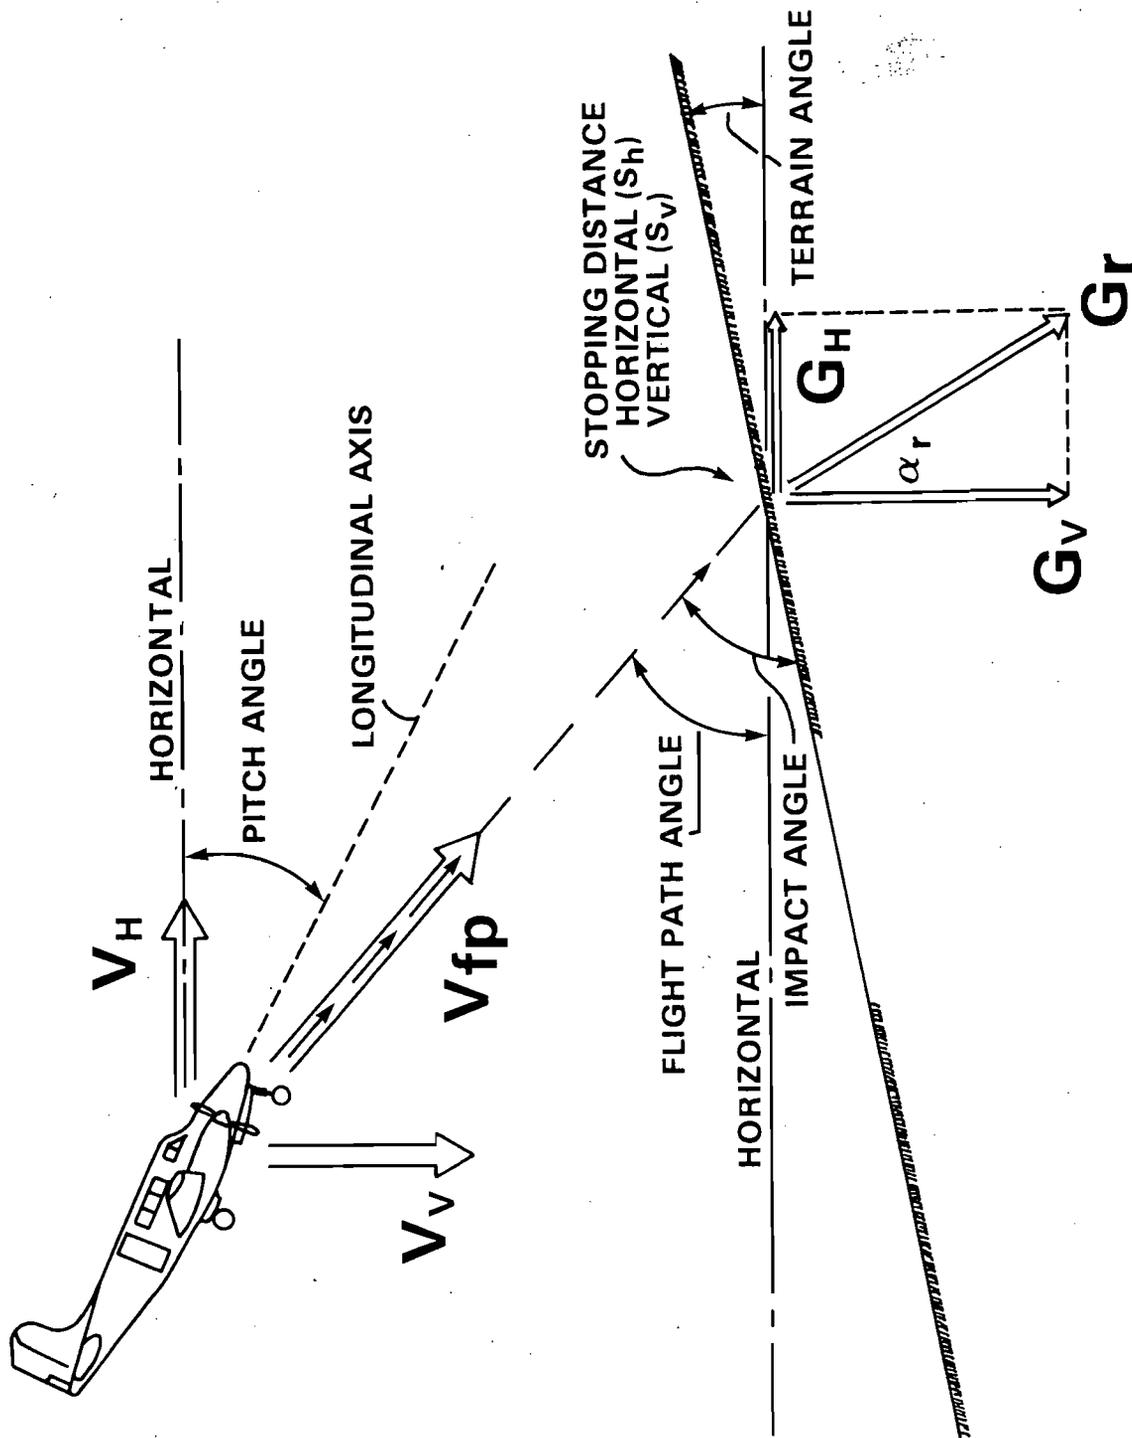
Figure 3.--Vector components.

The total velocity component of the principal impact acts along the flightpath. The flightpath angle is used to break down the total velocity component into its vertical and horizontal components, relative to the horizon. (See figure 3.) In the vertical direction, the final velocity is used to determine the velocity change. The final velocity usually is zero because the maximum vertical crush is achieved when the downward movement is stopped by the ground during the principal impact. As vertical velocity becomes zero the maximum vertical crush is achieved. In the horizontal direction, most airplanes tend to slide along the ground for some distance after the principal impact, and the difference between the initial velocity and the final velocity (a value greater than zero) must be established for the principal impact.

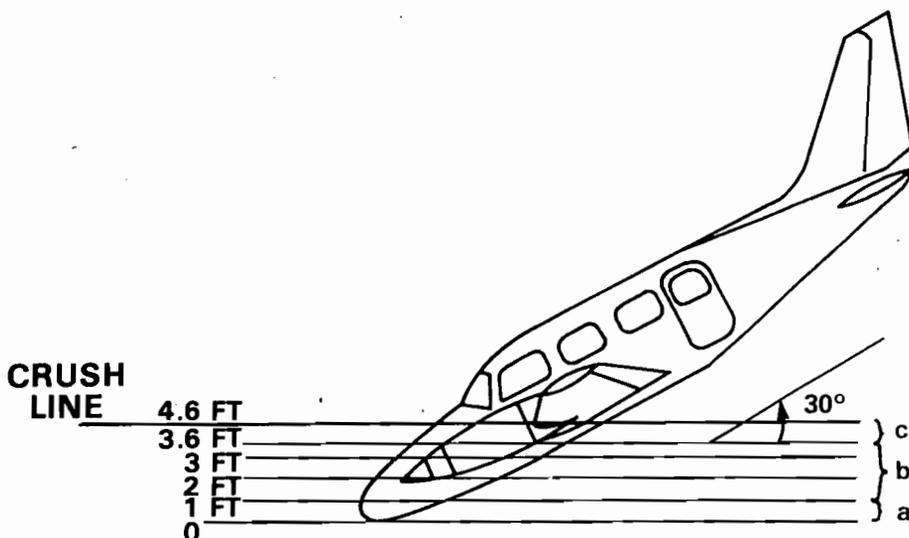
Figure 4.--Crash visualization.

Detailed Analysis Based on Shaping Techniques.—The following example illustrates how a detailed vertical pulse shape is developed. First, as in the "quick look" method, a visualization of the crash is developed, including the parallel lines showing the increasing amount of structure involved as the airplane crushes. Figure 4 shows that the nose area, which is comprised of lightweight material, is involved in the first 1 foot of crush (a). At the 1-foot mark, the components involved include some lightweight skin, the nose gear structure, and small frame structure (b). Starting at the 3.6-foot line, the structure being crushed includes the cockpit bulkhead, engine, engine mounts, cockpit floor, and side walls (c).

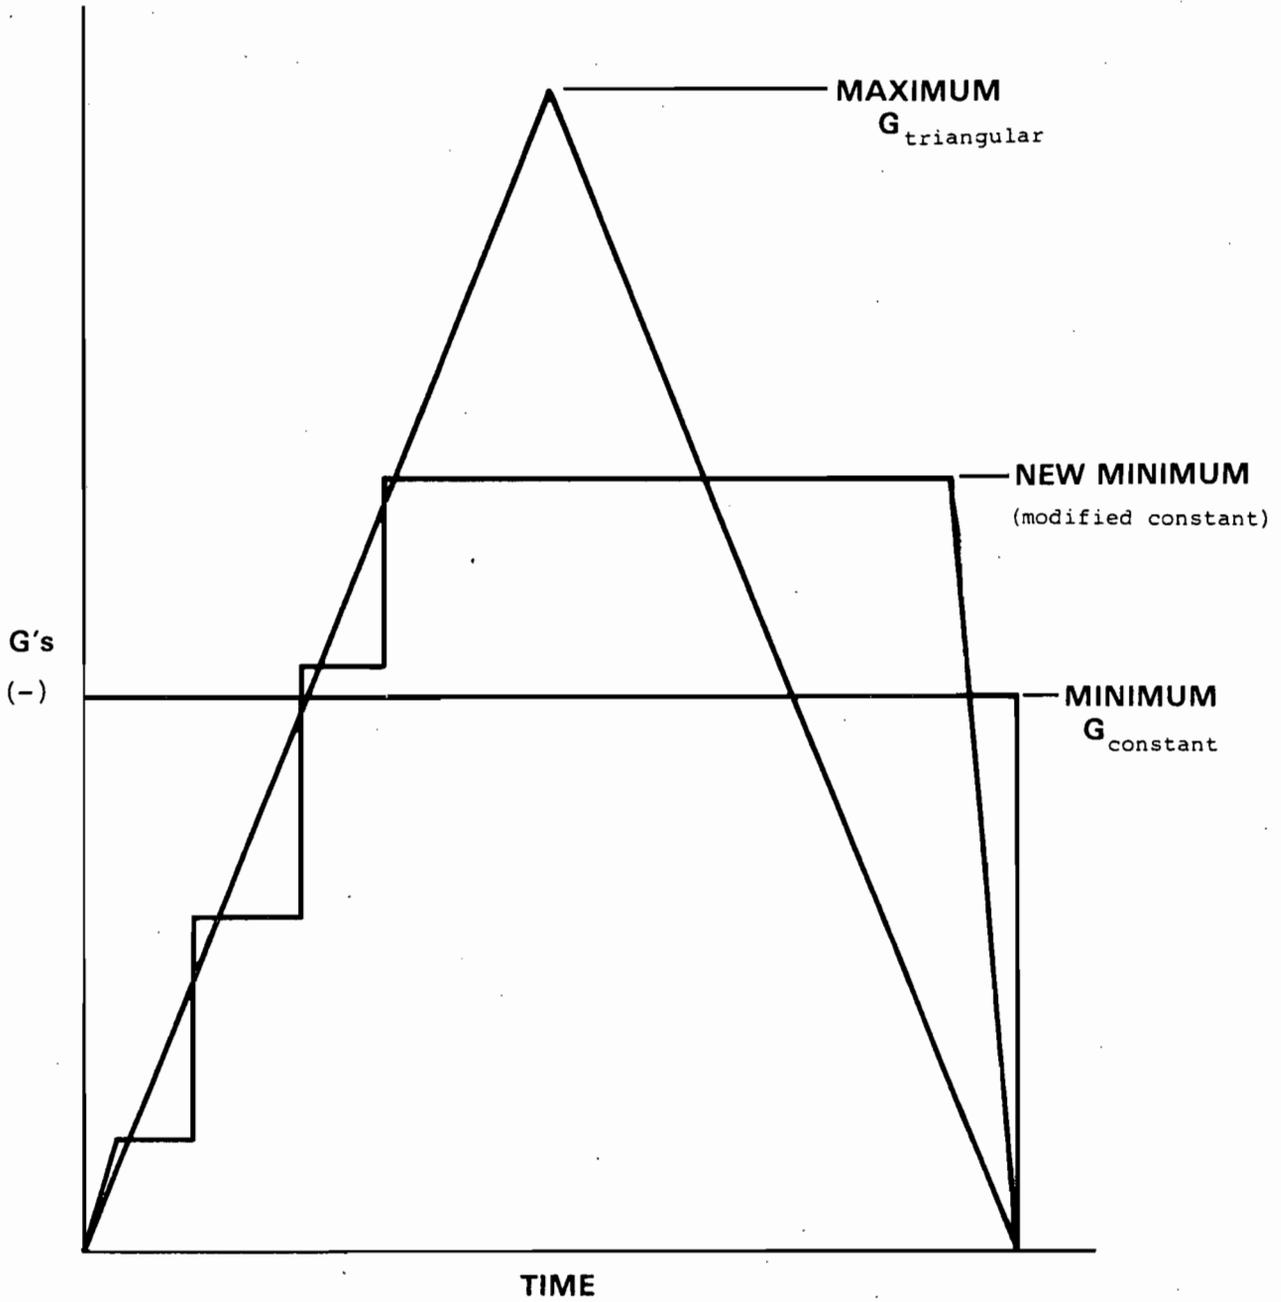
Figure 5.-- Minimum and maximum force limits.

Also, as in the "quick look" procedure, the minimum and triangular peak G's are calculated for the purpose of establishing a reasonable range of values. Since the first foot of crushing involves nonproductive structure, the stopping distance of 4.6 - 1.0 or 3.6 feet is used in calculations. The minimum peak G then, is $V^2/2gS = 66^2/2(32.2) = 3.6$, or 18.79 G's, and the triangular peak load is $V^2/gS = 66^2/32.2 = 37.58$ G's. These values become the minimum (19 G's) and maximum (38 G's) limits for the force values in the crash analysis. (See figure 5.) It should be noted that this step is quite easy and can be included in many quick look analysis.

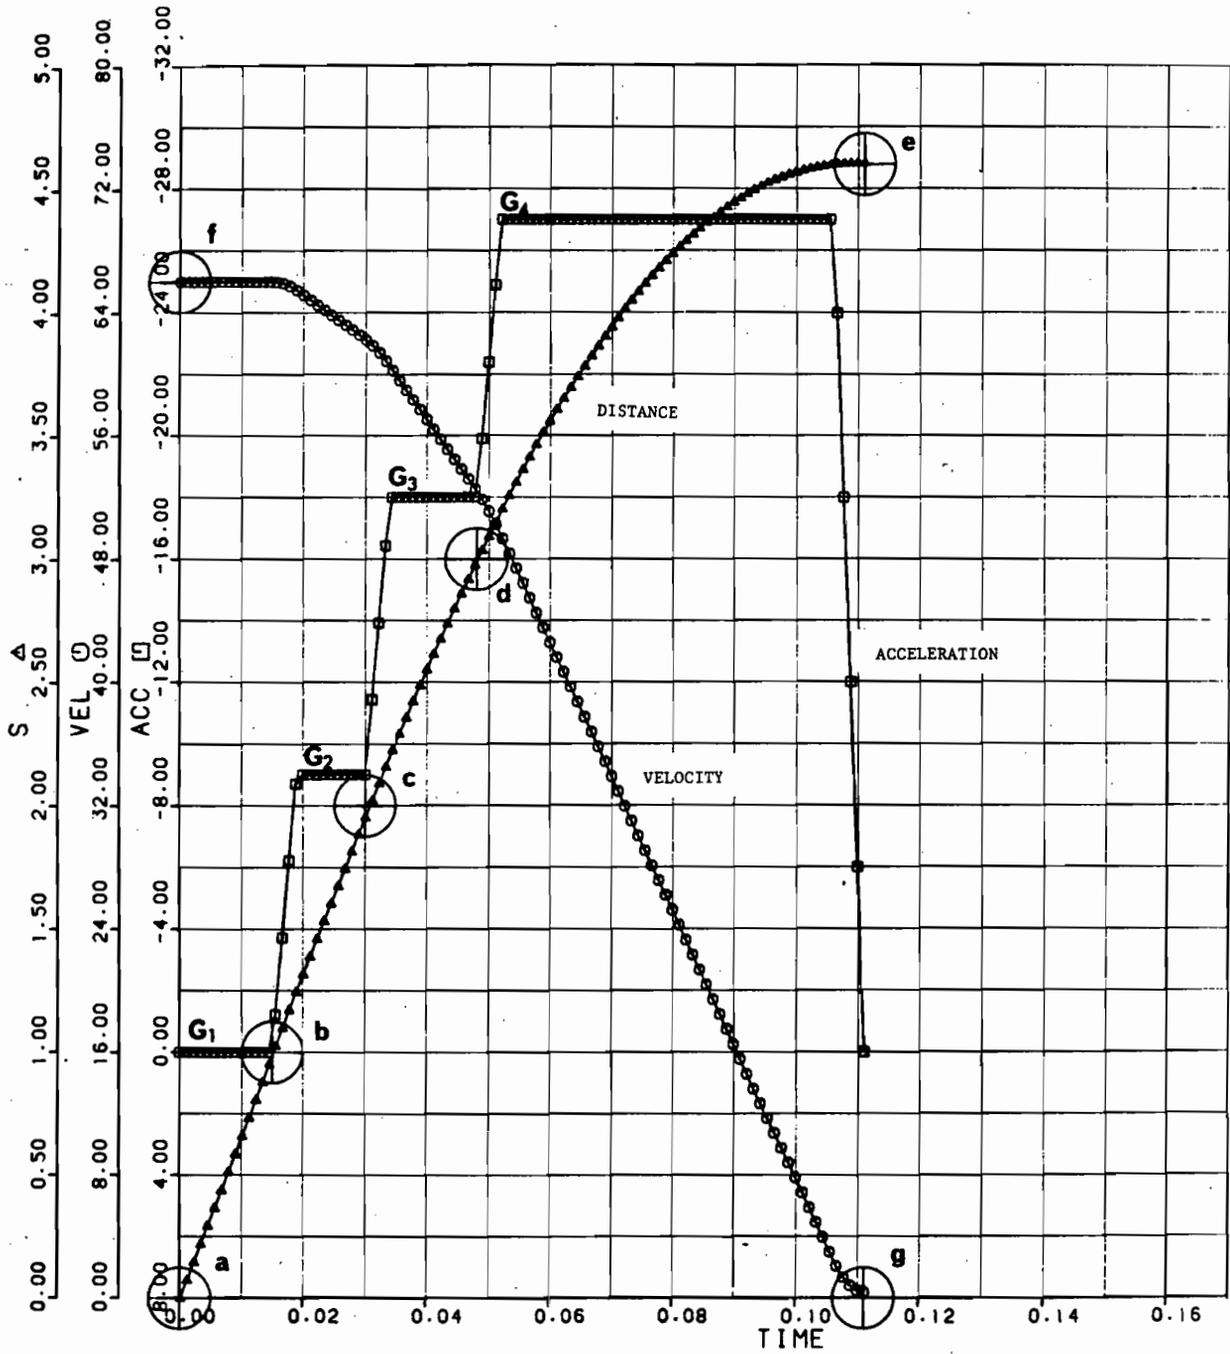
Figure 6.--Tiered crash pulse with targets.

A four-tiered pulse is assumed, based on the previously set distance targets. Each tier of the pulse represents the average G-load over a given distance. For this case, an initial estimated value of 27 G's was assumed as the highest value for the modified constant pulse. Any of the values between the established maximum and minimum values may be chosen for the estimate. However, analytical experience has shown that the midpoint, 27 G's in this case, is a reasonable value for the initial estimate. This value can be revised and the analytical procedure can be repeated for the number of iterations needed to satisfy the distance and velocity target criteria.

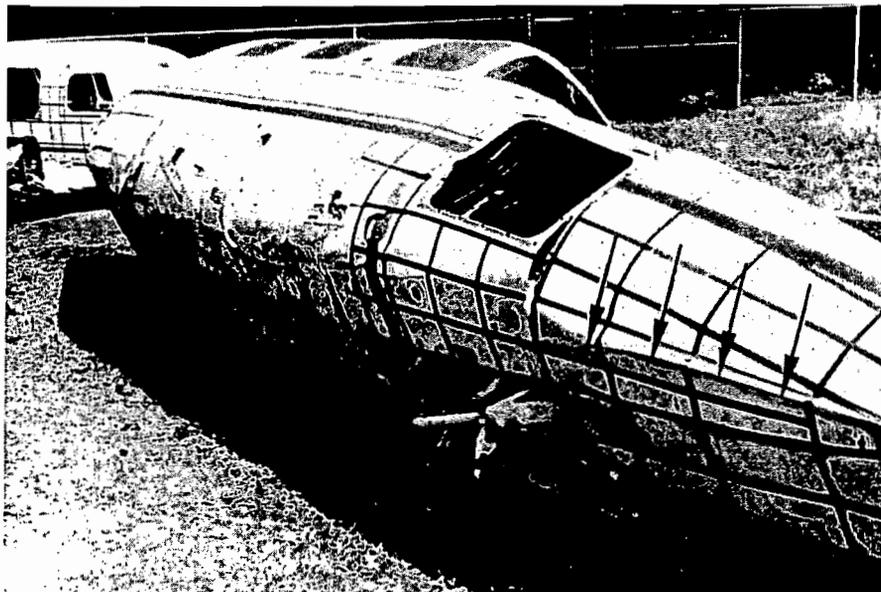
Figure 9.—NASA test vehicle No. 14. (Note flat area under nose in foreground.)

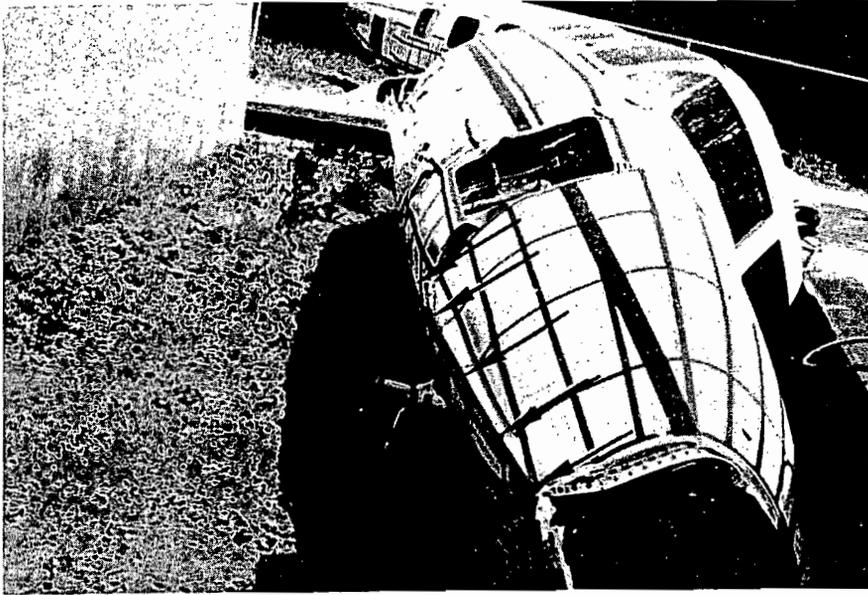
Figure 10.—Crush line on NASA test vehicle No. 14.

The measurements taken from the crush lines of the test airplanes were found to approximate closely the airplanes' attitudes at full development of the crushing. The comparison measurements were taken from NASA's crash test films. The film analyses showed that when crashed on concrete, the airplanes tended to rotate or bend during the principal impact, causing a change in pitch attitude between 3° and 9° . An example of this pitch rotation was identified in the film of a 45° nose down drop test. The airplane initially contacted the ground at 45° , but at the fully crushed position, the fuselage had rotated to a pitch angle of 36° . In the analyses of other drop test films, it was found that several of the 30° nose down tests resulted in pitch attitudes of 26° , and for 15° nose down tests, the pitch attitudes at full crush development were 12° .

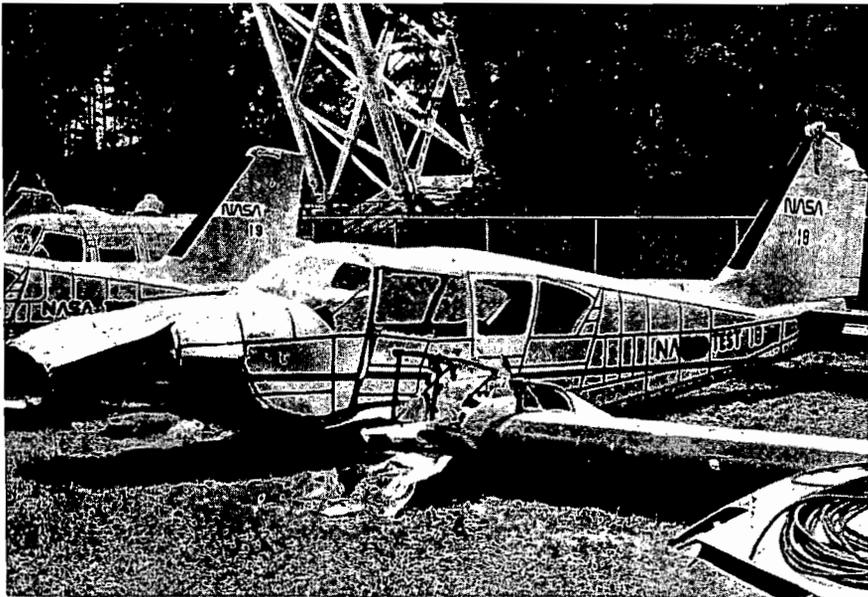
Figure 11.—NASA test vehicle No. 18.

Test vehicle No. 18 (see figure 11) illustrates how the use of only the crush line to establish attitude at impact can be misleading. The crush line is measured at 22° , but at full development during the crash, pitch was near 27° . The error in measurement is attributed to buckling of the fuselage top which caused the crush line on the fuselage bottom to stop development. Figure 12 shows the buckled area with a split rivet line. The rivet line is split 4° , so the pitch at full development could be measured as 22° plus 4° , or 26° .

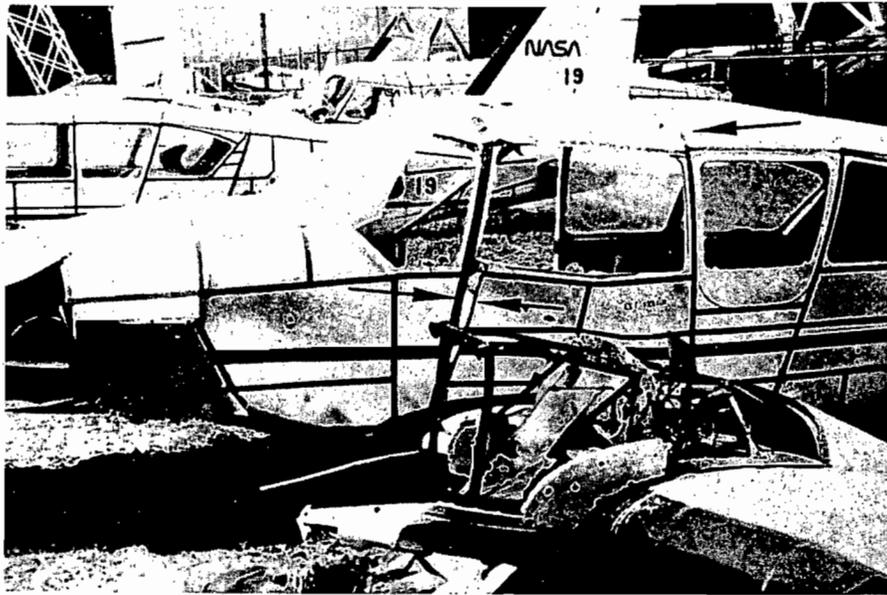
Figure 12.—NASA test vehicle No. 18 showing buckle and split rivet line.

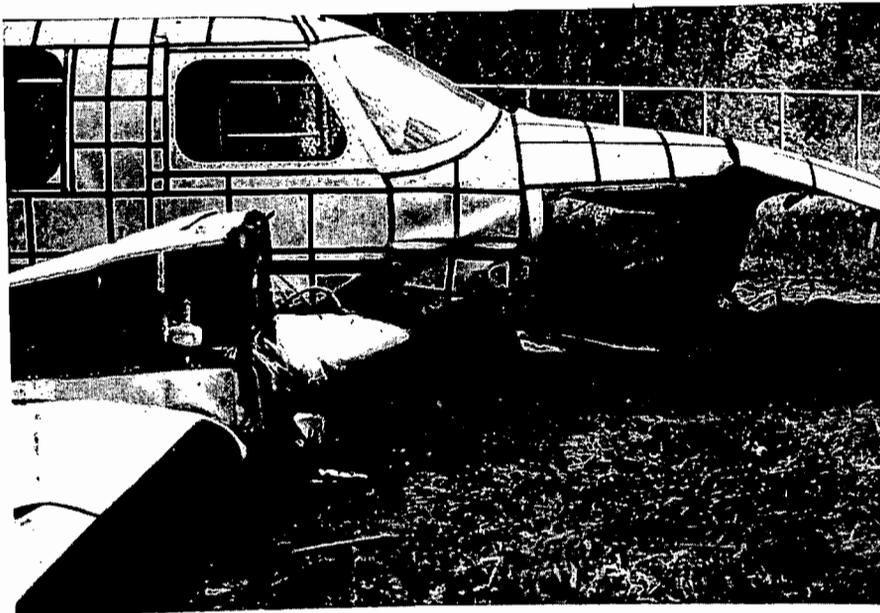
Figure 15.—Parallel wrinkles on right side of nose on vehicle No. 17.

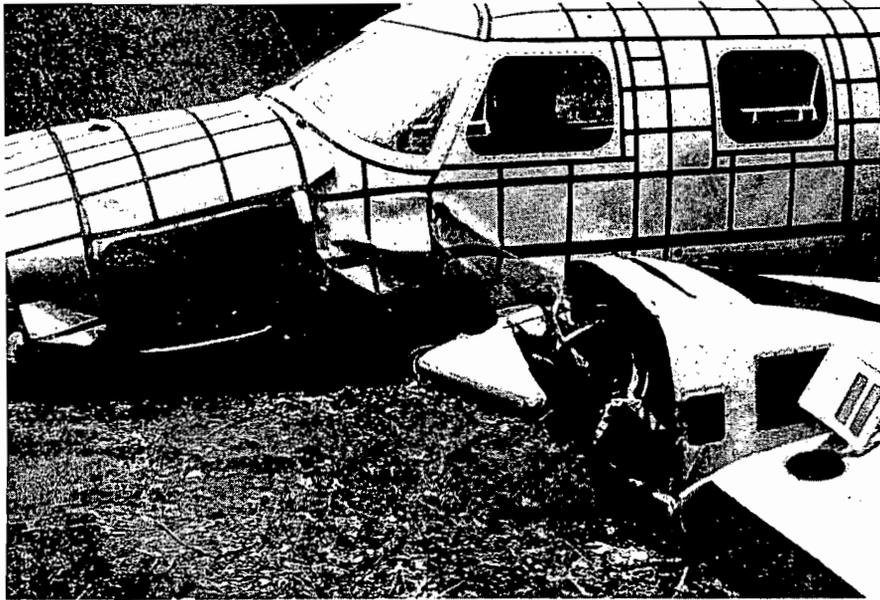
Figure 16.—Parallel wrinkles on left side of nose on vehicle No. 17.

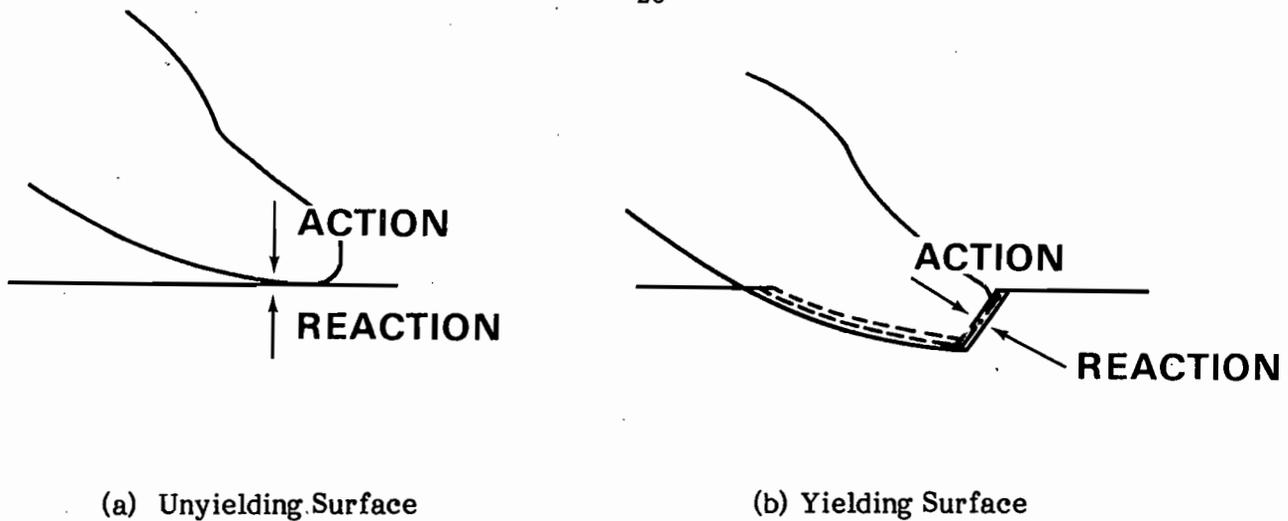
Figure 17.—Direction of reactions.

Stated in another manner, in both cases, the reaction to the force of the impact was normal, or at right angles to the impact surface. This reaction follows Newton's third law of motion which states that, for every action, there is an equal and opposite reaction. In figure 17, the principal impact surface in (b) is redefined as the airplane ploughs into the ground, resulting in a predominant loading along the airplane's longitudinal axis, while in (a), the predominant loading occurs in the direction normal to the unyielding surface.

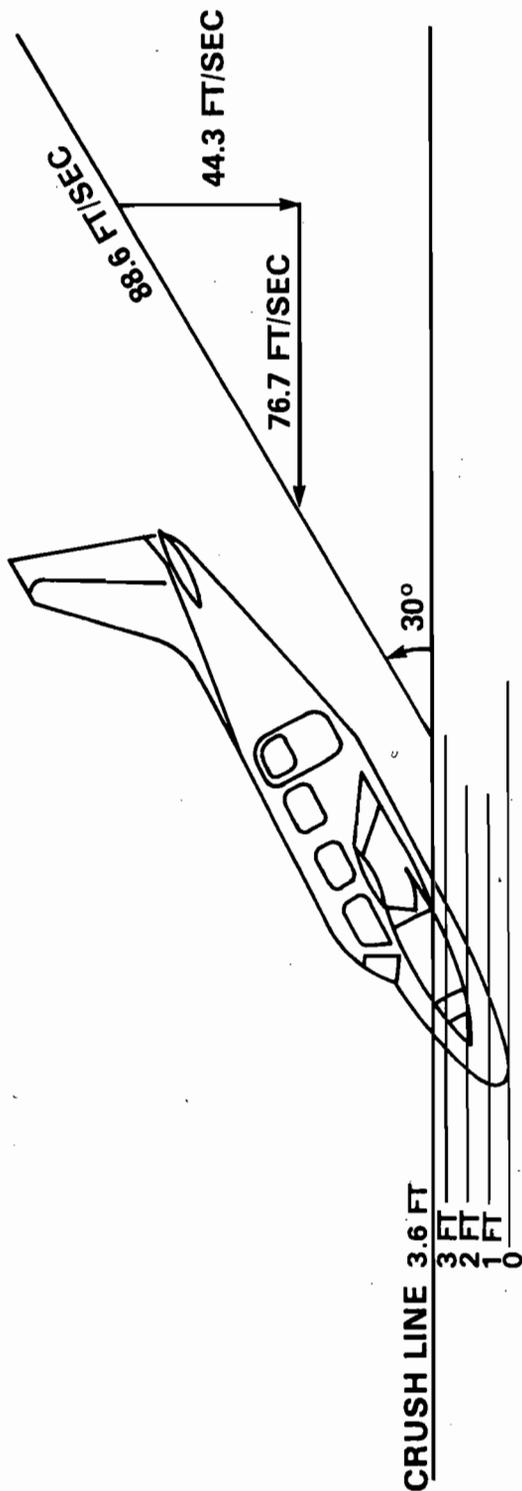
Figure 18:—NASA Test No. 8 --visualization.

Since the impact was on a flat, unyielding surface, the predominant loading was in the vertical direction in earth axis. Since the first foot of crush (0-1 ft) involved nonproductive structure, the net crush was 2.6 feet. The constant deceleration pulse peak value (G_{vC}) was 11.72 G's; this value was doubled to obtain the triangular shaped pulse peak value of 23.44 G's. The pulse duration was 0.117 second.

Assume net crush	3.6 - 1.0 = 2.6 ft
Velocity change	44.3 ft/sec
$G_{vC} = V^2/2gS$	
$= 44.3^2/2 (32.2)$	2.6
$= 11.72$	G's
$G_{vT} = 2 (11.72)$	
$= 23.44$	G's
$t_v = V_v/g G_{vC}$	
$= 44.3/(32.2)$	11.72
$= 0.117$	sec

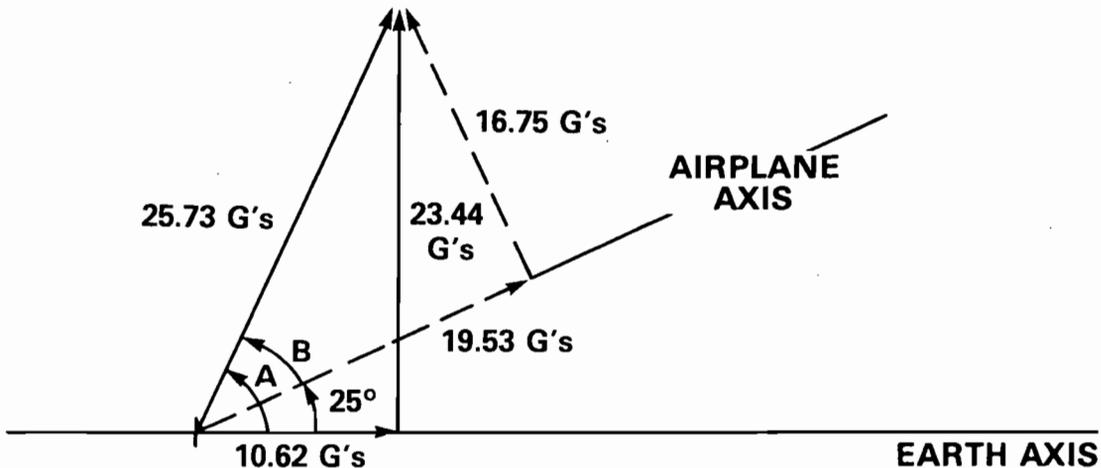
Figure 19.—Translation of forces into airplane axis.

Airplane Axis--The first portion of the analysis yielded a vertical peak pulse of 23.44 G's with a horizontal peak pulse of 10.62 G's in earth axis. The vector sum of the two pulses was a single pulse of 25.73 G's. To compare this analysis to the NASA data, the total pulse was broken down into two vectors relative to the airplane axis to coincide with the accelerometer alignment used in the tests. To obtain these values, the reference axis was rotated 25° from earth axis to airplane axis. (See figure 19.)

$$\begin{aligned} \text{Angle A} & = \text{Cos}^{-1}(10.62/25.73) \\ \text{Angle A} & = 65.62^\circ \\ \text{Angle B} & = 65.62 - 25 = 40.62^\circ \end{aligned}$$

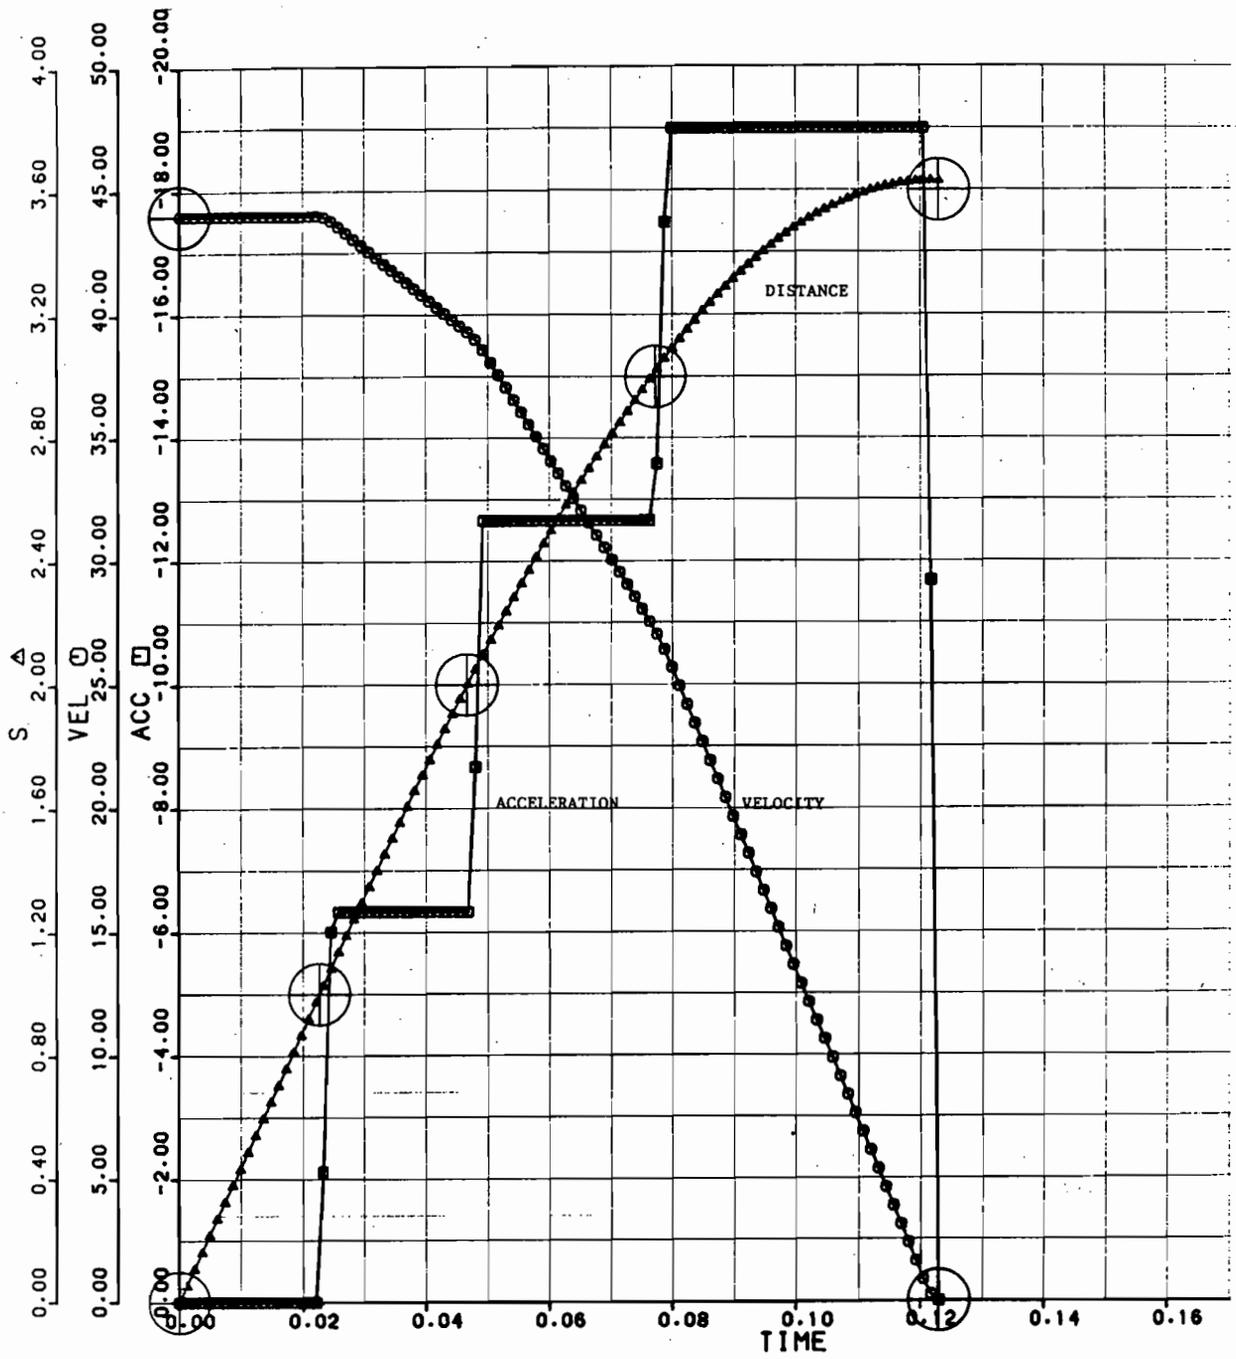
Figure 21.—Final modified constant pulse, NASA Test No. 8.

Insufficient detailed data exist for shaping the horizontal pulse. However, since a value for the horizontal pulse must be used in translating the deceleration levels from earth axis to airplane axis, the calculated horizontal value of 10.62 G's was used. Converting to airplane axis, the total pulse is 26.7 G's, the horizontal pulse is 20 G's, and the vertical pulse is 17.7 G's.

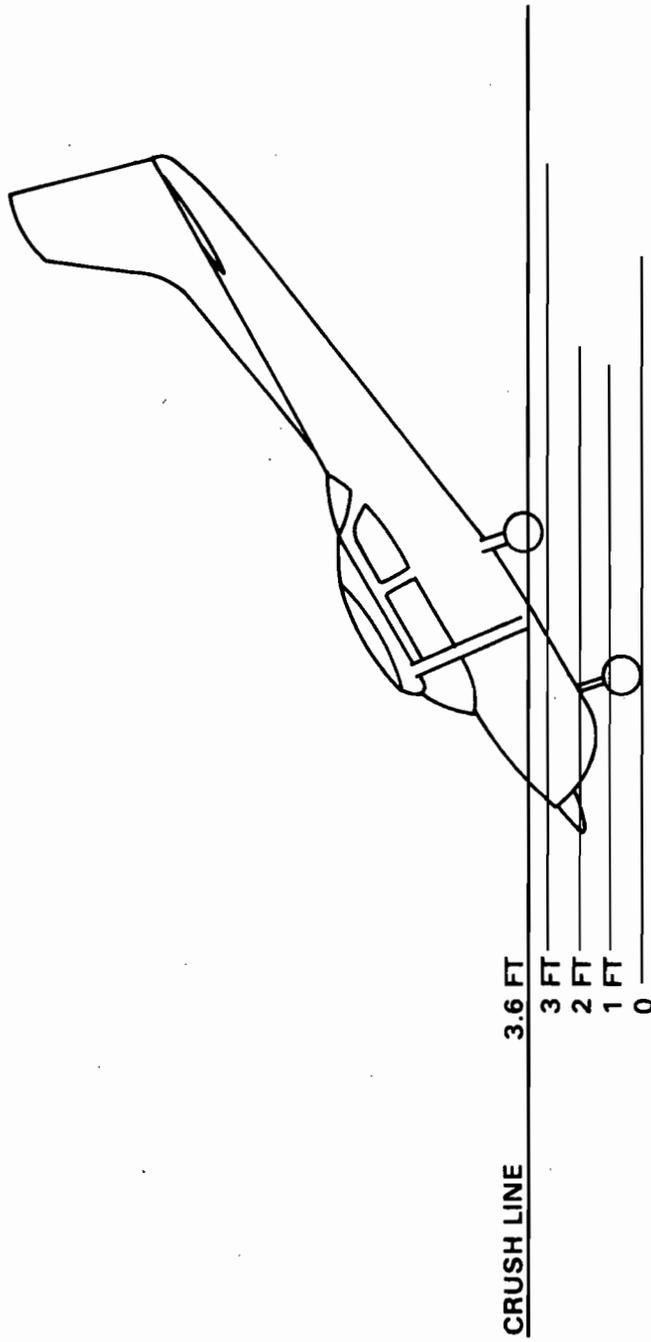
Figure 23.—NASA test No. FAA 4--visualization.

Visualization.--The visualization in figure 23 was derived from notes, photographs, and film data. This accident would have been difficult to reconstruct accurately in the field because the forward rotation of the airplane at impact caused crushing that gave the appearance of a 70° to 80° nose down pitch attitude. Reliance only on the crush line would have been inaccurate; reference to ground scars or tree strikes would have been necessary to establish a more accurate impact attitude.

The crush line was identified as starting just aft of the wing strut. As shown in table VI, the structure involved in the first 1.5 feet of crush involved the nose gear only and would have a negligible effect on the deceleration. The next 0.5 foot of crush involved some of the engine cowl structure and also was nonproductive. The crush from 2.0 to 3.6 feet included the engine, firewall, and floor structure. Thus, the total effective crushing distance on the airplane was 1.6 feet, and with surface gouging estimated at 6 inches or 0.5 foot, the total stopping distance was 2.1 feet.

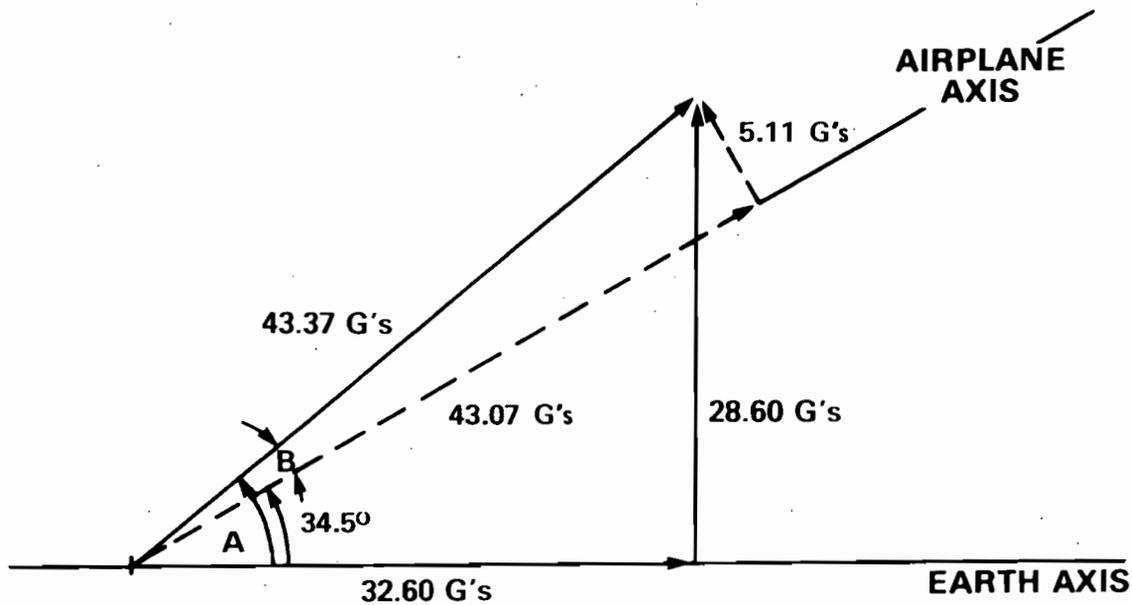
Figure 24.—Translation of forces into airplane axis.

Angle A = 41.26°
 Angle B = 41.26 - 34.5 = 6.76°

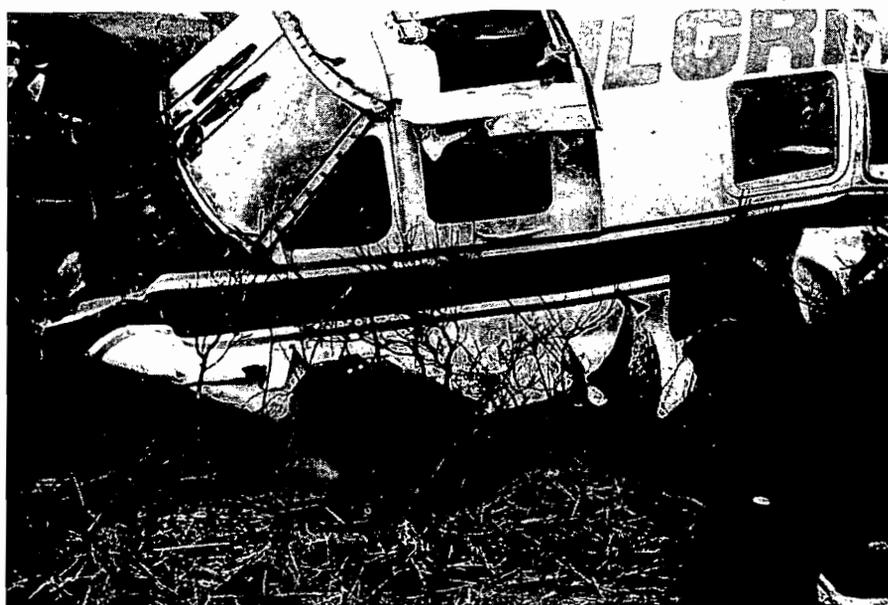
Figure 26.—Left side crush line.

The investigation included interviews of passengers and crew and an onsite documentation of the crash path, fuselage, seats, and restraints. Photographs taken at the accident site showed the crush line and general fuselage damage. (See figures 26 through 29.) The crush line was documented further on a three-view drawing of the airplane. (See figure 30.)

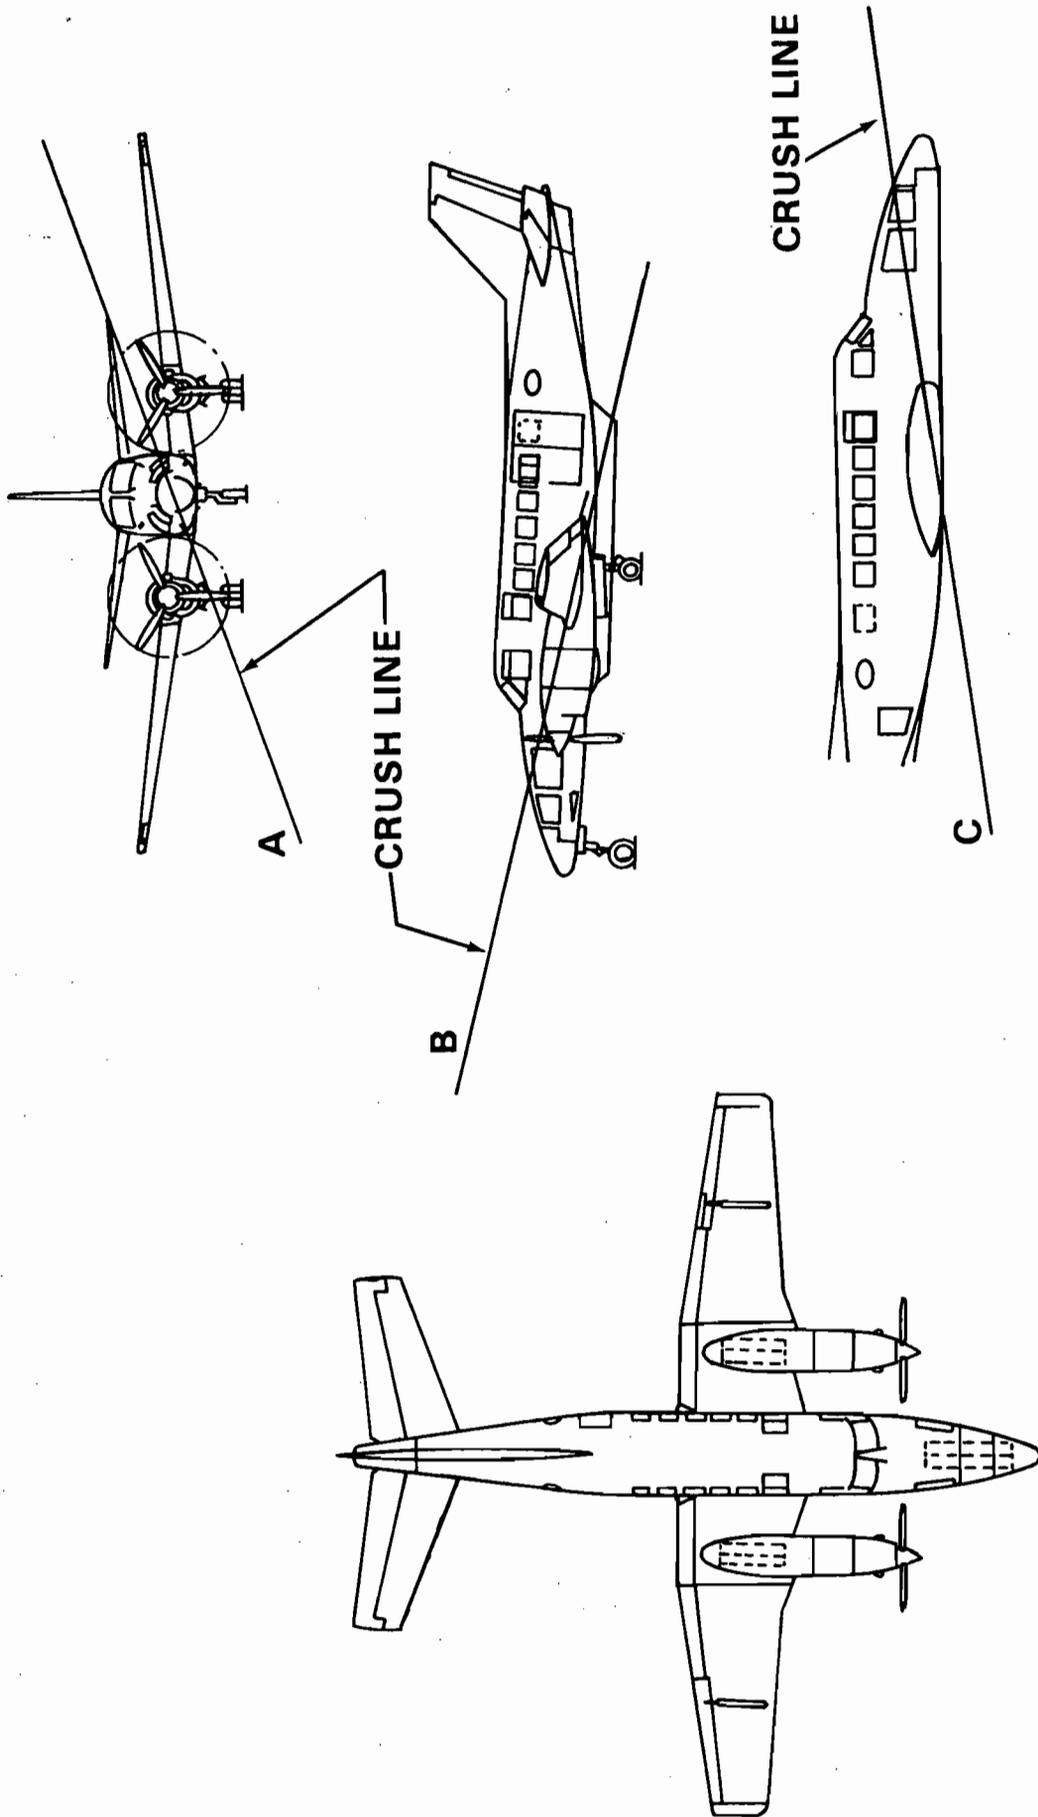
Figure 30.—Three-view drawing showing crush line.

The crush line in the photographs and the three-view drawing were consolidated into a separate drawing in which the crush plane was rotated to the horizontal position. (See figure 31.) Parallel lines, labeled 1 through 5, were drawn to represent the crush levels at which different parts of the structure became involved during the crash. The airplane attitude, measured directly from the drawing, showed a roll angle of 21° left wing down and a nose down pitch attitude of 9°.

SCALE = 144 in/in
PITCH = -9°
FLIGHT PATH = -2° -9° -12° = -23°
STALL SPEED — POWER OFF, 30% FLAPS =
82 KCAS = 86 KIAS = 86 KTAS
ROLL = 21° LEFT
V_v = 145 FT/SEC sin 23° = 57 FT/SEC

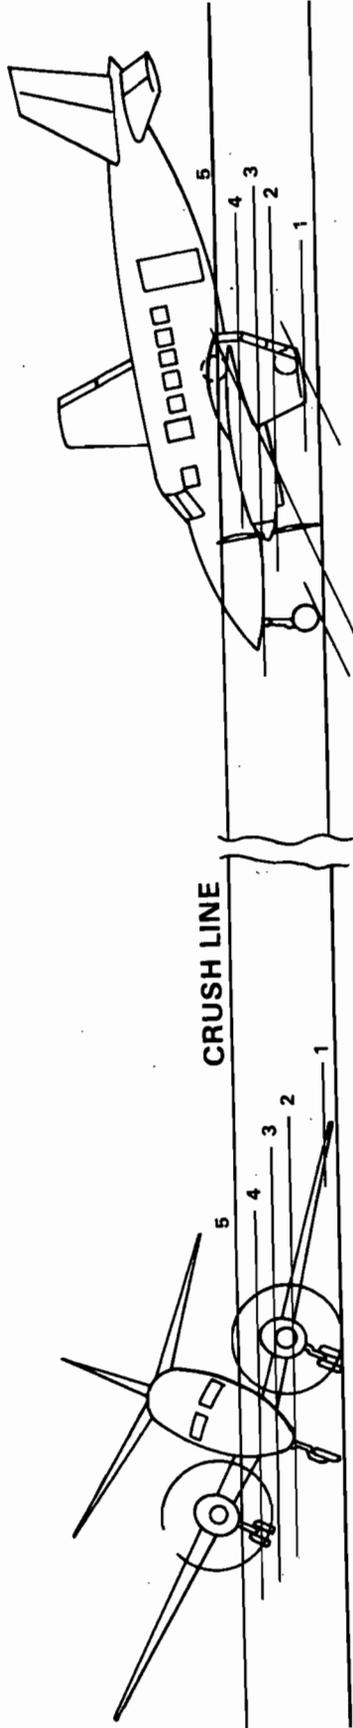
Figure 31.—B99 visualization.

CRASH INVOLVEMENT
1. WING TIP — 0 FT
2. ENGINE — 2.28 FT
3. FUSELAGE — 3.30 FT
4. COCKPIT — 4.00 FT
5. FULL STROKE — 6.12 FT

The first distance target was set at 3.3 feet, the distance from the wing tip to the beginnings of fuselage involvement. Using an entering velocity of 57 ft/sec, time for the first segment of the pulse was calculated as:
