NATIONAL TRANSPORTATION SAFETY BOARD

SAFETY REPORT

GENERAL AVIATION CRASHWORTHINESS PROJECT, PHASE ONE

NTSB/SR-83/01

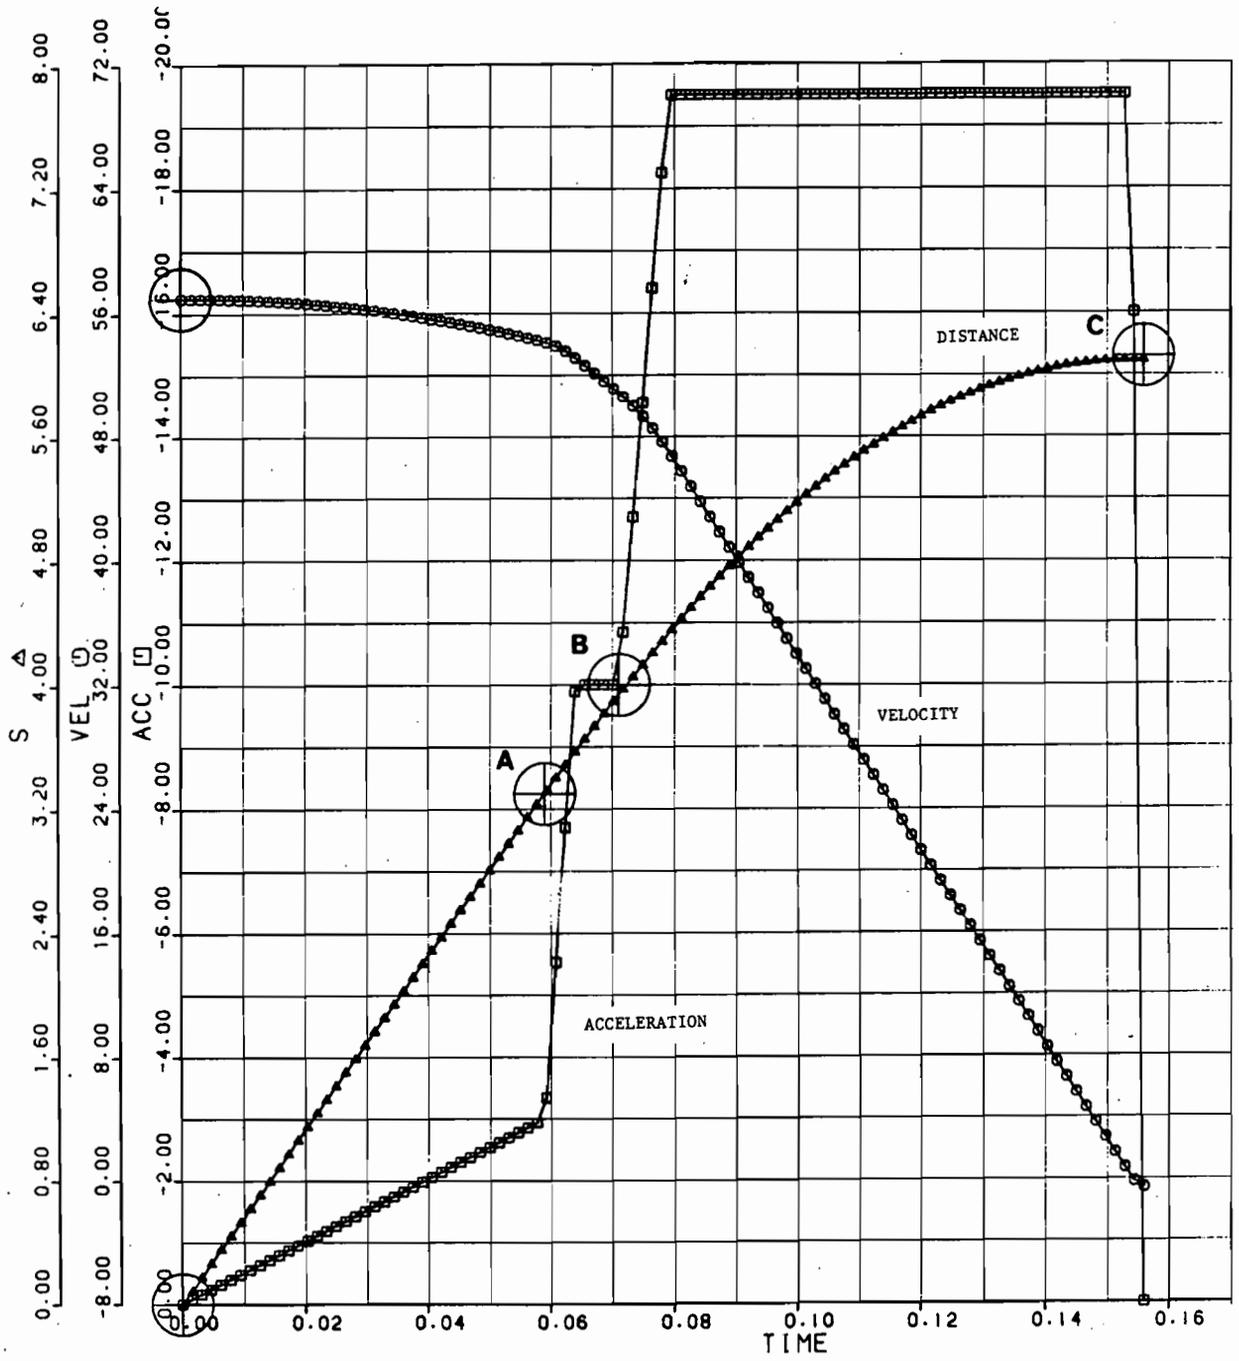
Figure 32.—Crash pulse with targets.

The calculated data points were entered into the computer, and the program was run. Distance targets, which are fixed in magnitude, were adjusted on the time scale until the final distance target of 6.12 feet and the final vertical velocity target of zero were met simultaneously. This resulted in the calculation of a 19.5G constant vertical crash pulse for a total time of 0.157 second. (See figure 32.)

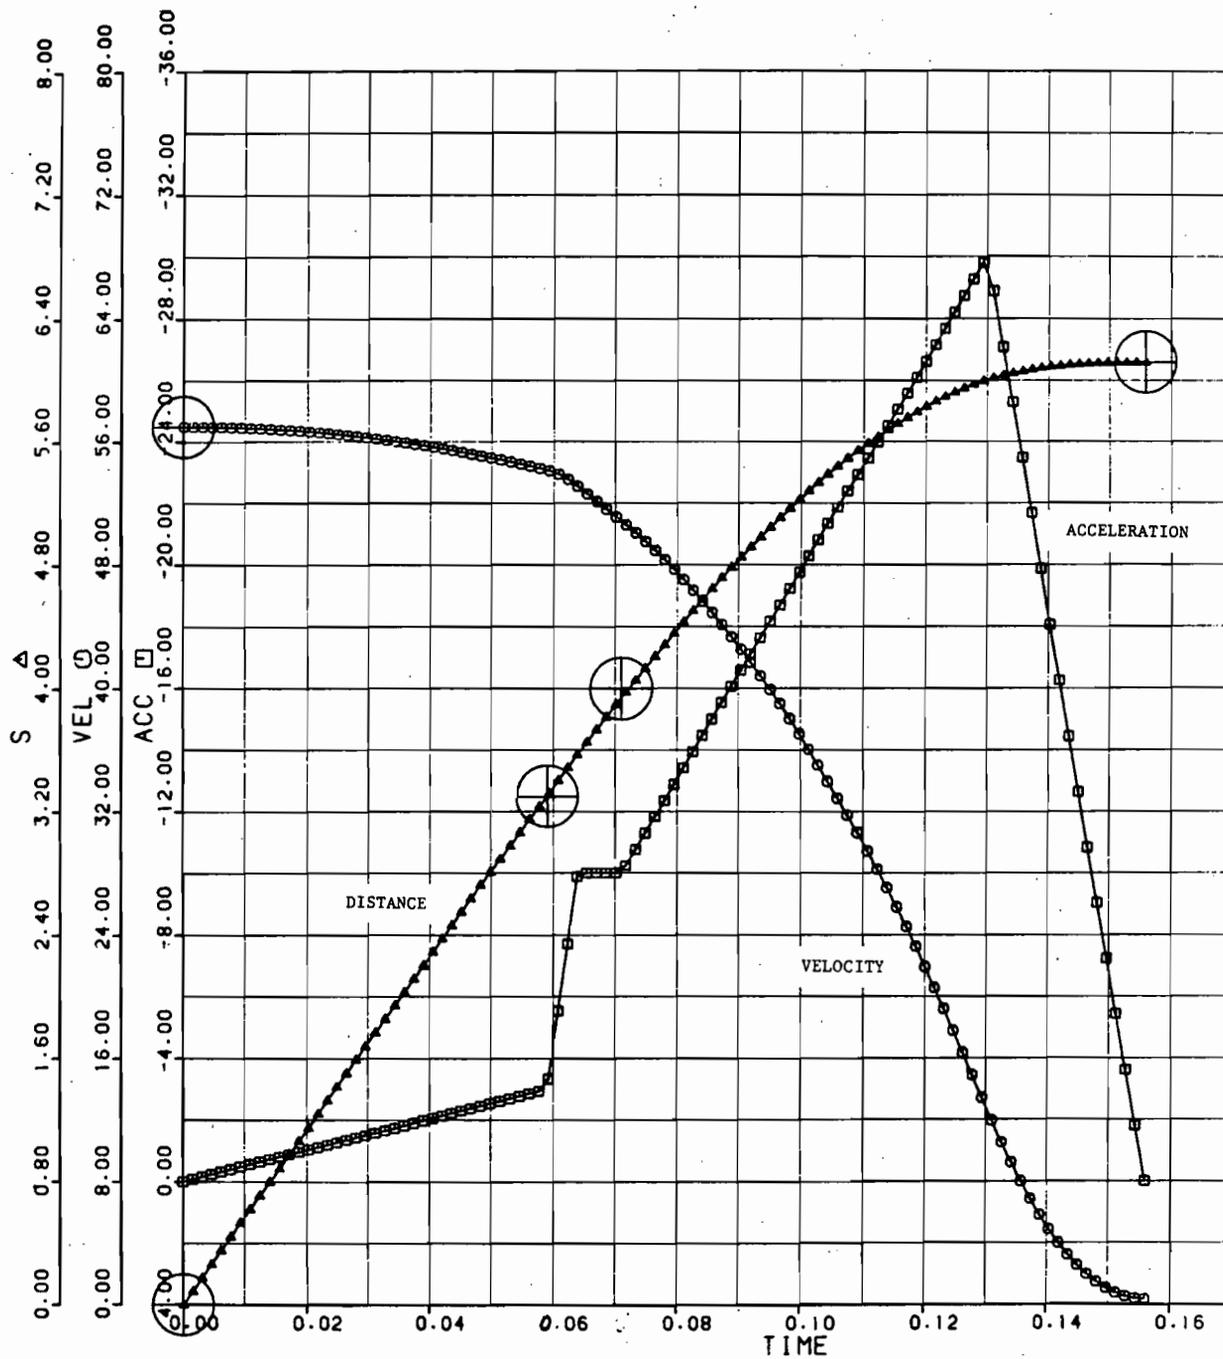
Figure 33.—B-99 shaped triangular crash pulse.

Figure 33 shows the results of substituting the plateau type pulse shape with the triangular pulse shape. Adjustments were made so that the distance and velocity targets still were met. The triangular pulse shape, which is more consistent with pulse shapes resulting from crash tests, showed a short duration peak load of 30 G's acting on the airplane near the point of impact.
