NATIONAL TRANSPORTATION SAFETY BOARD

SAFETY STUDY

Safety at Passive Grade Crossings
Volume 1: Analysis

**NTSB/SS-98/02
PB98-917004
Notation 7036
Adopted July 21, 1998**

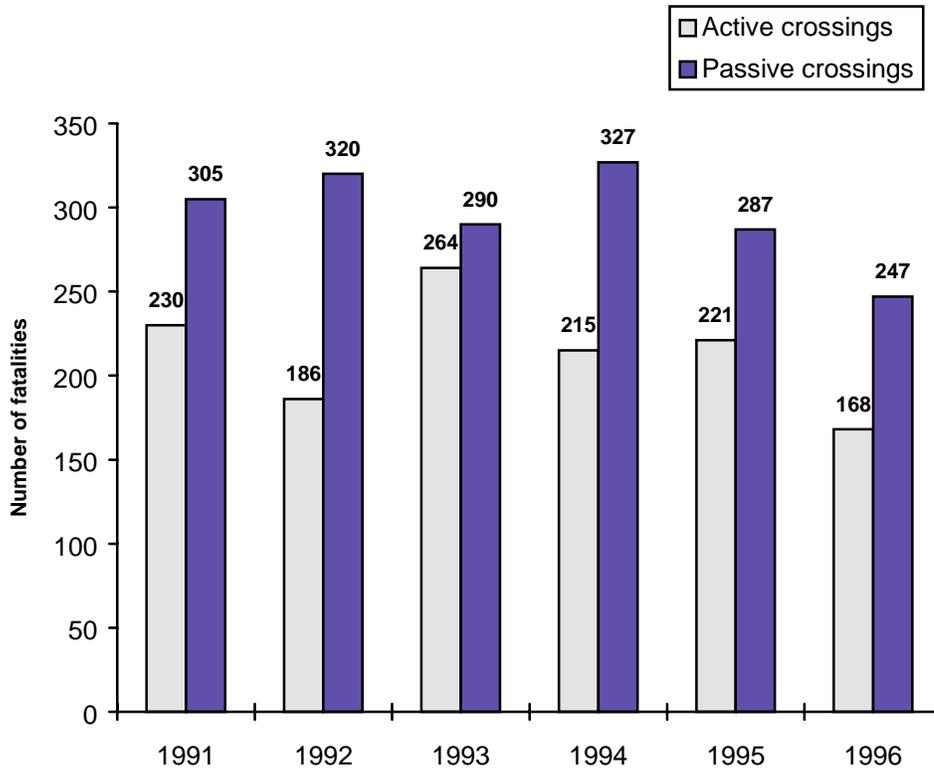
Figure 1–1. Fatalities from accidents involving highway vehicles at active and passive highway–rail grade crossings, 1991–1996. (Source: U.S. Department of Transportation, Federal Railroad Administration. 1992–1997. Highway–rail crossing accident/incident and inventory bulletin. Nos. 14–19. Washington, DC. Annual.)

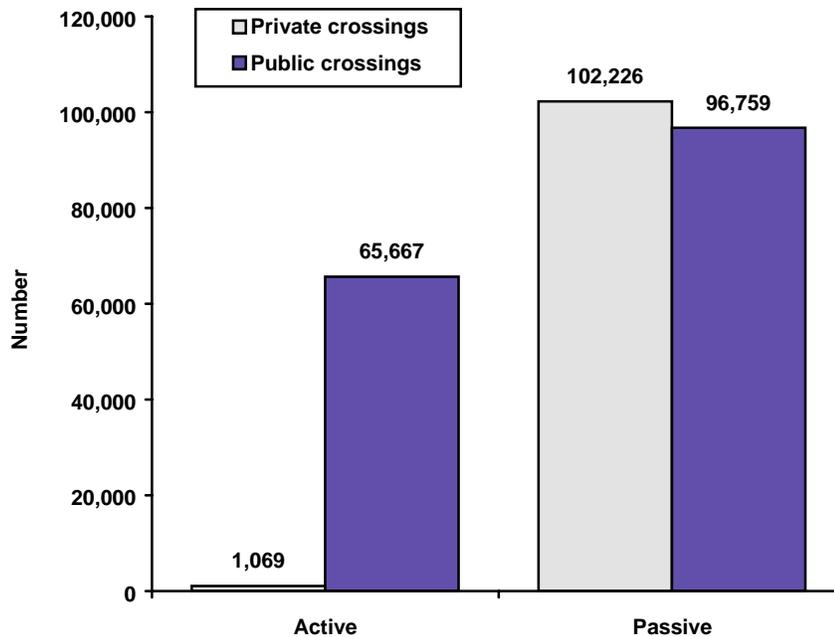
Figure 1–2. Number of active and passive, public and private grade crossings in the United States, 1996. (Source: U. S. Department of Transportation, Federal Railroad Administration. 1997. Highway–rail crossing accident/incident and inventory bulletin. No. 19. Washington, DC.)

Grade crossings are also categorized as either public or private. A private crossing is a grade crossing that is not classified by the FRA as a public crossing,⁸ such as a crossing on a private road giving access to a farm. Of the 103,295 private crossings reported to the FRA, only 1,069 have active signals, thus 99 percent of all private grade crossings are also passive crossings (figure 1–2).

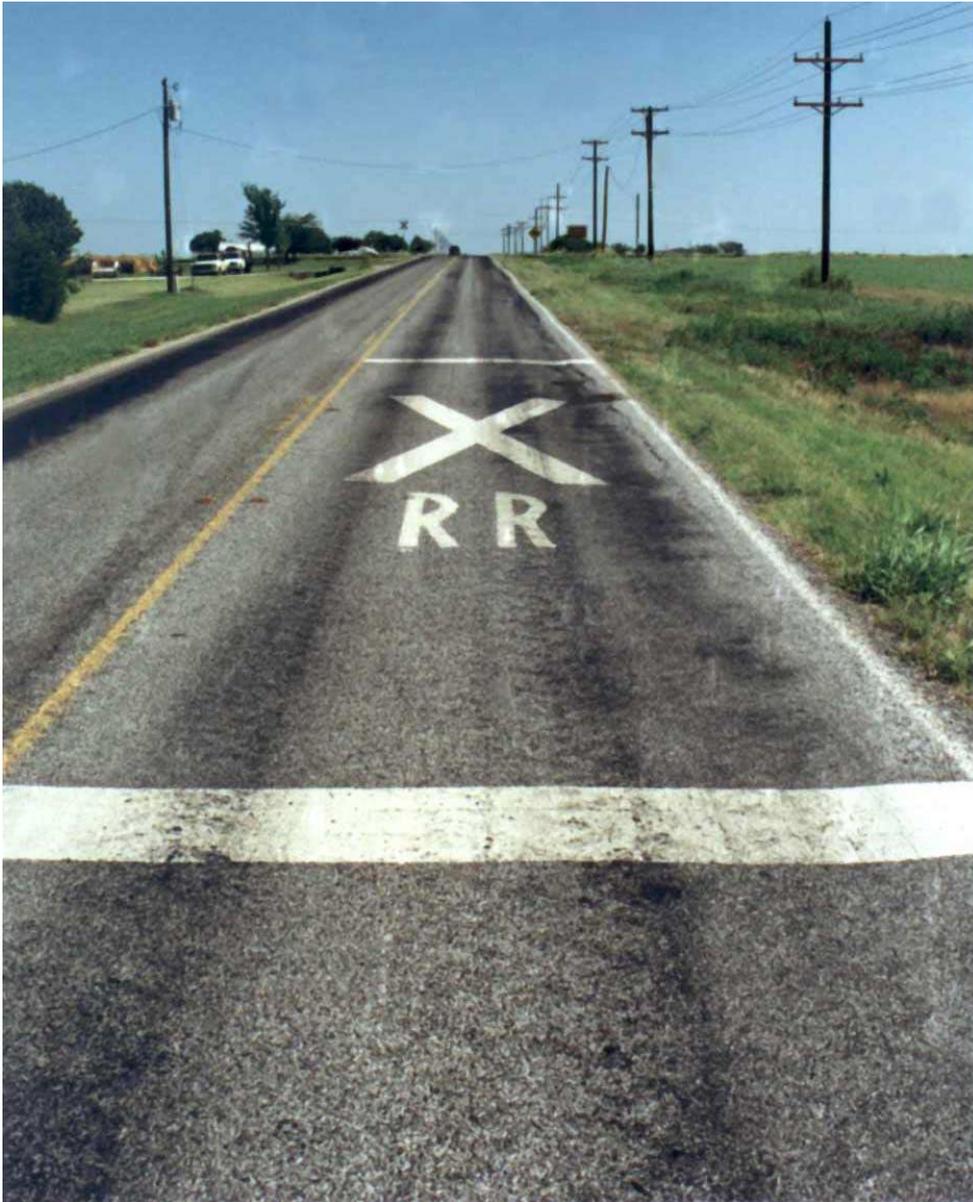
Figure 4–1. Full set of pavement markings on a roadway approach paved with either asphalt or concrete and with a traffic speed over 40 mph: “X,” “RR,” transverse lines, and no-passing zone lines. Some portion of the pavement markings should be directly opposite the advance warning sign but no closer than 50 feet from the crossing.

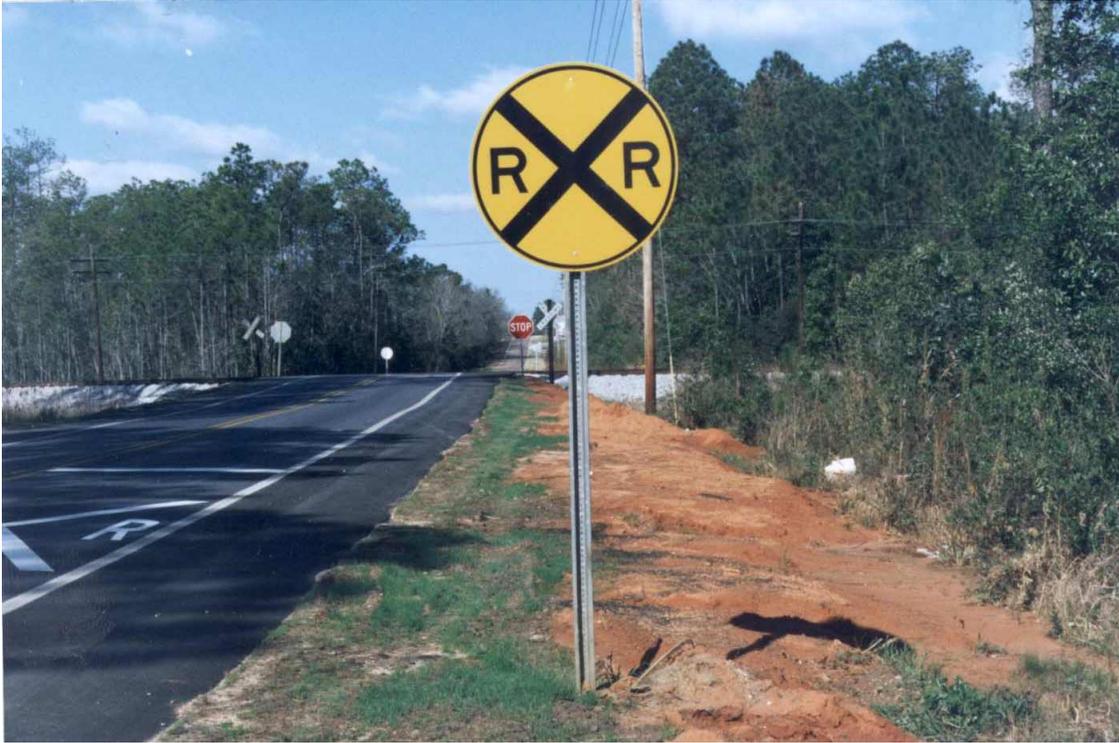
Figure 4–2. Circular railroad crossing advance warning sign.

None of the 24 public crossings without the circular advance warning sign met the exemptions specified in the MUTCD. According to FRA data, about 61 percent of all active and passive crossings are equipped with the circular advance warning sign.

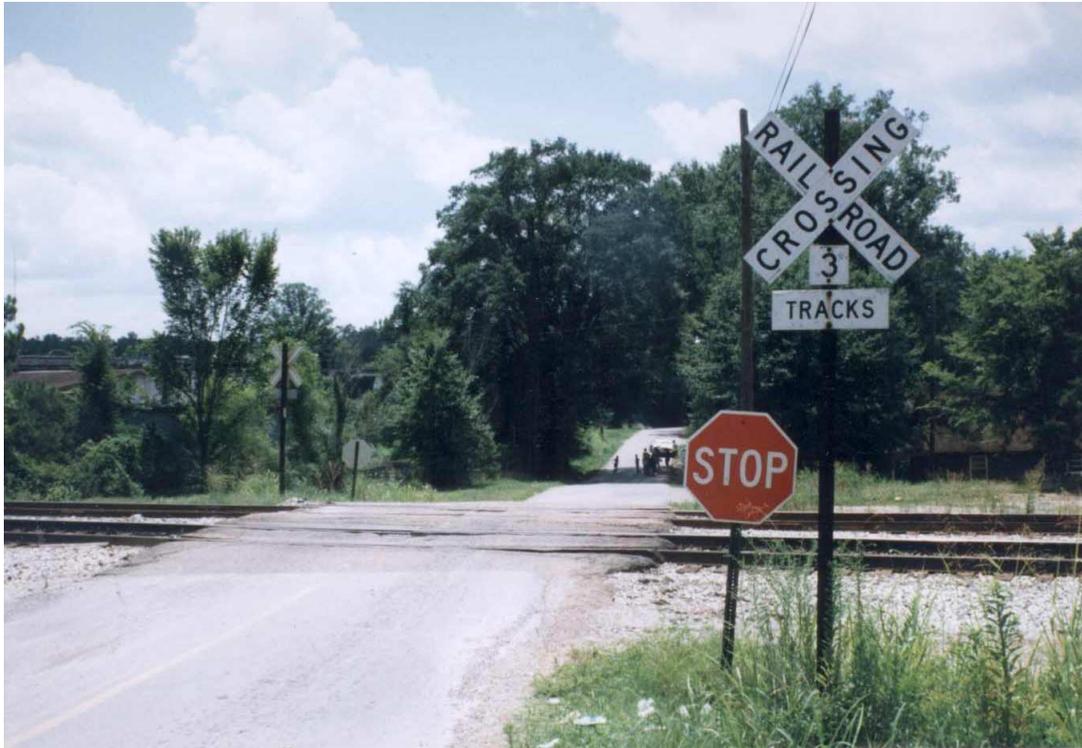
Figure 4–3. Crossbuck sign, multiple tracks sign, and stop sign placed at a crossing.

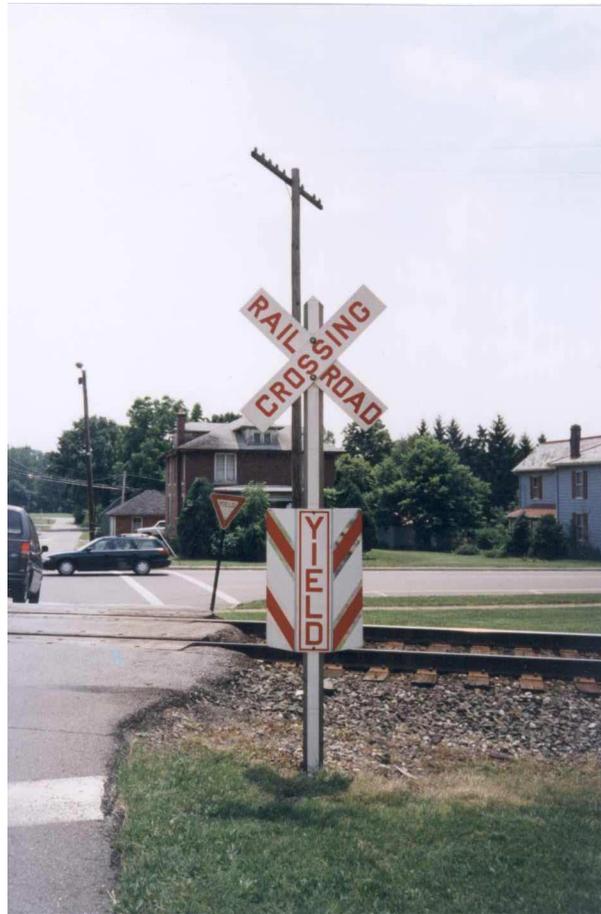
Figure 4-4. "Ohio buckeye" crossbuck, an experimental configuration.

The experimental crossbuck configuration present at the grade crossing in study case 41, the Ohio buckeye crossbuck (figure 4-4), may solve some of the nighttime visibility problems inherent in the standard crossbuck configuration. Reflective strips extend the full length of both the front and back of the sign mast. In addition, a reflective shield is placed below the crossbuck at a height that may be better illuminated by automobile low-beam headlights. The sides of the shield are also angled to catch light from the headlight of an oncoming train and reflect that light toward an oncoming highway vehicle. The lettering and chevrons are printed in red, rather than black, to enhance daytime visibility. The crossing in case 41 was one of about 3,700 grade crossings in Ohio where this crossbuck configuration was being tested; the testing concluded in December 1997, and the report will be published in the fall of 1998.⁹⁷ The Safety Board looks forward to reviewing the report on the effectiveness of the buckeye crossbuck, and depending on the results of the Ohio study, may issue recommendations about the buckeye crossbuck in the future.

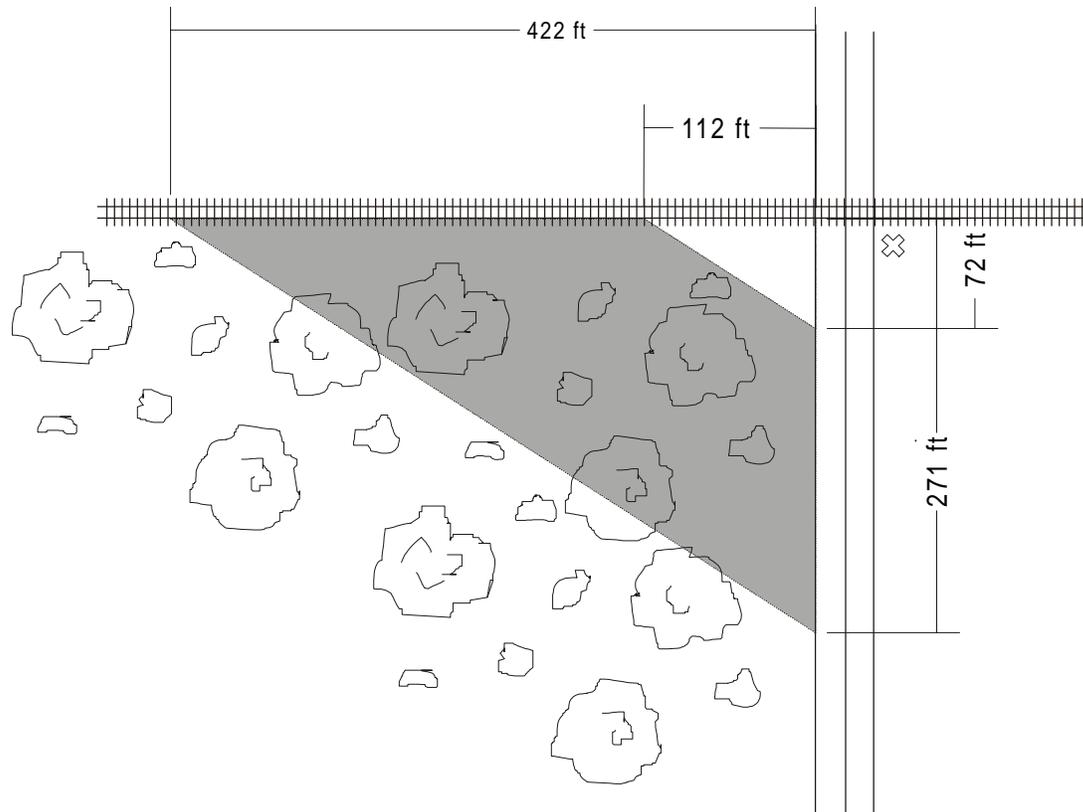
Figure 4-6. Sight distance needed (shaded area) versus the sight distance available at the accident crossing in Calhoun, Louisiana (case 16).

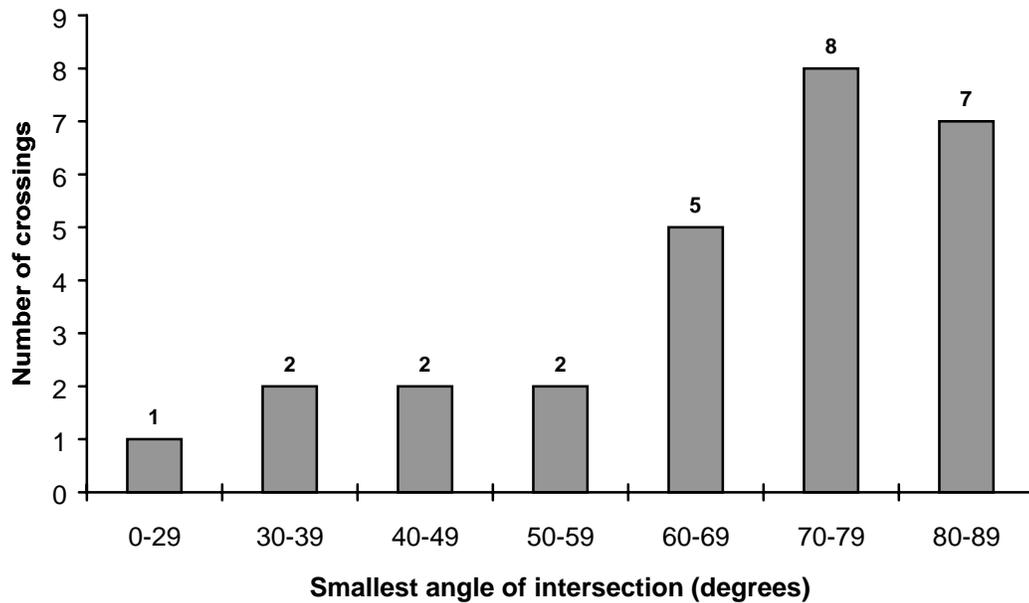
Figure 4–7. Smallest angle of intersection between the railroad tracks and roadway for the 27 study accident crossings with intersections that did not meet at 90°.

According to AASHTO guidelines, “[r]egardless of the type of intersection, for safety and economy, intersecting roads should generally meet at or nearly at right angles.” AASHTO recommends that when there is an acute angle of intersection, the road be realigned so that the angle of intersection can be more nearly 90°. ¹⁰¹ The distance a highway vehicle must traverse in order to clear the intersection is greater when the angle is skewed, and therefore the time it takes to safely cross is greater. Trucks are particularly at risk in such a situation because elements of the truck cab environment can further obscure the truckdriver’s view of the train.

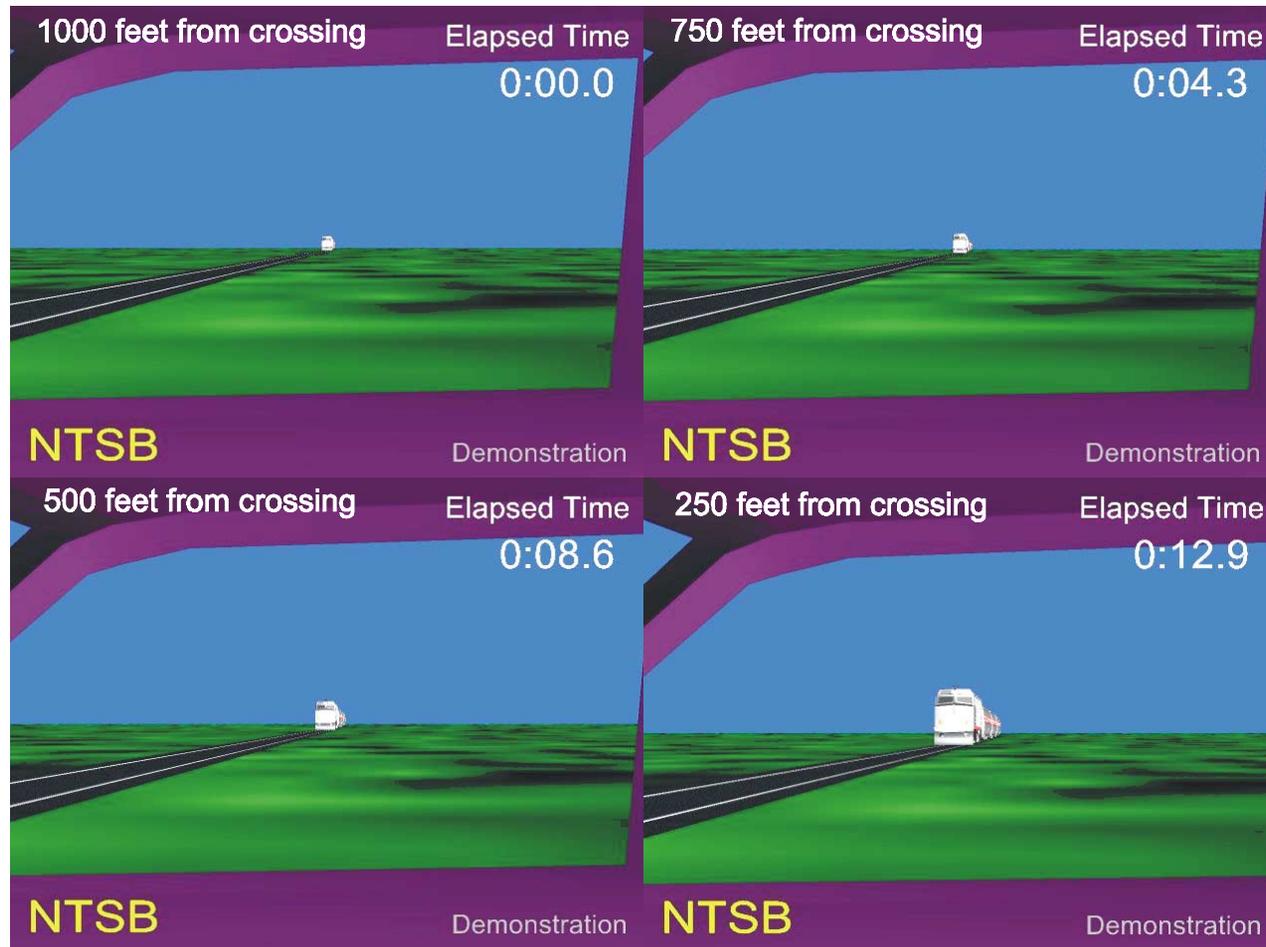
Figure 5–1. Illustration of the apparent change in object size as a train approaches a crossing, as seen by a motorist stopped at the crossing. The train is traveling at 40 mph. (These images were taken from a computer simulation produced by the National Transportation Safety Board, available on the Web at <http://www.nts.gov/events/gradxing/default.htm>.)

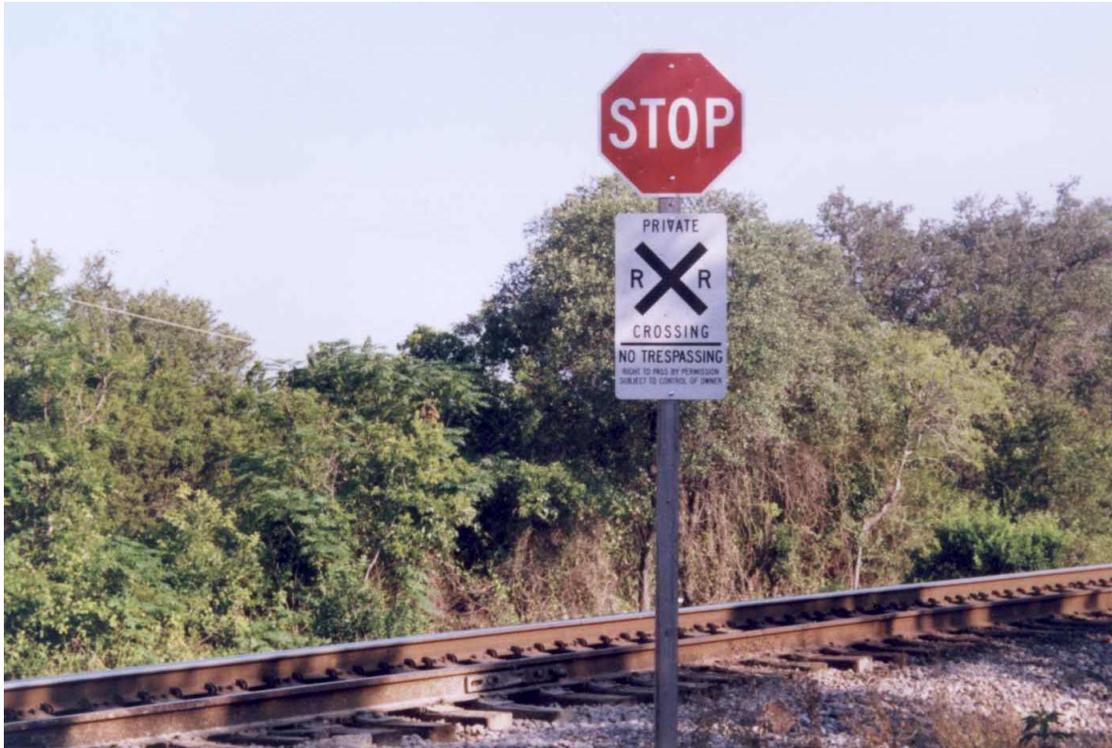
Figure 6–1. Private crossing sign used by some railroads at private crossings on their property.

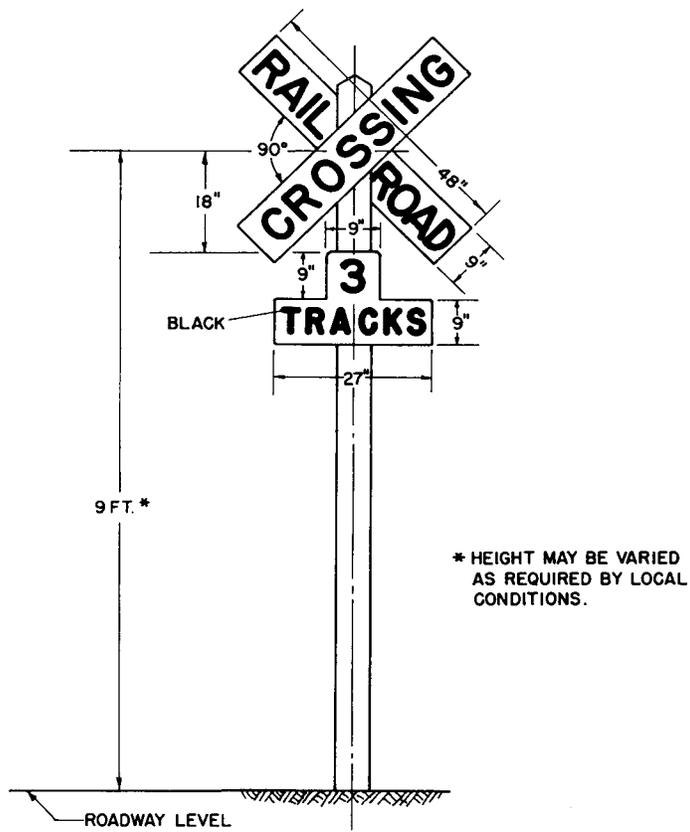
Figure 8-1. Railroad-highway crossing (crossbuck) sign.

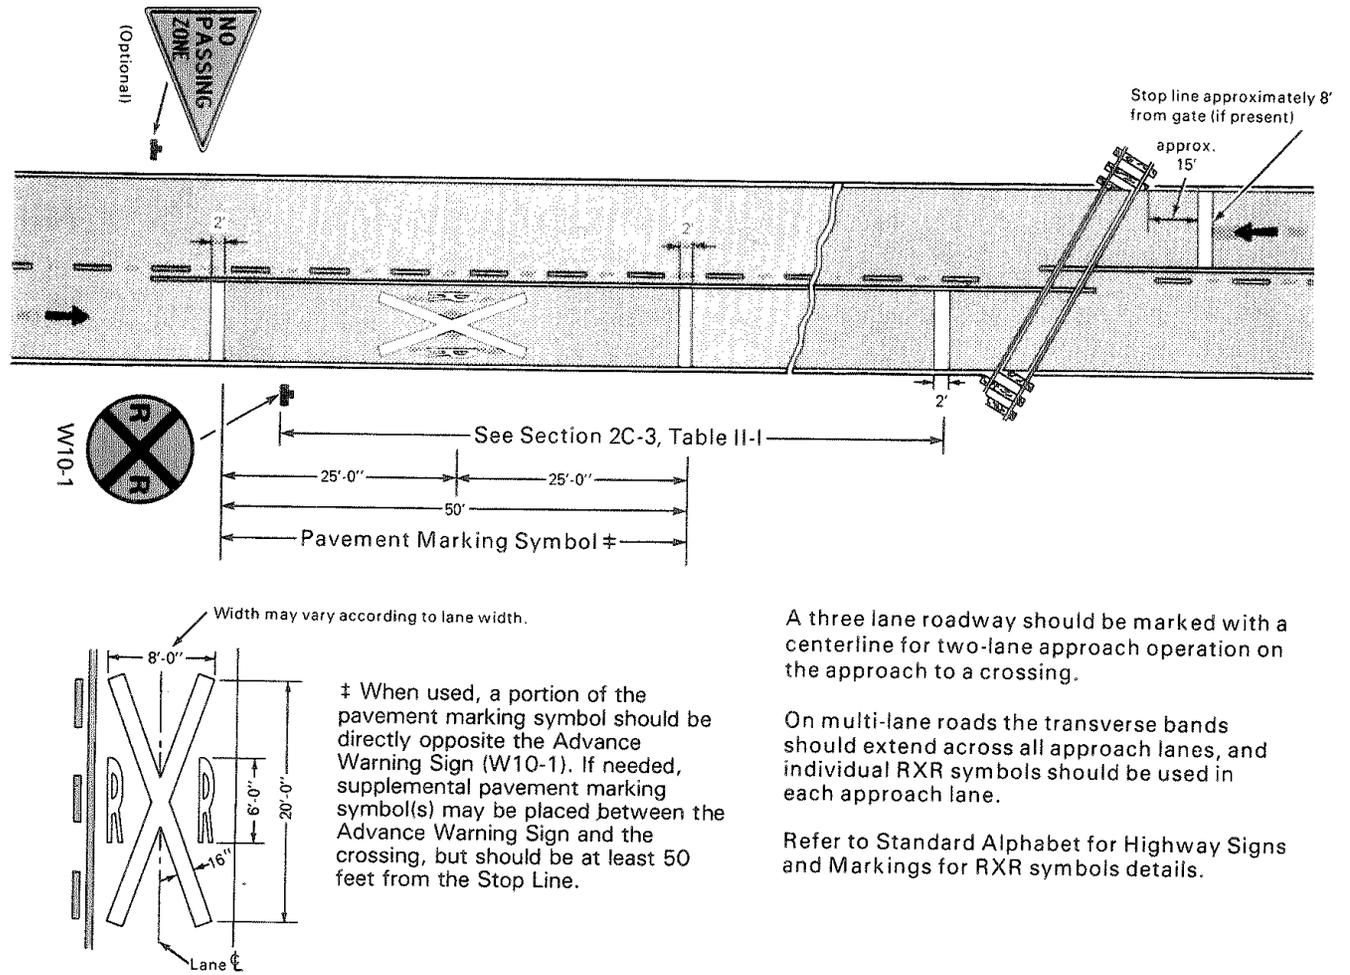
Figure 8-2. Typical placement of warning signs and pavement markings at railroad-highway grade crossings.

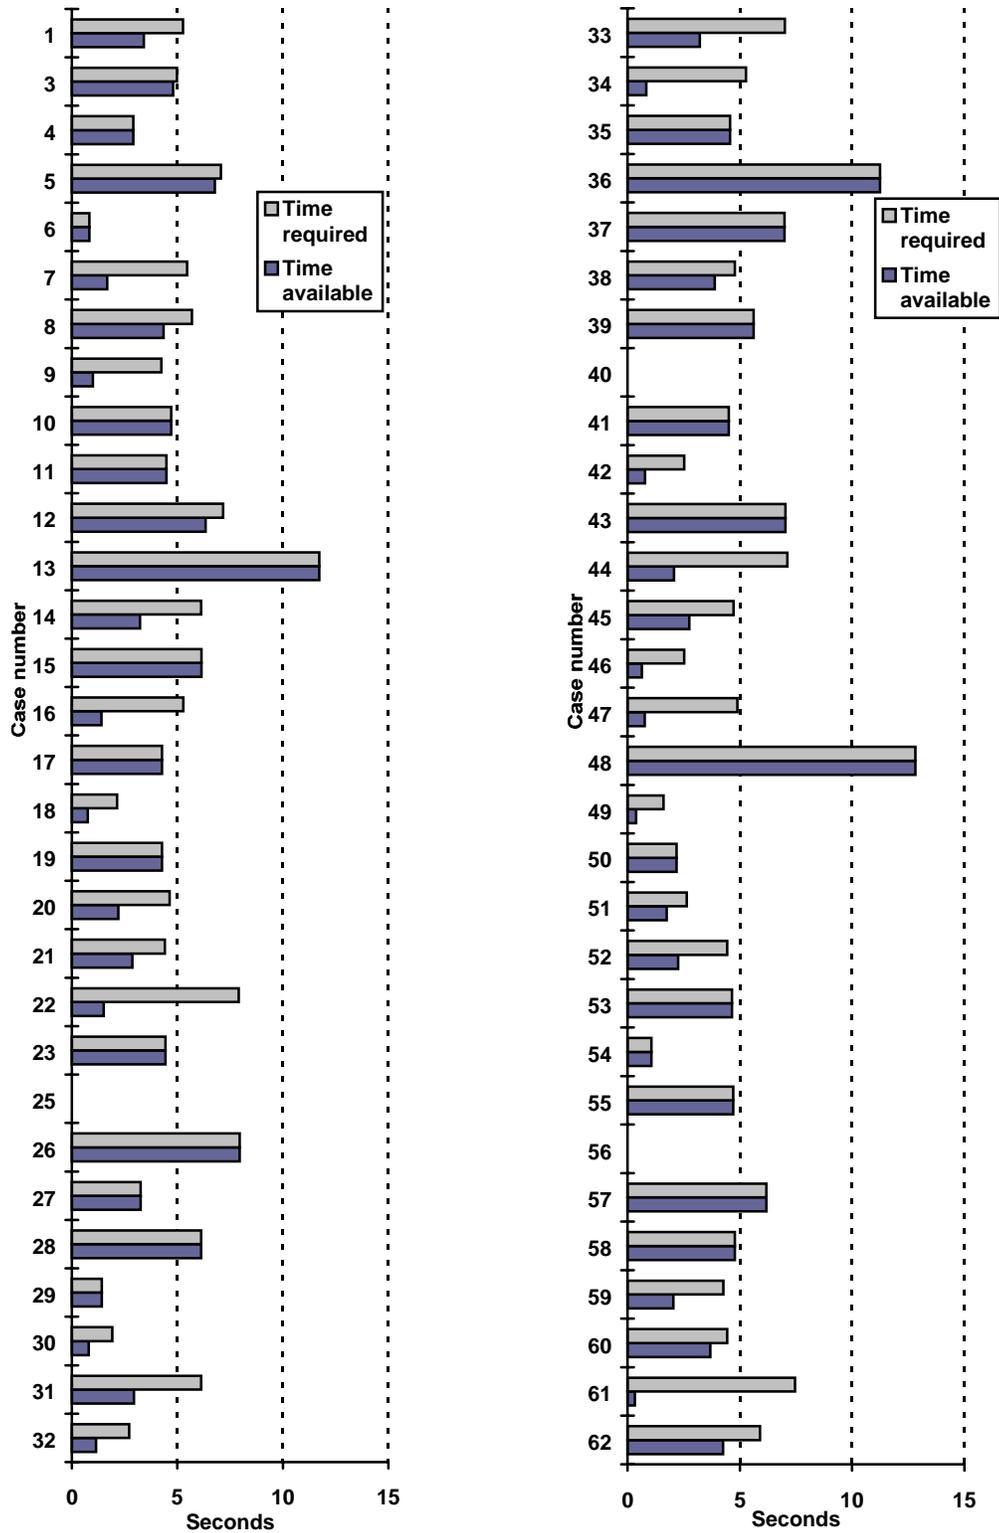
Figure E-1. Safe stopping time needed by highway vehicles approaching the passive grade crossings in the study cases compared with the stopping time available given the sight distance along the roadway. (Data were not available for the crossings in cases 25, 40, and 56.)
