National Transportation Safety Board

Highway Accident Brief

Collision of Two School Buses with Subsequent Rollover

Accident Number:	HWY15FH002
Accident Type:	Collision of two school buses with subsequent rollover
Location:	Asheville Highway (State Route 9), near John Sevier Highway (State Route 168) in Knoxville, Knox County, Tennessee
Date and Time:	December 2, 2014; about 2:52 p.m.
Vehicle #1:	2000 Navistar International transit-style school bus (bus #44)
Operator:	Knoxville Independent School District
Vehicle #2:	2001 Thomas Built transit-style school bus (bus #57)
Operator:	Knoxville Independent School District
Fatalities:	3
Injuries:	22

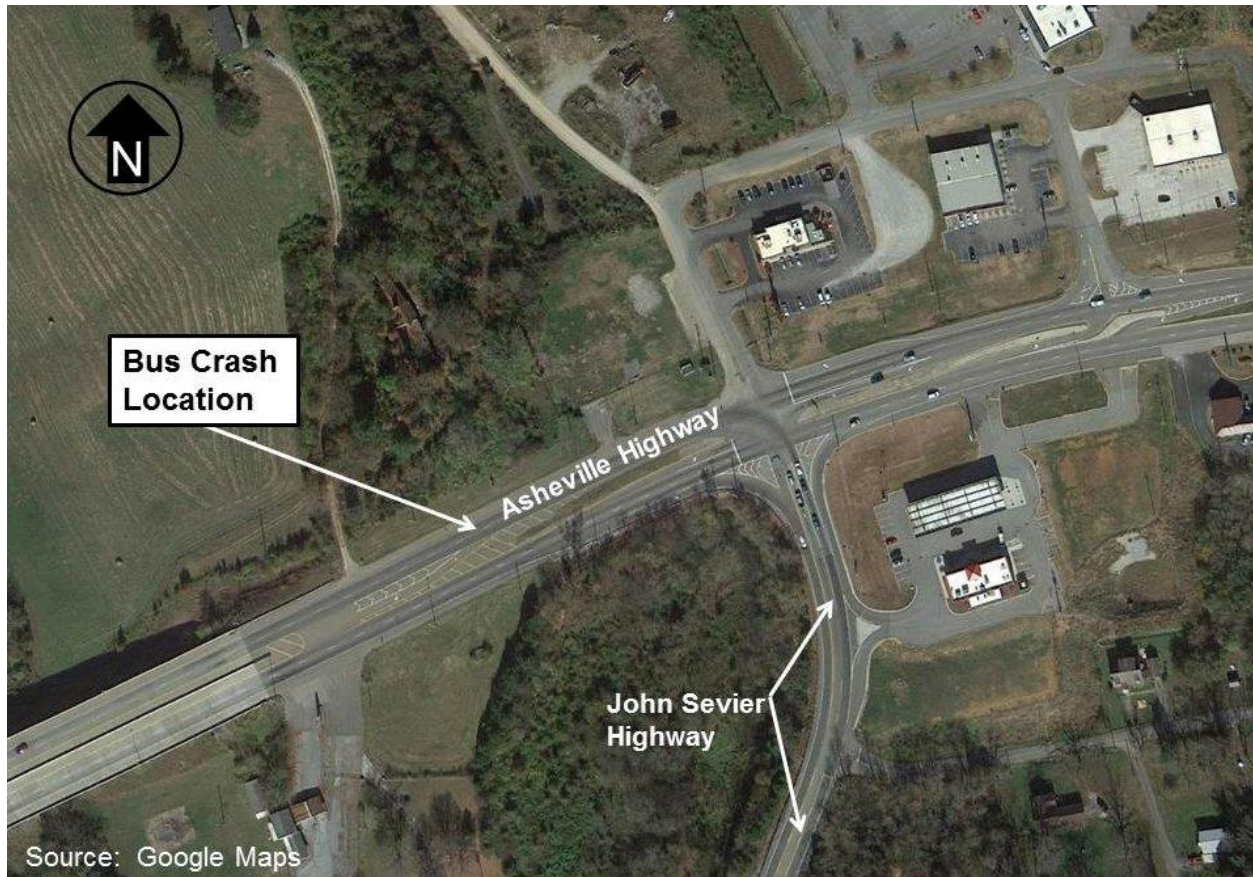
Figure 1. Crash location on westbound Asheville Highway, west of intersection with John Sevier Highway.

On Tuesday, December 2, 2014, about 2:52 p.m. eastern standard time, a 2001 Thomas Built transit-style school bus, identified as bus #57, was transporting 18 students and an adult teacher's aide from Sunny View Primary School in Knoxville, Knox County, Tennessee. The bus was traveling westbound in the left lane of Asheville Highway and had just crossed the intersection with John Sevier Highway (East). In the meantime, a 2000 Navistar International transit-style school bus, identified as bus #44, was traveling eastbound in the left lane of Asheville Highway transporting 22 students from Chilhowee Intermediate School. As bus #44 approached the signalized intersection with John Sevier Highway, traffic in front of the bus was stopped at the intersection. The driver of bus #44 swerved left to avoid the stopped traffic and crossed a 30-foot-wide painted median into the westbound lanes of Asheville Highway. The front of bus #44 collided with the left (driver) side of bus #57. (See figure 1 for crash location.)

The crash occurred on Asheville Highway (State Route 9) approximately 465 feet west of the intersection with John Sevier Highway. The roadway in the area of the crash is a four-lane divided highway with a posted speed limit of 45 mph. The roadway consists of two 12-foot-wide lanes in each direction.

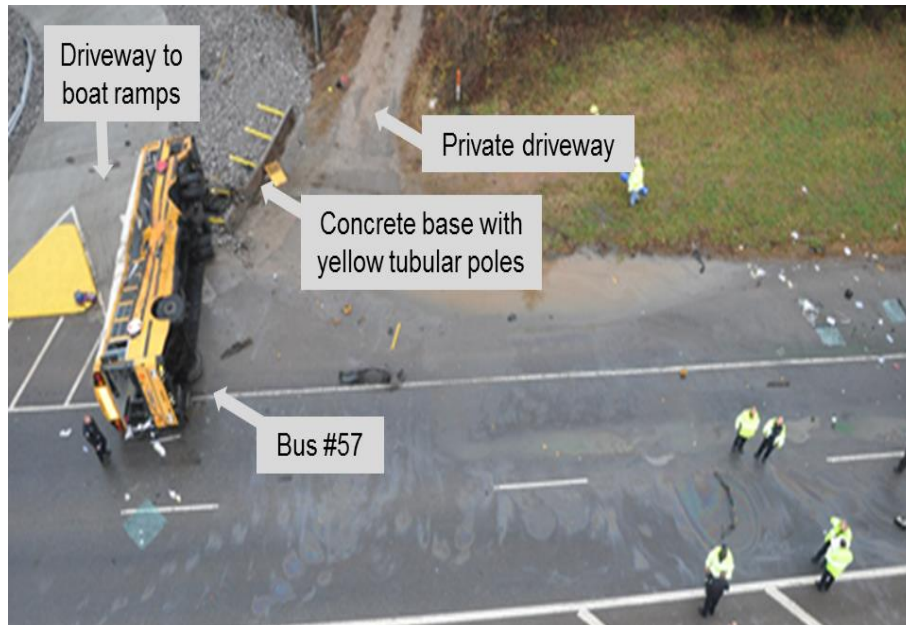
Figure 2. Bus #57 at final rest postaccident; also shown are a private driveway entry, the barricade the bus struck, and the entry to a driveway to the boat ramps on the Holston River. (Courtesy of the Knoxville Police Department)

Following the initial impact, bus #57 rotated, slid onto the shoulder, and collided with a barricade consisting of a concrete curb supporting five yellow vertically mounted tubular steel

poles. The barricade was used to delineate a private driveway from another driveway that provided access to the Holston River boat ramps. (See figures 2 and 3.)

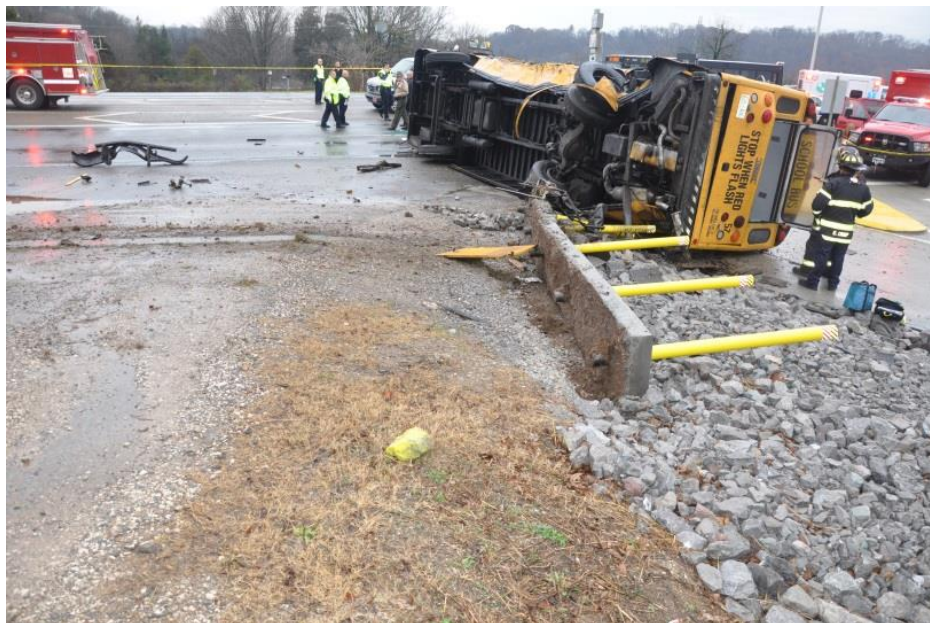
Figure 3. Bus #57 at final rest on its right side and the overturned barricade. (Courtesy of the Knoxville Police Department)

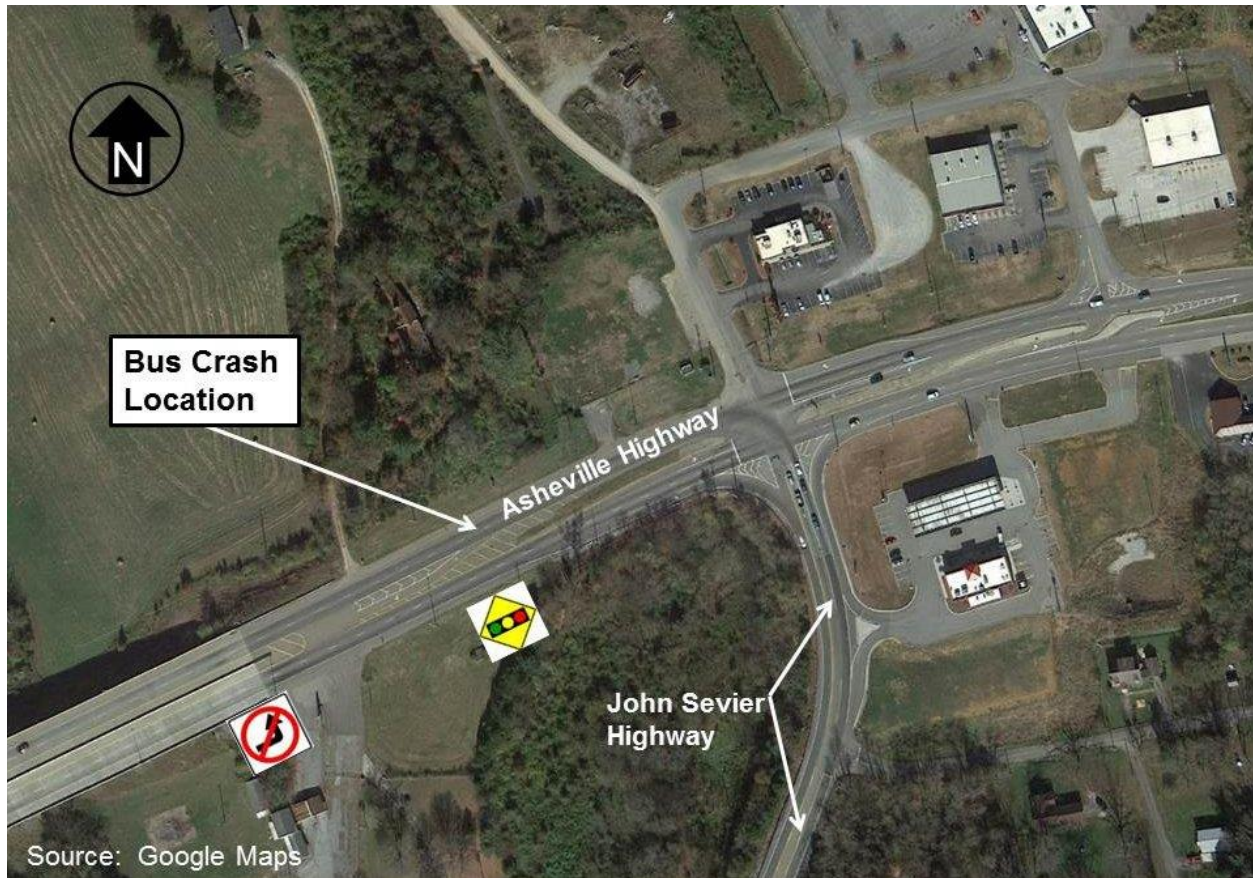
Figure 4. Locations of the advance “no left turn” and “signal ahead” signs on eastbound Asheville Highway, approaching the intersection with John Sevier Highway from the west (precrash route of eastbound bus #44).

Traffic control signs for eastbound traffic in the area of the crash consisted of a "no left turn" sign approximately 675 feet in advance of the intersection with the John Sevier Highway and a "signal ahead" sign approximately 450 feet in advance of the intersection. (See figure 4.)

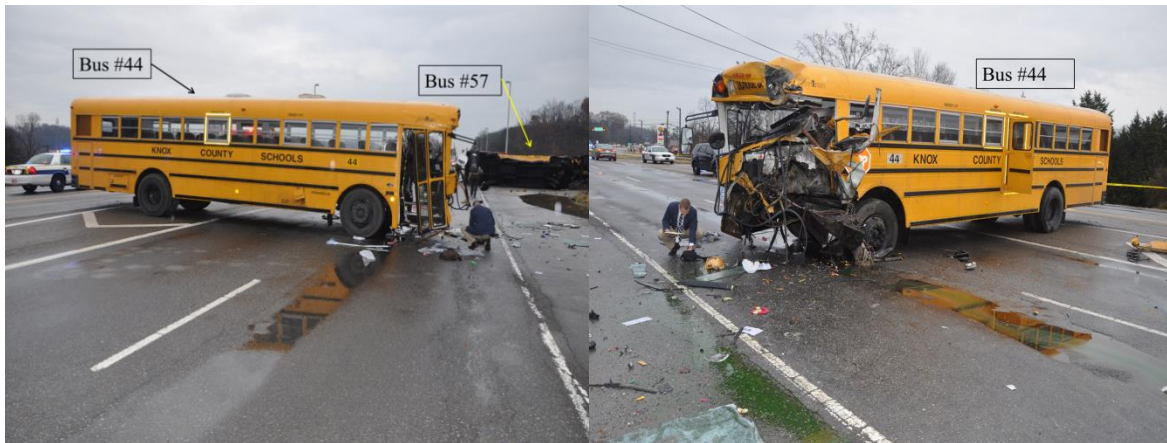
Postcrash examination of the vehicle revealed that damage was most severe at the left front corner. The left frame rail was displaced outward and split open 36 inches from the front. The left steering tie rod was bent about 90 degrees outward, and the steering box was displaced to the region of the left front wheel well. The right frame rail was displaced to the left at an angle of about 162 degrees and buckled at its attachment to the front suspension.

The bumper and front body panels below the windshield were deformed or missing. The windshield frame was deformed, and the glazing was missing. The front surface of the frame of the passenger loading door was crushed rearward approximately 10 inches. The stairs at the

loading door were crushed in about 3 inches at the bottom. No significant damage was noted on the right (passenger) side or the back of the bus. (See figure 5.)

Figure 5. At left, bus #44 in final rest position, showing the right side of the bus (overturned bus #57 can be seen in the photo background). At right, the focus is on damage to the left front of bus #44. [Note: In both photos, the bright yellow tape used on the bus exterior to highlight emergency exits is visible.] (Courtesy of the Knoxville Police Department)

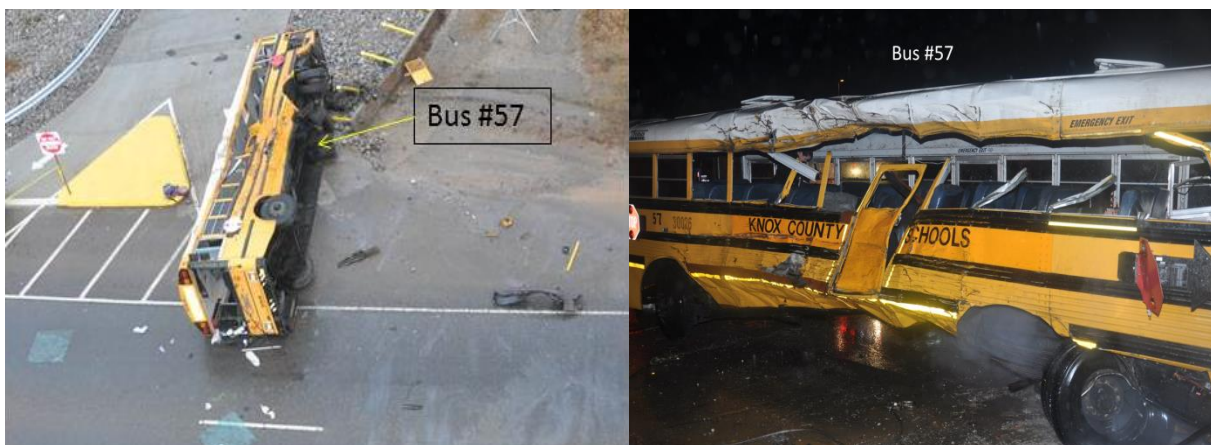
The postcrash inspection revealed that the left side exit door was heavily damaged, nonfunctional, and displaced inward into the passenger compartment. The seat in front of the side exit door was found in the folded-up position. The rear exit door was found latched and was functional except for the gas struts designed to keep it open. The struts were present but did not function. The area around the rear exit door was littered with debris, dirt, and glass; there were no obvious indications of exit use. Both exit doors were marked on the outside and inside of the bus. The two roof hatches were found open and functional. The hatches measured 24 by 24 inches.

The passenger loading door on the right side was not damaged and was functional. There were dents along the roofline beginning just aft of the loading door and extending to just above the fifth passenger window. There were vertical scrape marks on the body trim along the entire right side of the bus, and the right side marker lights were crushed. The right rear wheels were rotated inward at the front at an angle of about 163 degrees to the body of the bus. The body

panel below the mid-height trim was dented inward from the point aft of the rear wheel well extending to the back.

Significant damage, consisting of scrapes and dents, began at the left front wheel well and extended along the entire left side. The left sidewall was deformed inward; the deformation was most severe near the midpoint of the bus. The approximate intrusion distances into the passenger compartment measured 23 inches at the top of the windows, 15 inches along the lower portion of the window line, and 5 inches at the floor level. The panel at the bottom of the bus body had been pushed inward about 22 inches. There was a large tear in the left sidewall, beginning vertically at the level of the top of the wheel well and horizontally 78 inches aft of the front wheel well. The tear extended horizontally to 109 inches aft of the front wheel well. (See figure 6.)

Figure 6. At left, bus #57 at final rest on its side. At right, view of bus #57 after it had been returned to an upright position, showing impact damage along the left (driver) side. (Courtesy of the Knoxville Police Department)
