ATTACHMENT 17 – UNIVERSITY OF MINNESOTA FATIGUE EVALUATION OF THE DECK TRUSS OF BRIDGE 9340 FINAL REPORT DATED MARCH 2001

Final Report 2001-10

Fatigue Evaluation of the Deck Truss of Bridge 9340

March 2001

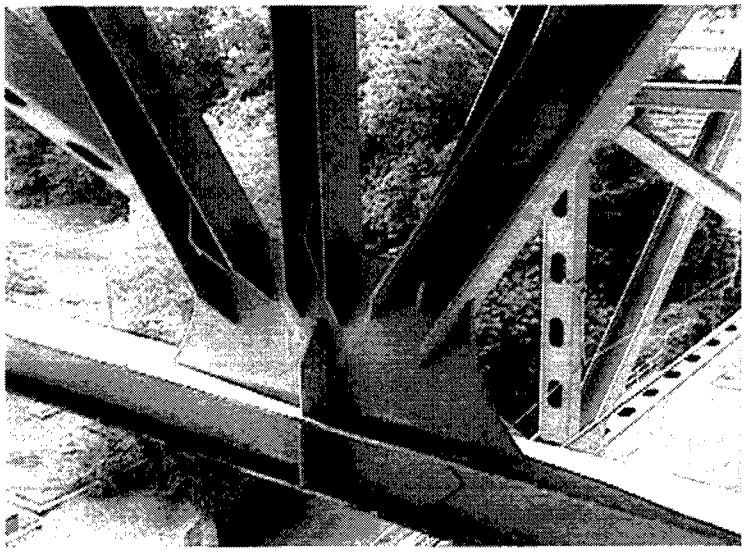
The built-up box sections have attachments measuring 8.9 cm square welded to diaphragms at the interior of all tension members (Figure 5). There are also intermittent fillet welds at the interior of all box sections. These are both Category D details. The floor truss members have longitudinal stiffeners measuring 30.5 cm, which would be considered a Category E detail (Figure 6).

Figure 6: Longitudinal Stiffeners at Floor Truss Connections

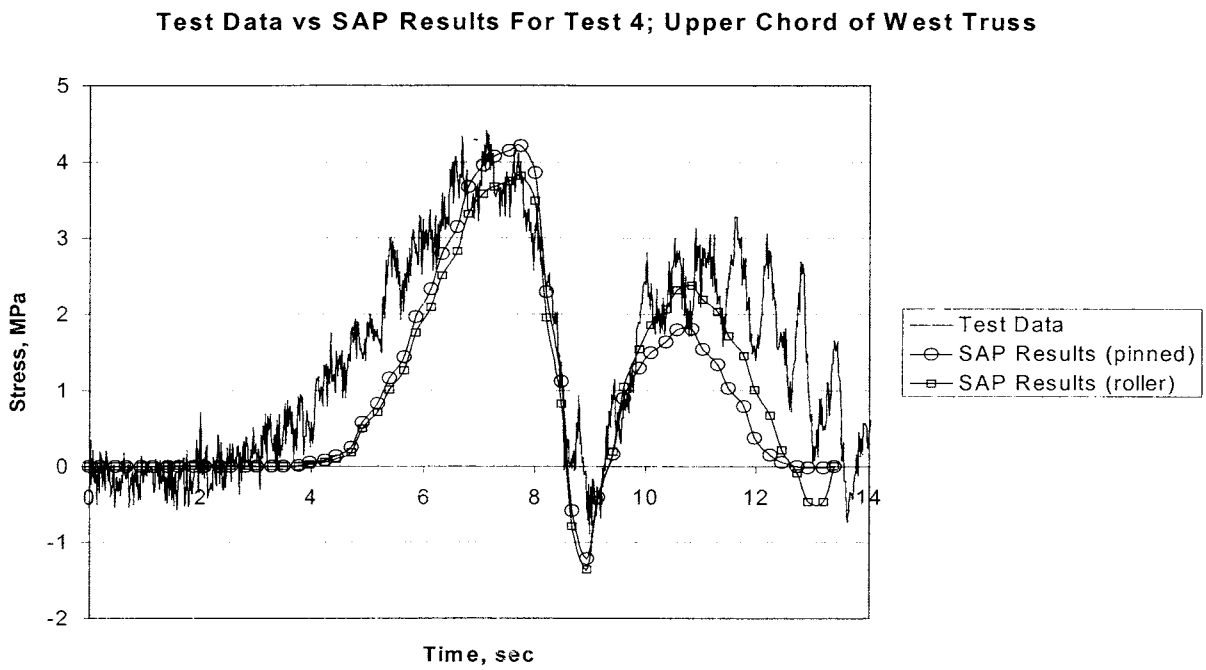
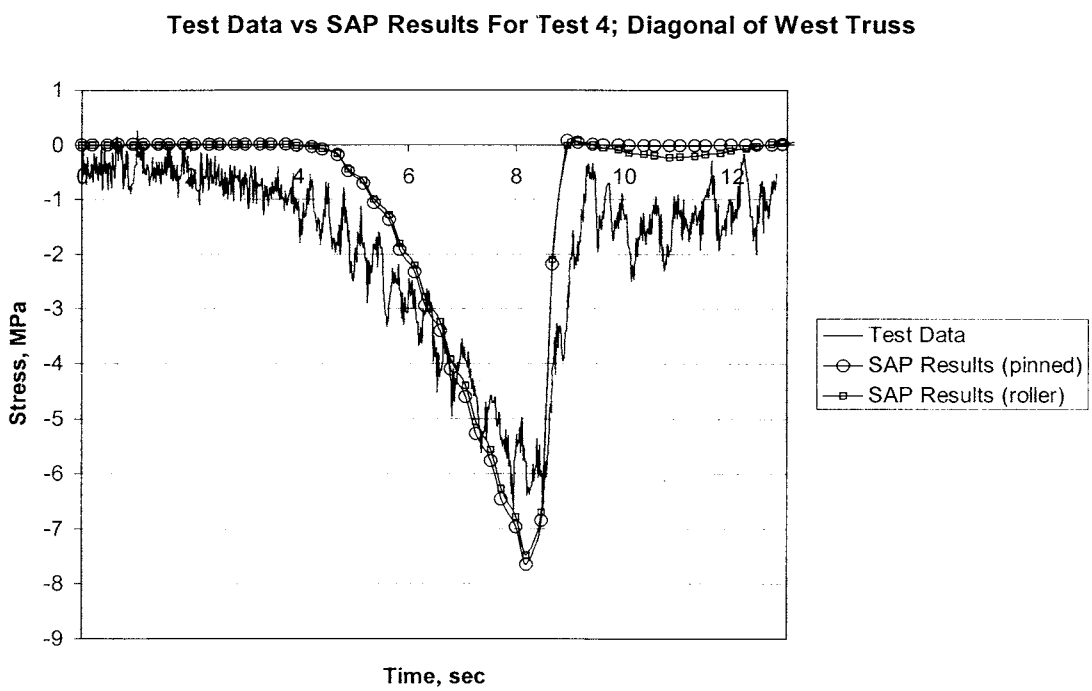
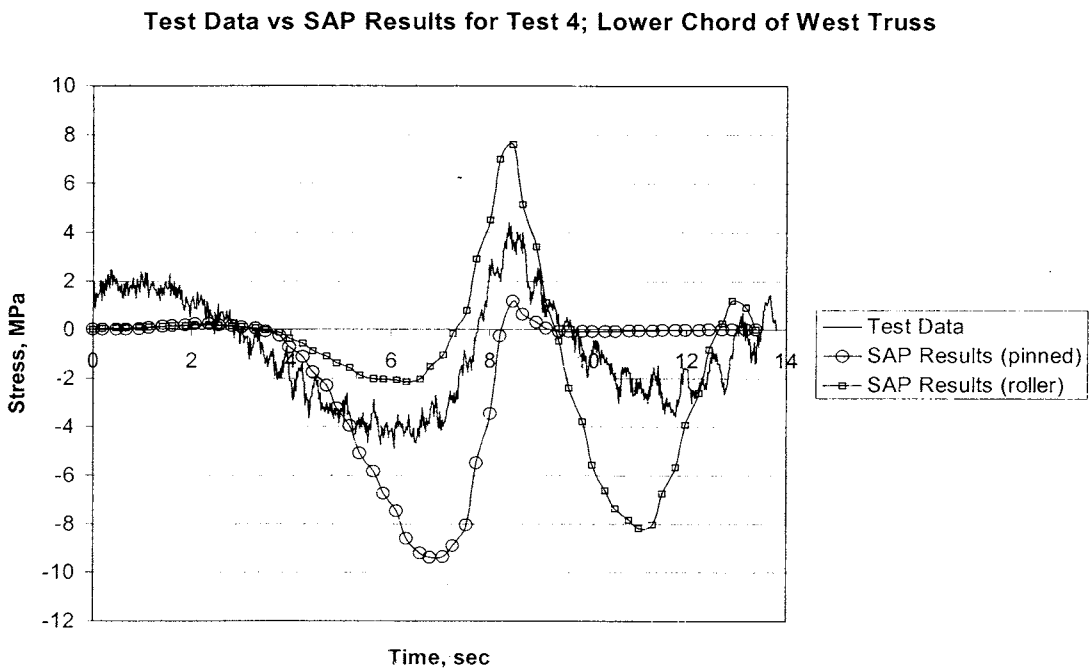
Figure 22: Comparison of 3-D Analysis and Test Data for Main Truss in Test 4

Since the 3-D analysis is meant to refine the current analyses, it was only applied to Test 4 as it was the most accurate and consistent under 2-D analysis. The bearings were again modeled as both roller and pinned supports. The results of the analyses are presented in Figure 22a-c.

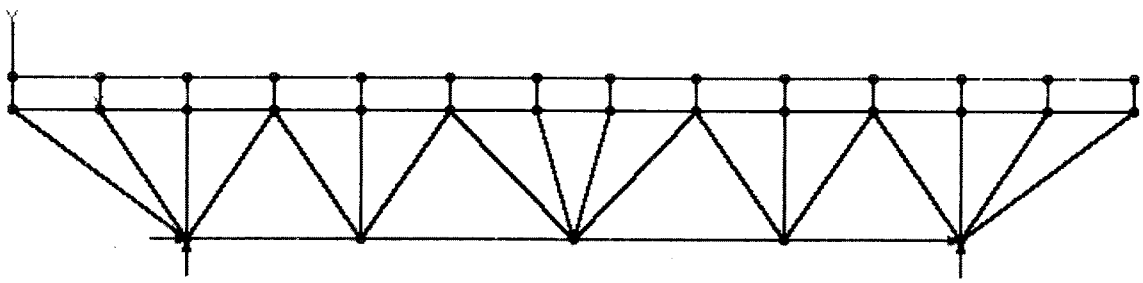
Figure 23: 2-D Visual Analysis Model of Floor Truss with Concrete Deck

Visual Analysis was also used to create a two-dimensional model of the floor truss to analyze Tests 1 and 4 (Figure 23). A concrete deck was incorporated into the model to account for added strength from unexpected composite action. As in the 3-D analysis, the deck was modeled as a 16.5 cm by .8 m beam resting atop stiff stub W27x539 columns.

To get analytical results for the first test, the front axle of a truck was assumed to be 4.57 meters away from the rear axle of the truck directly in front of it. An influence line for the floor truss showed that the load on the truss would be largest when the rear axle of the center truck was directly on the truss. For simplicity, a single load for each axle was applied at the center of each interior lane. The maximum stress range during this test occurred in the lower chord and measured 28 MPa. The analysis yielded a maximum stress for the same member of 36.7 MPa, yielding an actual to predicted stress range ratio of 76 percent. If the distance between the front and rear axles was reduced to 3.05 meters, the analysis yielded a maximum stress in the lower chord of 42.8 MPa, a ratio of 65 percent.

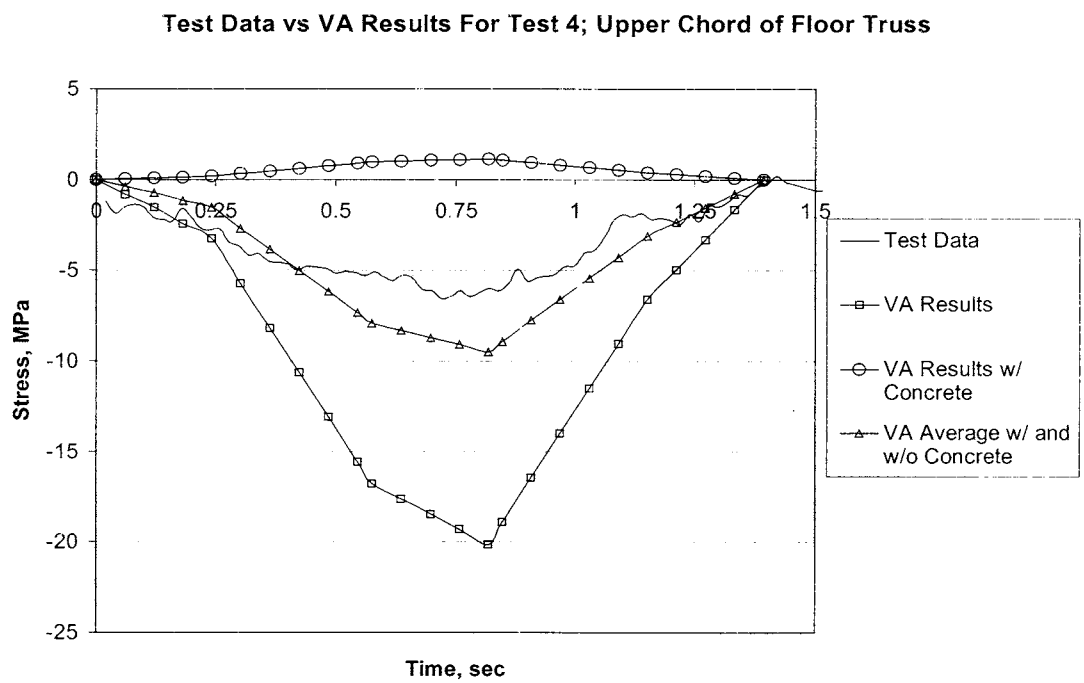
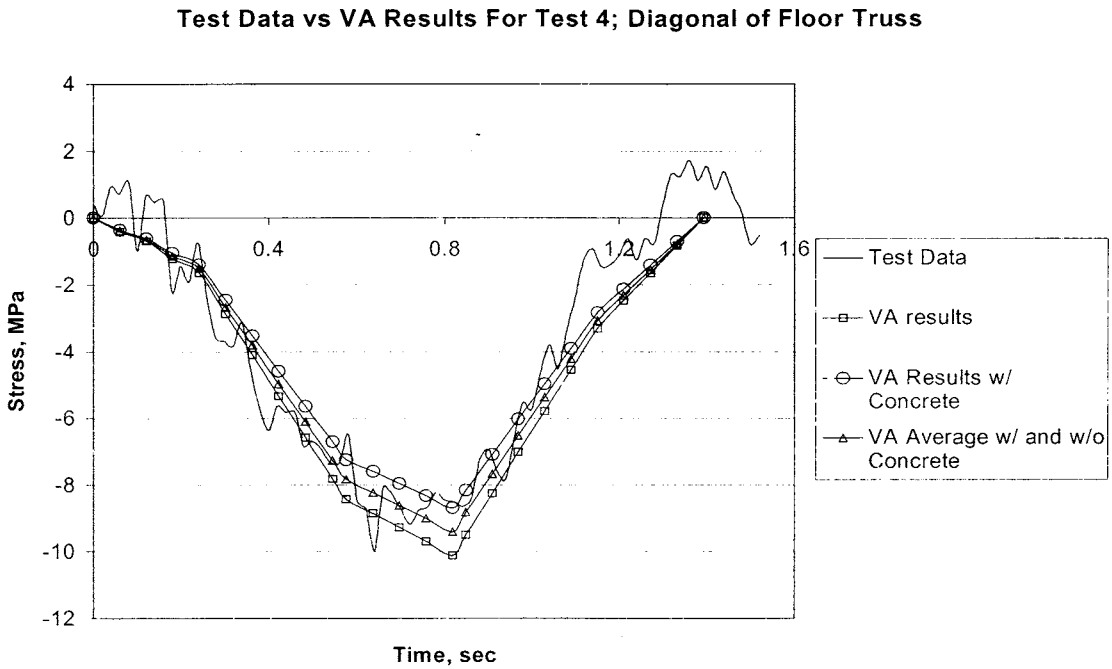
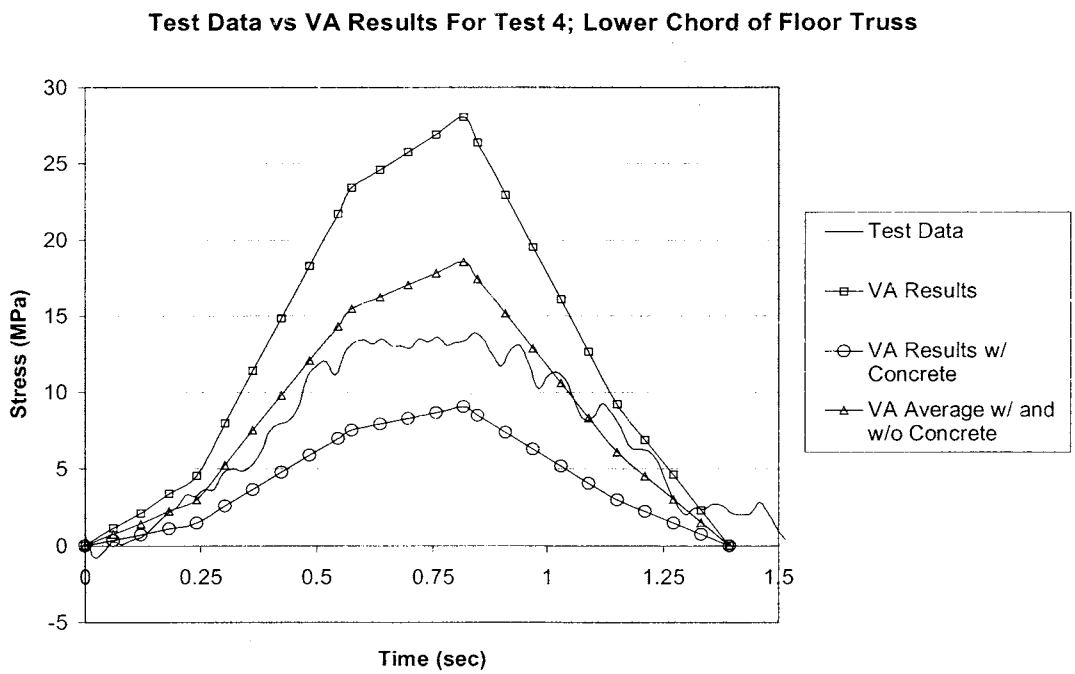
Figure 24: Comparison of 2-D Analysis and Test Data for Floor Truss in Test 4

Analyses of the floor truss results for the fourth test were done in much the same way. Truck loads were applied to an influence line, which was used to determine the load distribution between neighboring floor trusses as the line of trucks moved across the bridge. Analysis was done with and without the concrete deck in place. Later, these results were averages. The time histories for each member of the floor truss versus the analysis results are shown in Figures 24a-c.
