INVESTIGATIVE REPORT TO JOINT COMMITTEE TO INVESTIGATE THE I-35W BRIDGE COLLAPSE

MAY 2008

INVESTIGATIVE REPORT

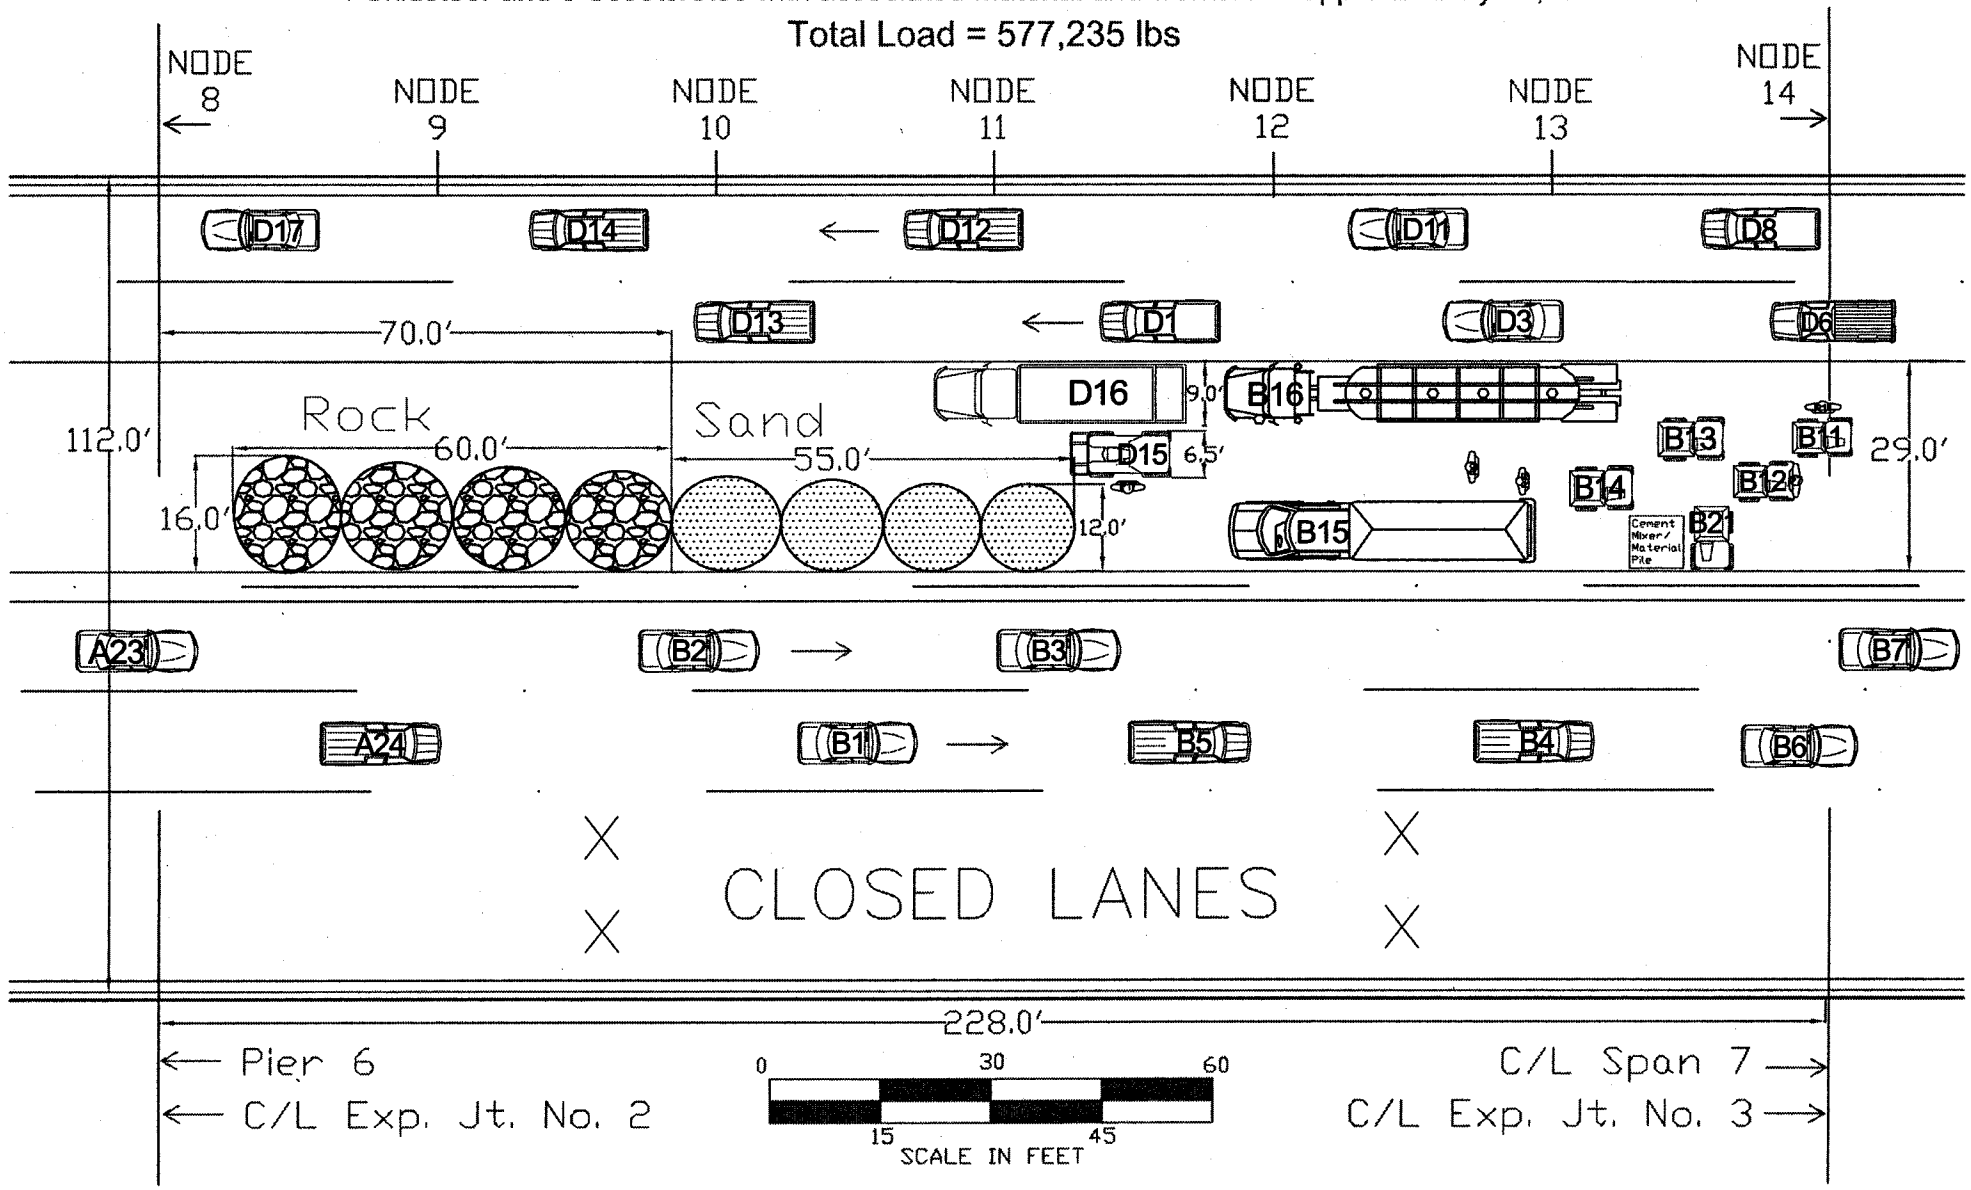
Figure 2 – Construction Staging Area

1 Skidsteer and 5 Scootcretes with associated material and workers = approximately 21,655 lbs

Total Load = 577,235 lbs
