Caldive International 10/13/06 Dive Survey

West Cote Blanche Bay
MAR07MM001

DAILY LOG

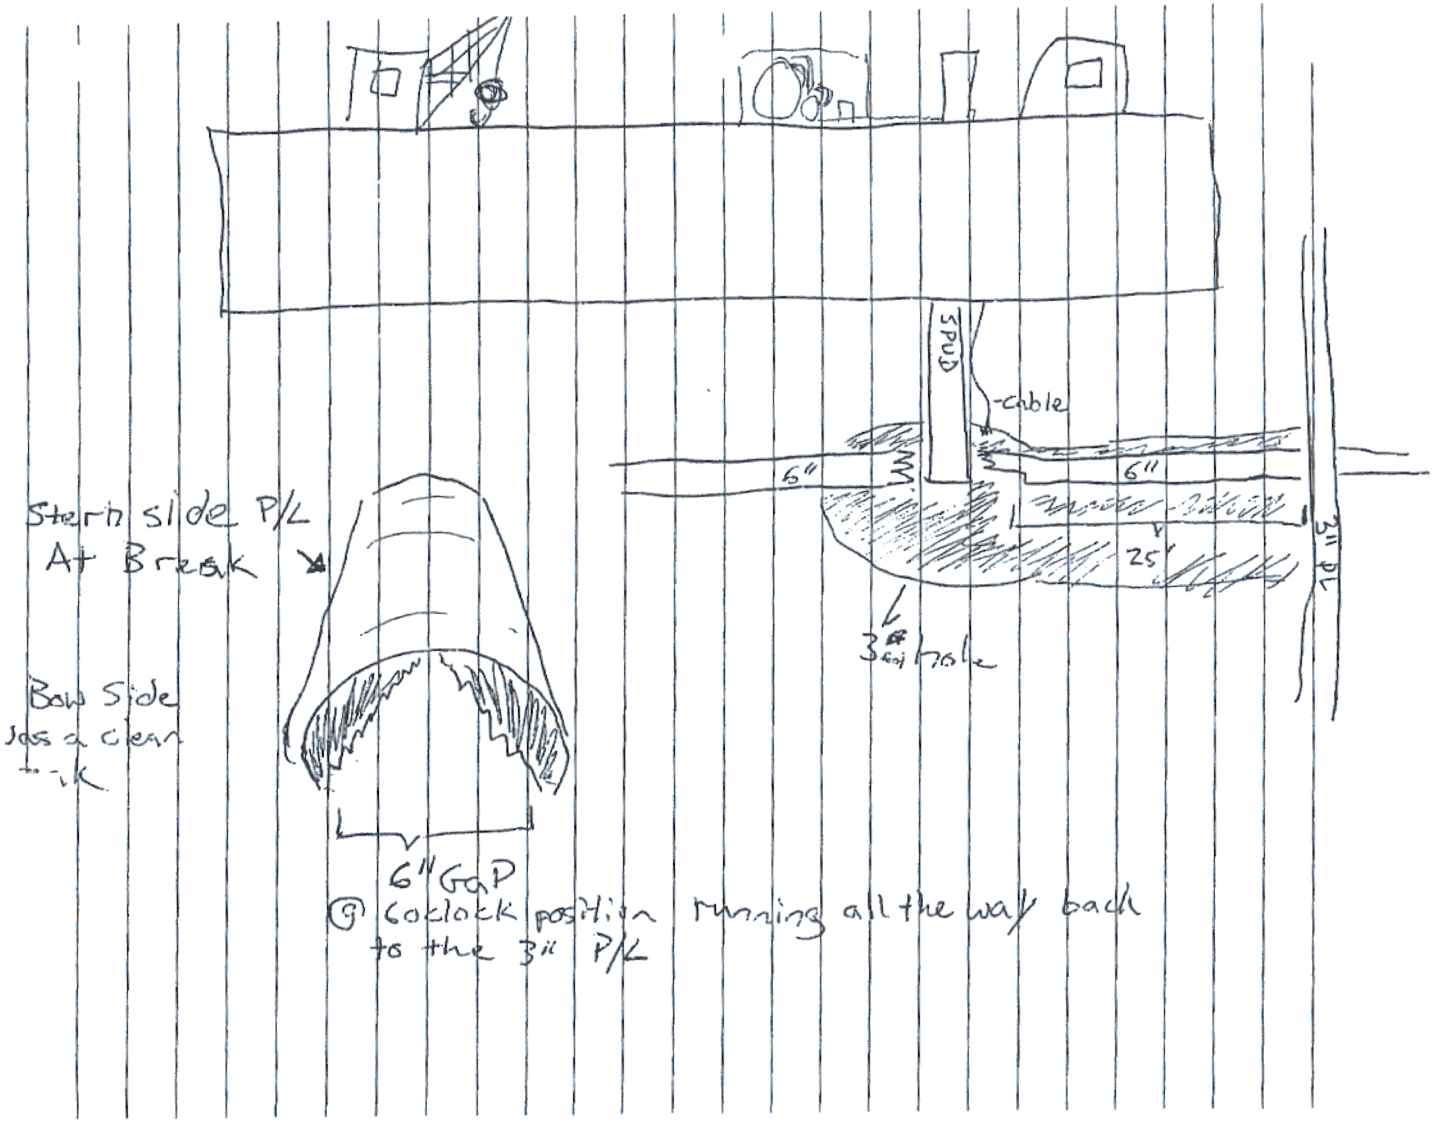
Stern side P/L
At Break
Bow Side
has a clean
break
6" GaP
@ 6 o'clock position running all the way back
to the 3" P/L
SPUD
cable
6"
6"
25'
3" P/L
3" hole
