National Transportation Safety Board

Safety Recommendation

In reply refer to: H-01-01

VEHICLE GROUP FACTUAL REPORT — HWY-99-M-H007

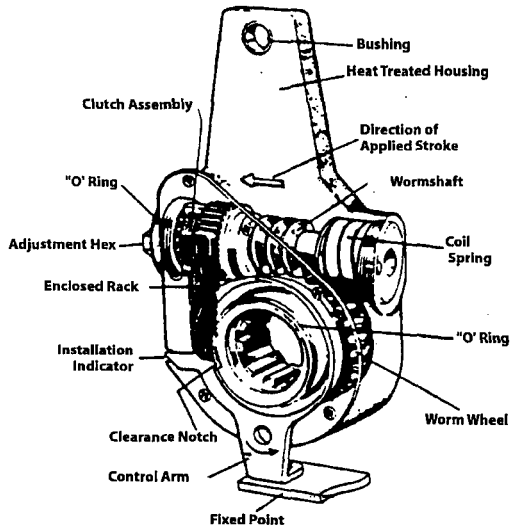
Figure 1 illustrates the automatic slack adjuster, which was manufactured by Haldex, on the accident bus. Figure 2 illustrates the relationship of a slack adjuster to the rest of the foundation brake system.[1]

Figure 1. Automatic slack adjuster.

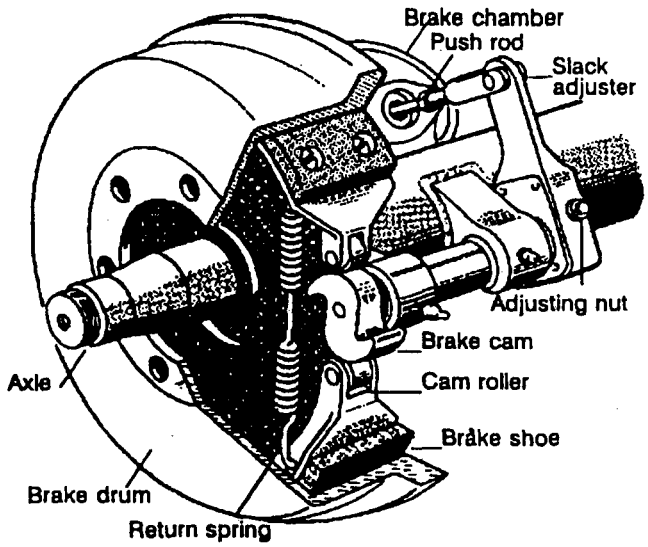
Figure 2. Foundation brake system.

[1] Air pressure from the brake chamber exerts force on the push rod. The push rod, through the slack adjuster, uses the force to rotate the brake cam shaft. The brake cam forces the shoes away from one another, pressing them against the inside of the brake drum.

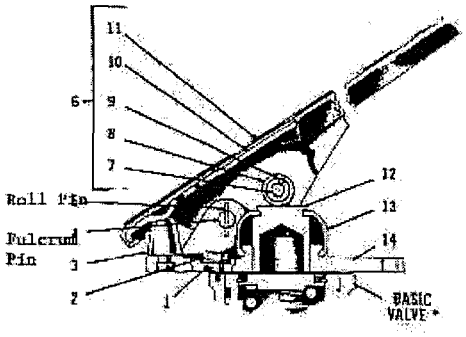
Defects - During Safety Board brake inspections, the brake pedal was found unsecure. The roll pin, which functioned to secure the fulcrum or treadle pin, through the foot pedal and floor mounting plate, was sheared off with a portion of the roll pin remaining in the guide hole of the treadle pin. At the time of inspection, it was observed that the treadle pin had been inserted into the mounting plate backwards. With the roll pin absent, and the treadle pin inserted backwards, the treadle pin was not secured in the mounting bracket.

E-10 DUAL BRAKE VALVE
WITH TREADLE AND MOUNTING PLATE

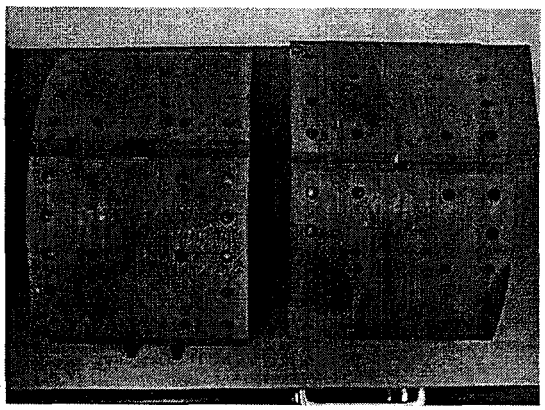
Inspection of the foundation brake components including the S-cam bushings, as well as the brake drum revealed no deficiencies or defects. However, a difference in brake lining wear was observed between the right and left drive axle linings.

Left Drive Axle Brake Linings

Right Drive Axle Brake Linings

The right axle's upper and lower brake shoe linings exhibited little evidence of full burnishing[1] while the left brake shoe linings exhibited full contact on the entire surface area of the linings. Maintenance records indicated that both brake linings had been simultaneously replaced on November 23, 1998, 3,945 miles prior to Safety Board inspections.

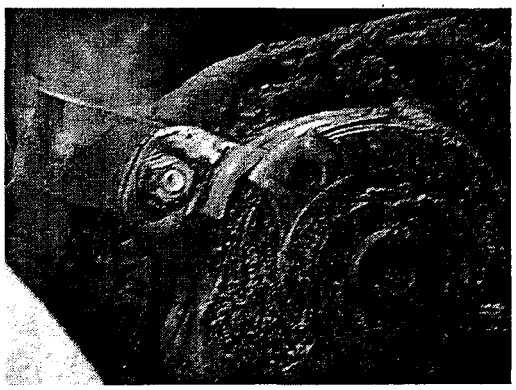
Further examination of the right-side slack adjustment hardware revealed that the control arm had fractured. The pieces of the control arm were still in contact with each other, constraining the motion of the arm. Although investigators could not determine when the fracture had occurred, the wear pattern suggested that the fracture had been present for some time.

Inspection of the right drive axle slack adjuster revealed that the adjusting hex nut was encrusted in thick, greasy debris. After clearing away the debris from the adjusting nut, the slack adjuster was manually adjusted into an adjustment of approximately 1-½ inches of push rod stroke. While clearing away the greasy road grime from the hex adjusting nut, it was observed that the slack adjuster's control arm was broken and was also covered in greasy road grime. The brakes were then repeatedly applied and the slack adjuster failed to hold the previously made adjustment. The right drive axle's dual wheel assembly was removed and the slack adjuster, serial number 80310205, was removed for closer visual examination and photographing. The design of the Haldex slack adjuster relies on the proper installation of the slack adjuster, as well as the control arm being securely attached. According to Haldex, the broken control arm bracket would have prohibited the slack adjuster from making automatic brake adjustments as the linings and drums wore.

Right slack adjuster broken control arm

> Monitor the progress of Haldex Brake Products Corporation in correcting the brake deadjustment caused by a fractured or disconnected control arm and ensure that Haldex takes appropriate corrective action. (H-01-01)

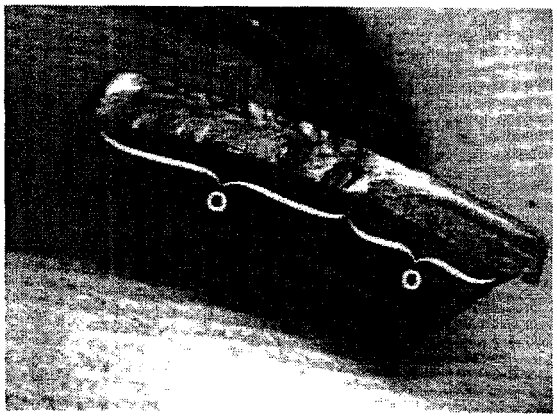
Fracture surface of control arm

Metallurgic examinations of the right slack adjuster's control arm indicated the presence of crack arrest marks typical of fatigue. Fatigue progression was observed through at least fifty percent of the wall thickness. The fatigue striations on the fracture surface near the origin also contained corrosion damage. The remaining portion of the fracture contained mechanical damage that obliterated the fracture features.

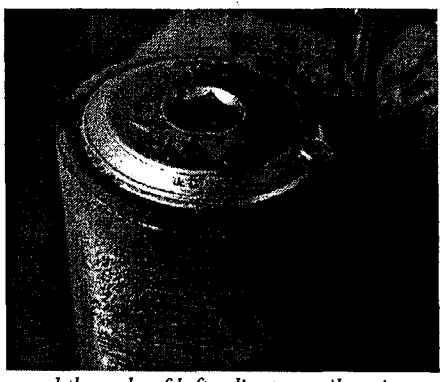
- The internal coil spring force was below factory specifications.
- Brake application pressures were higher.
- Brake application and release times were faster.
- The control arm bracket was slightly constrained in motion, as if fractured and each fracture surface was making contact, or as if the bracket was not secure or properly fastened.

Exposed threads of left adjuster coil spring cover
