National Transportation Safety Board

Safety Recommendation

In reply refer to: H-01-05

VEHICLE GROUP FACTUAL REPORT **HWY-99-M-H007**

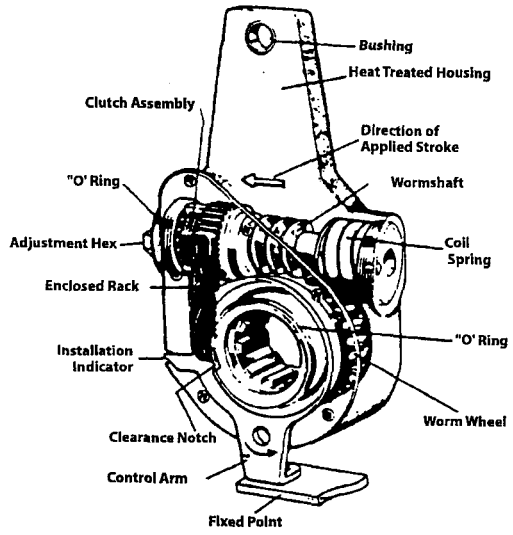
Figure 1. Automatic slack adjuster.

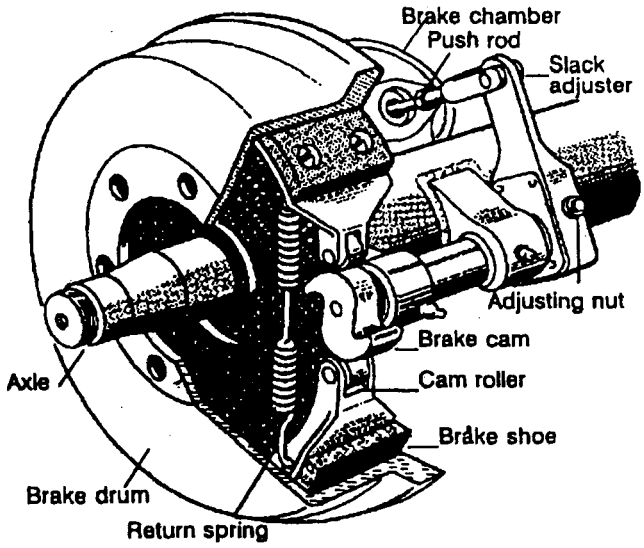
Figure 2. Foundation brake system.

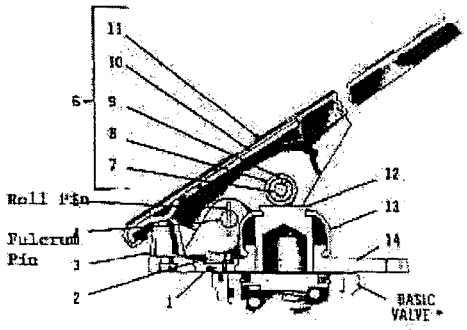
E-3C DUAL BRAKE VALVE WITH TREADLE AND MOUNTING PLATE

Defects - During Safety Board brake inspections, the brake pedal was found unsecure. The roll pin, which functioned to secure the fulcrum or treadle pin, through the foot pedal and floor mounting plate, was sheared off with a portion of the roll pin remaining in the guide hole of the treadle pin. At the time of inspection, it was observed that the treadle pin had been inserted into the mounting plate backwards. With the roll pin absent, and the treadle pin inserted backwards, the treadle pin was not secured in the mounting bracket.

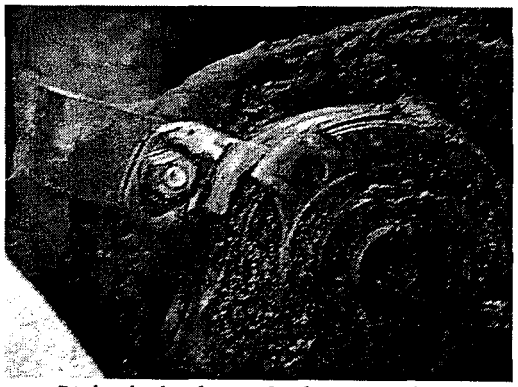
Further examination of the right-side slack adjustment hardware revealed that the control arm had fractured. The pieces of the control arm were still in contact with each other, constraining the motion of the arm. Although investigators could not determine when the fracture had occurred, the wear pattern suggested that the fracture had been present for some time.

When an automatic slack adjuster has a fractured control arm, the adjuster no longer works automatically; it, like a manual slack adjuster, then requires periodic adjustment by hand. However, the adjustment of the right-rear brake on the accident bus had degraded much more rapidly than would be expected with a manual slack adjuster.

Inspection of the right drive axle slack adjuster revealed that the adjusting hex nut was encrusted in thick, greasy debris. After clearing away the debris from the adjusting nut, the slack adjuster was manually adjusted into an adjustment of approximately 1-½ inches of push rod stroke. While clearing away the greasy road grime from the hex adjusting nut, it was observed that the slack adjuster's control arm was broken and was also covered in greasy road grime. The brakes were then repeatedly applied and the slack adjuster failed to hold the previously made adjustment. The right drive axle's dual wheel assembly was removed and the slack adjuster, serial number 80310205, was removed for closer visual examination and photographing. The design of the Haldex slack adjuster relies on the proper installation of the slack adjuster, as well as the control arm being securely attached. According to Haldex, the broken control arm bracket would have prohibited the slack adjuster from making automatic brake adjustments as the linings and drums wore.

Right slack adjuster broken control arm

> Advise all State and local inspectors of commercial vehicles to inspect all vehicles with automatic slack adjusters for fractured or disconnected control arms and inform them of the circumstances of the December 24, 1998, bus accident near Old Bridge, New Jersey. (H-01-05)

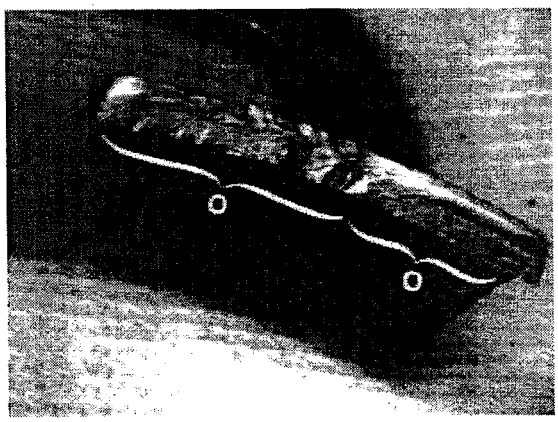
Fracture surface of control arm

Metallurgic examinations of the right slack adjuster's control arm indicated the presence of crack arrest marks typical of fatigue. Fatigue progression was observed through at least fifty percent of the wall thickness. The fatigue striations on the fracture surface near the origin also contained corrosion damage. The remaining portion of the fracture contained mechanical damage that obliterated the fracture features.

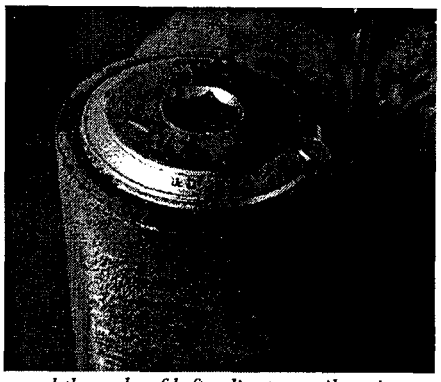
- The internal coil spring force was below factory specifications.
- Brake application pressures were higher.
- Brake application and release times were faster.
- The control arm bracket was slightly constrained in motion, as if fractured and each fracture surface was making contact, or as if the bracket was not secure or properly fastened.

Exposed threads of left adjuster coil spring cover

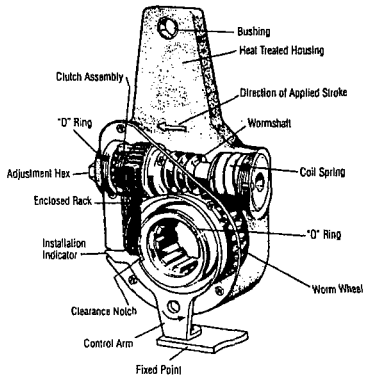
During the time period of the coach's manufacture, VanHool had been researching a braking issue that involved the over-heating of Eaton drive axle brake assemblies. The over-heating issue was thought to be caused by the over adjustment of the brakes caused by the Haldex automatic slack adjuster.

The Haldex Brake Products Corporation provided Safety Board investigators with information that mechanics with ABC Bus of Hillsboro MO, a VanHool distributor, had been instructed by VanHool to back off the rear cover of Haldex part number 70905 slack adjusters on Eaton drive axles. An official with ABC Bus in Winter Garden, Florida, stated to Safety Board investigators that the coil spring cover was being turned counter-clockwise to reduce pressure on the internal worm shaft providing additional brake lining to drum clearances in an effort to resolve the overheating issues with those brake assemblies.

Mechanical diagram of Haldex adjuster
