Exhibit 13C

Letter from Captain Mohsen El Missiry, dated 7/27/00,
Egyptian Delegation comments on
Group Chairman's Aircraft Performance Study Addendum 1

July 27, 2000

OUTBOARD AILERONS ASSYMETRIC OPERATION ANALYSIS

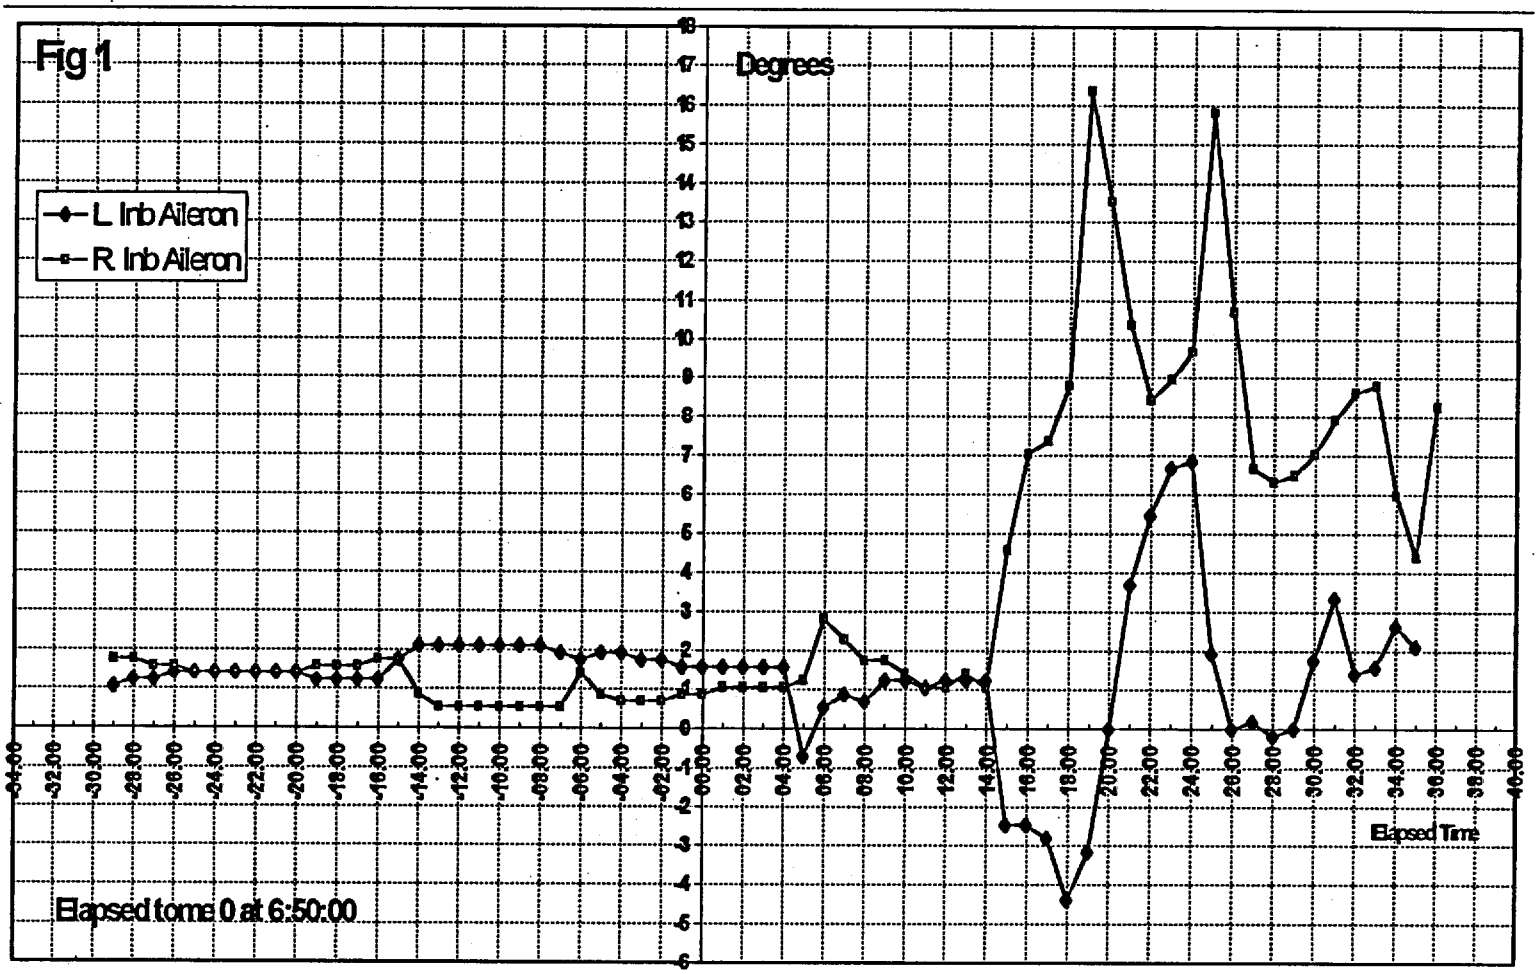
Fig 1
Degrees
L Inb Aileron
R Inb Aileron
Elapsed Time
Elapsed tome 0 at 6:50:00

- Analysis of the FDR data showed non normal behavior of the inboard ailerons, outboard ailerons and elevators at the end of the airplane dive (figures 1 to 5)

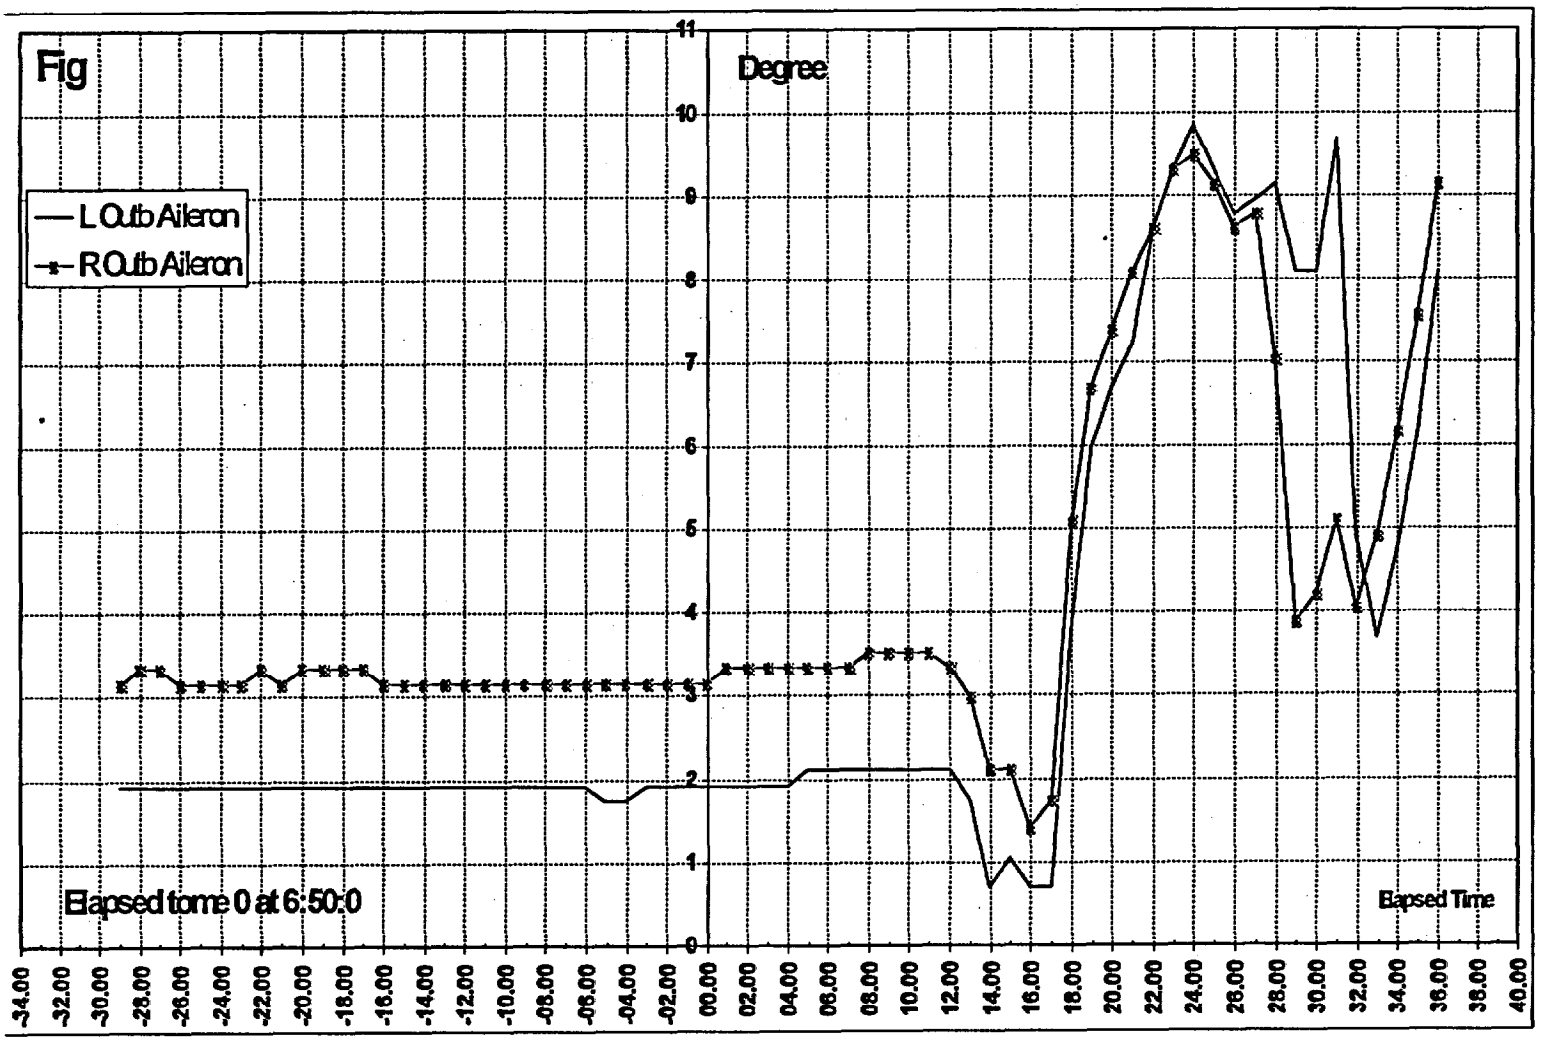
The DFDR data indicate a split, or asymmetry, in the left and right outboard ailerons panels almost between 6:50:27.98 and 6:50:31.98 UTC. This report examines whether or not the recorded outboard aileron split could have been caused by differential hinge moments on the left and right aileron panels. The results of these calculations indicate that an aerodynamic cause for the split is inconsistent with the performance of the airplane and the data recorded on the DFDR.

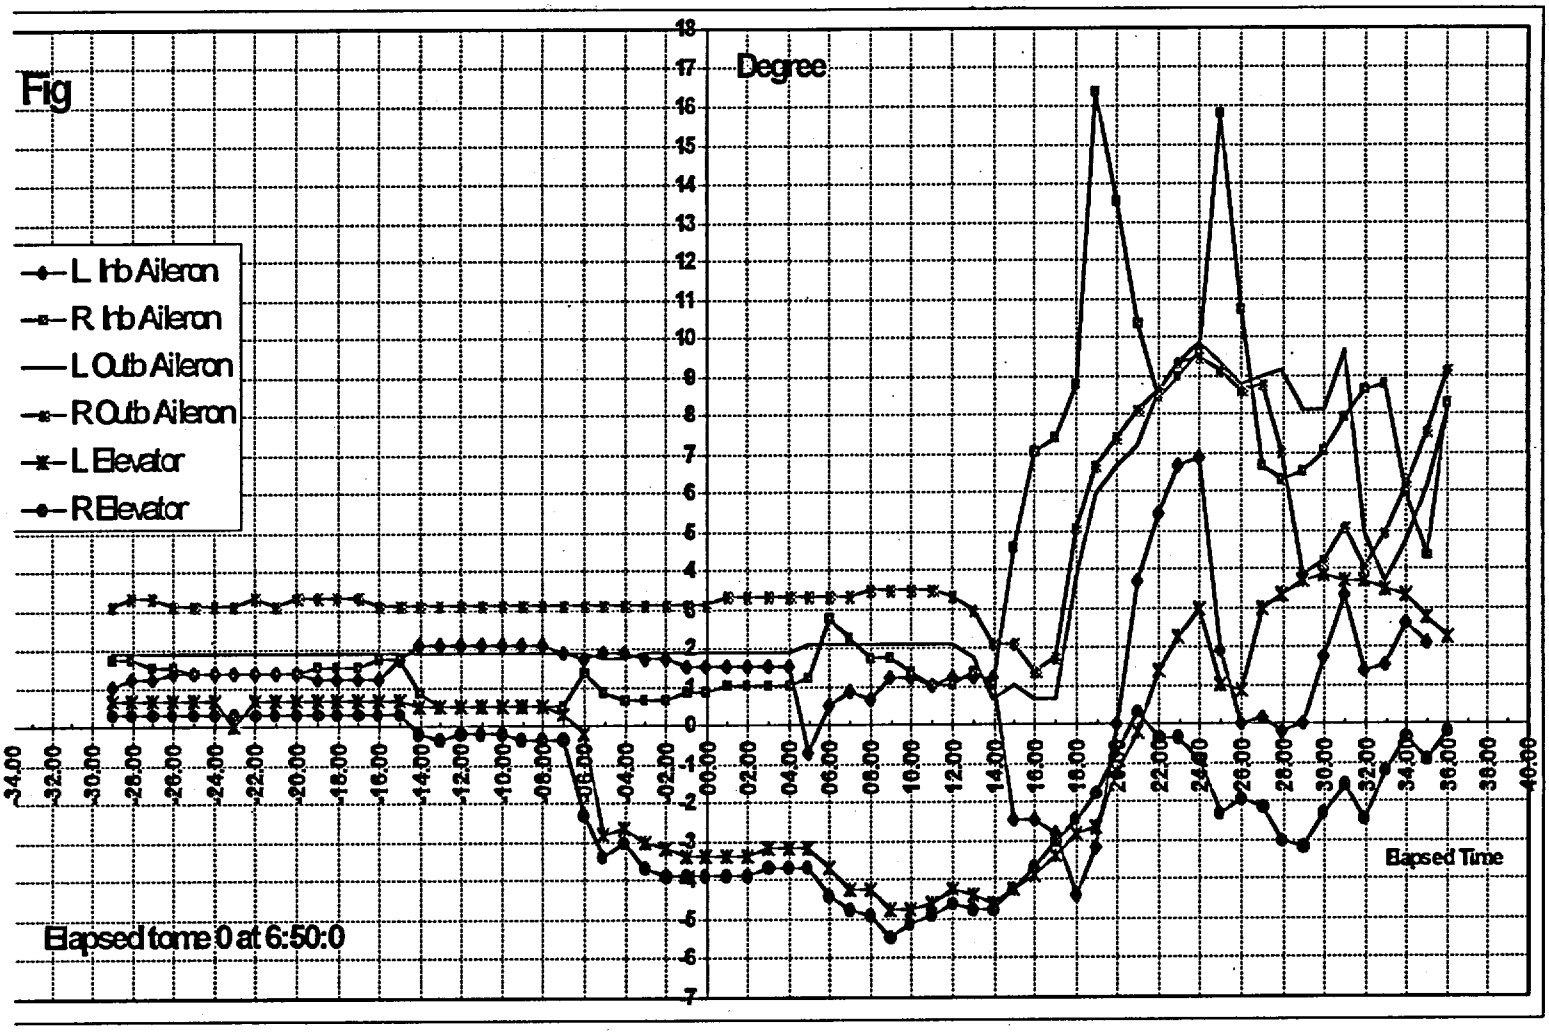
Fig
Degree
L Inb Aileron
R Inb Aileron
L Outb Aileron
R Outb Aileron
L Elevator
R Elevator
Elapsed Time
Elapsed tome 0 at 6:50:0

- The Egyptian Delegation believed that it is likely that whatever caused the elevators to deflect as they did also caused the aileron to deflect.

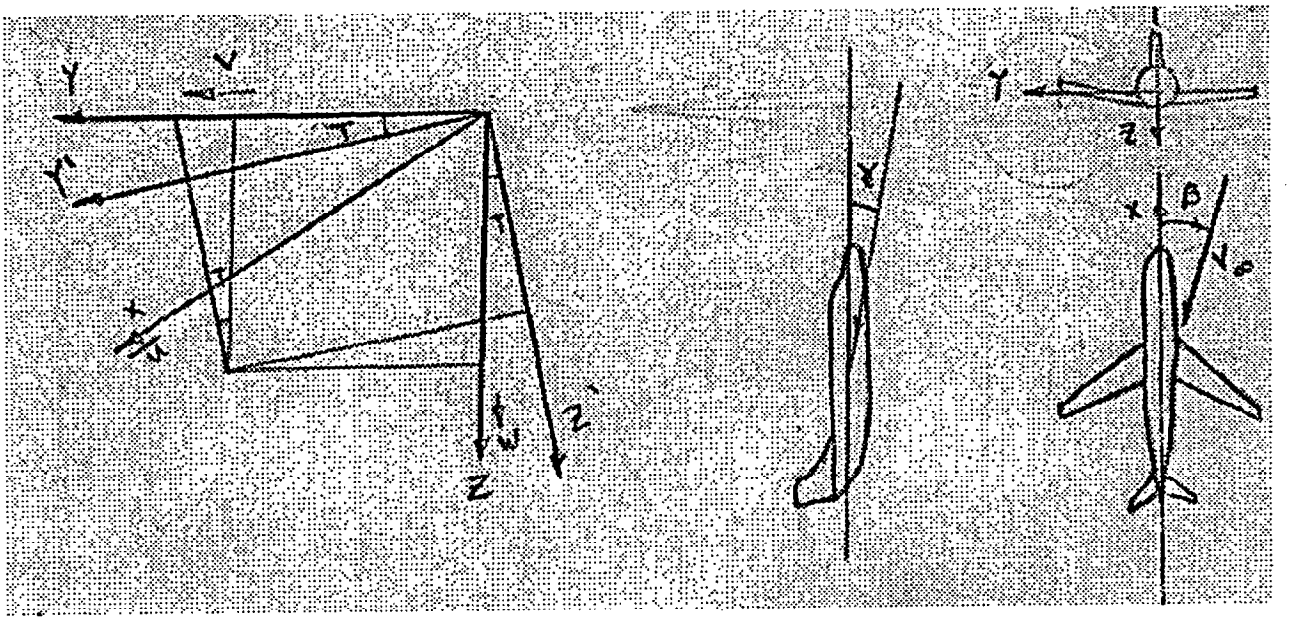
Side Slip Effect:

The dihedral angle of the wing is 6 degrees. This angle will cause one wing to be at a different angle of attack than the other while in a sideslip.

The above table shows that, to change the wing angle of attack by 5 degrees (difference of 10 between the wings) requires a sideslip angle of about 40 degree. Such a sideslip angle is inconsistent with the lateral load factor, aileron angles, and rudder angles recorded on the DFDR, and at the flight condition in question is probably beyond the aerodynamic and structural capability of the airplane.

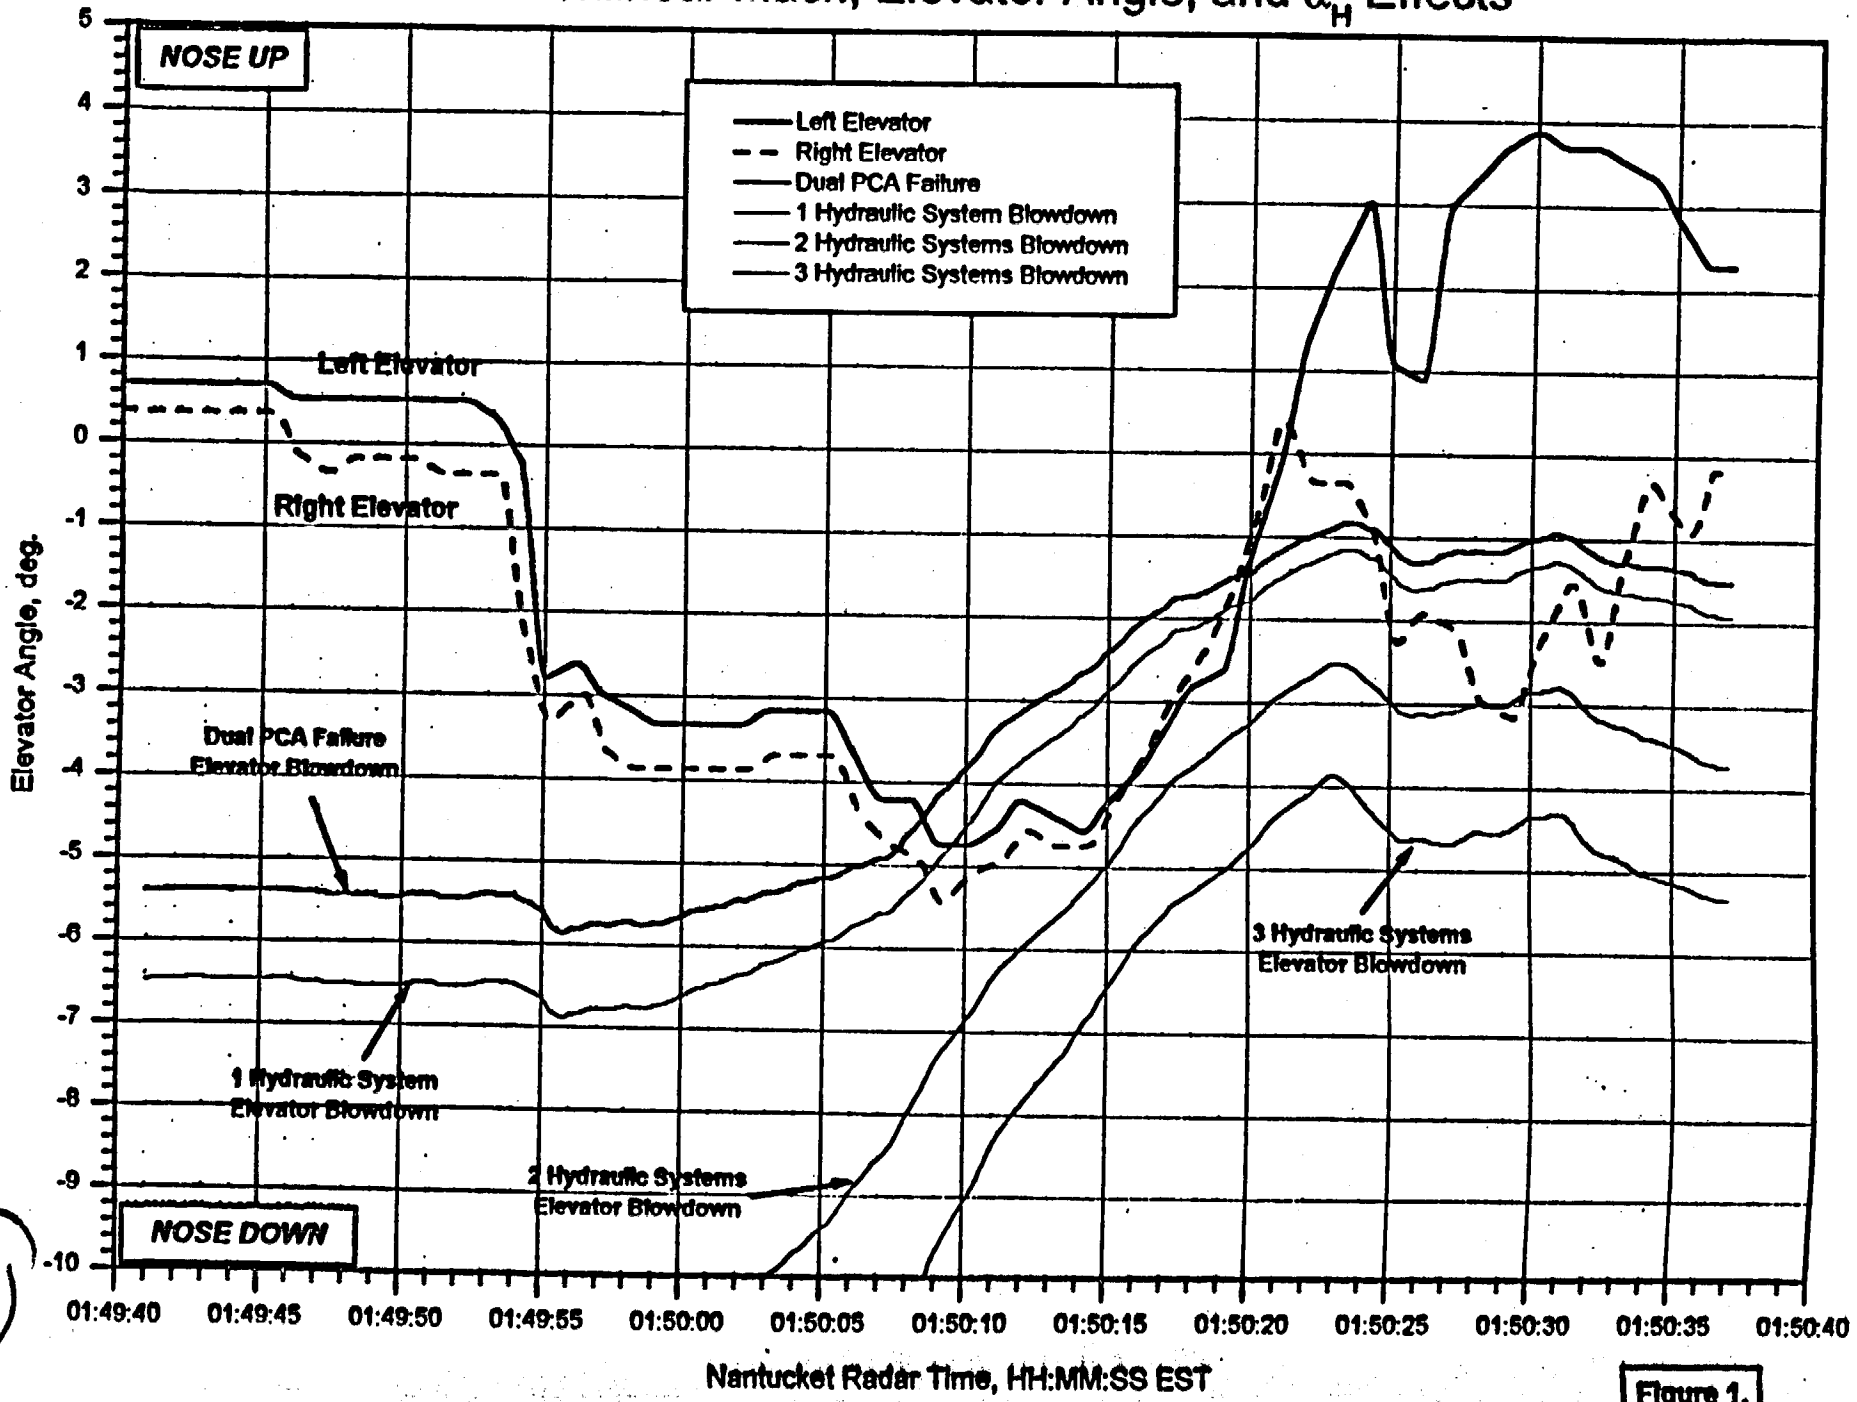
The solutions for δ_e with n = 0.78, 1, 2, and 3 are shown in Figure 1. These solutions are the blowdown angles corresponding to the Dual PCA Failure and various hydraulic systems turned off. The elevator positions recorded on the DFDR are also shown in Figure 1. The elevator blowdown angle is primarily dependent on the dynamic pressure, decreasing as dynamic pressure increases. Changes in angle of attack produce oscillations about the general trend set by the increasing dynamic pressure. Nonlinear Mach effects become more pronounced after about 01:50:07, where the Mach number is increasing through 0.86 and the slope of the blowdown curves changes abruptly. The extrapolated C_H data provided by Boeing indicates that the C_H for a given δ_e deflection starts to increase significantly above Mach 0.86, and at Mach 0.98 reaches over twice its Mach 0.8 value for some values of δ_e and α_H .

The Addendum also presents the elevator blowdown angles corresponding to different numbers of hydraulic systems powered on and off, and to a Dual Elevator PCA Failure scenario. The blowdown angles are estimated using extrapolated, non-linear elevator hinge moment data. The results of the calculations are shown in Figure 1.
