National Transportation Safety Board

Marine Accident Brief

Grounding of Mobile Offshore Drilling Unit *Kulluk*

Accident no.	DCA13NM012
Accident type	Grounding
Vessel	Mobile offshore drilling unit *Kulluk*
Location	Near Ocean Bay, Sitkalidak Island, Alaska
Date, time	December 31, 2012 2040 Alaska standard time (coordinated universal time – 9 hours)
Damage	Substantial
Injuries	Four minor
Environmental damage	None
Weather and sea conditions	At departure, moderate winds and seas with scattered precipitation, expected to continue during first days of voyage; several days later, low pressure moved into Gulf of Alaska area. By December 31, recorded winds reached 40–55 knots, with seas more than 20 feet.
Waterway information	Gulf of Alaska lies south of the state of Alaska in the northern Pacific Ocean

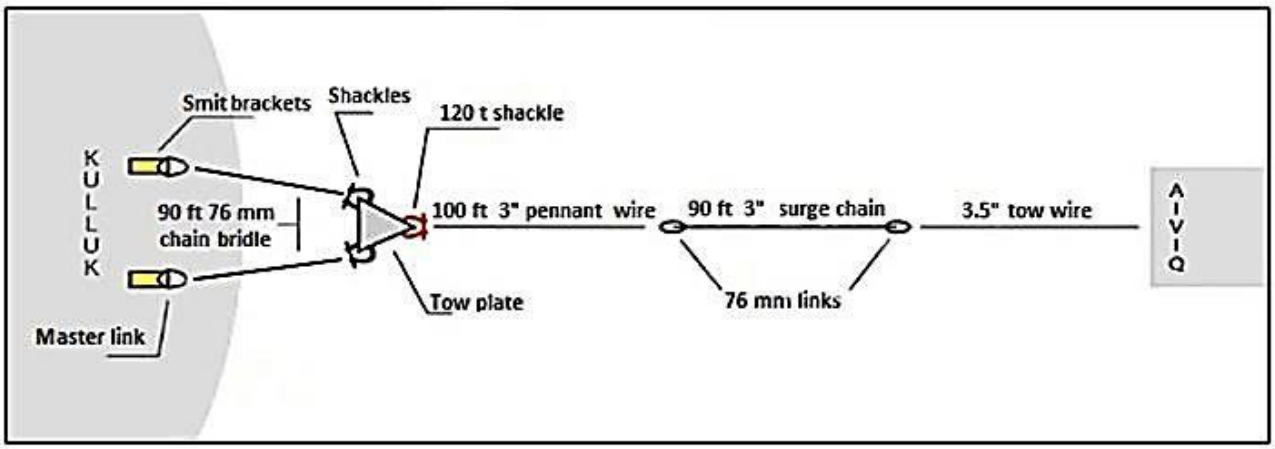
No regulations or class rules govern the demonstrated strength, useful life, number of cycles, or repeated stresses to which the tow line and tow gear could be subject, although the IMO has established guidelines and several countries have promulgated regulations to that effect. Shell testimony and documentation provided to the Coast Guard hearing demonstrated that the company followed industry practices with regard to manufacture, use, and inspection of the tow gear, and as noted, the warranty surveyor visually inspected the tow gear. The *Aiviq*'s towing gear consisted only of a 3.5-inch tow wire connected to the *Kulluk*'s gear with a segment of surge chain followed by the towing pennant. This pennant was connected to shackles and then to the towing plate. Shackles connected the towing plate to chain bridles, which were secured on the *Kulluk* with Smit brackets.[5]

Configuration of *Kulluk* and *Aiviq* tow gear. (Drawing adapted from Coast Guard)

The broken component of the *Kulluk*'s tow gear, a 120-ton shackle that was connecting the towing plate to the 100-foot-long, 3-inch pennant, was lost at sea during the initial December 27 tow gear separation, and investigators were unable to determine the cause of its failure.

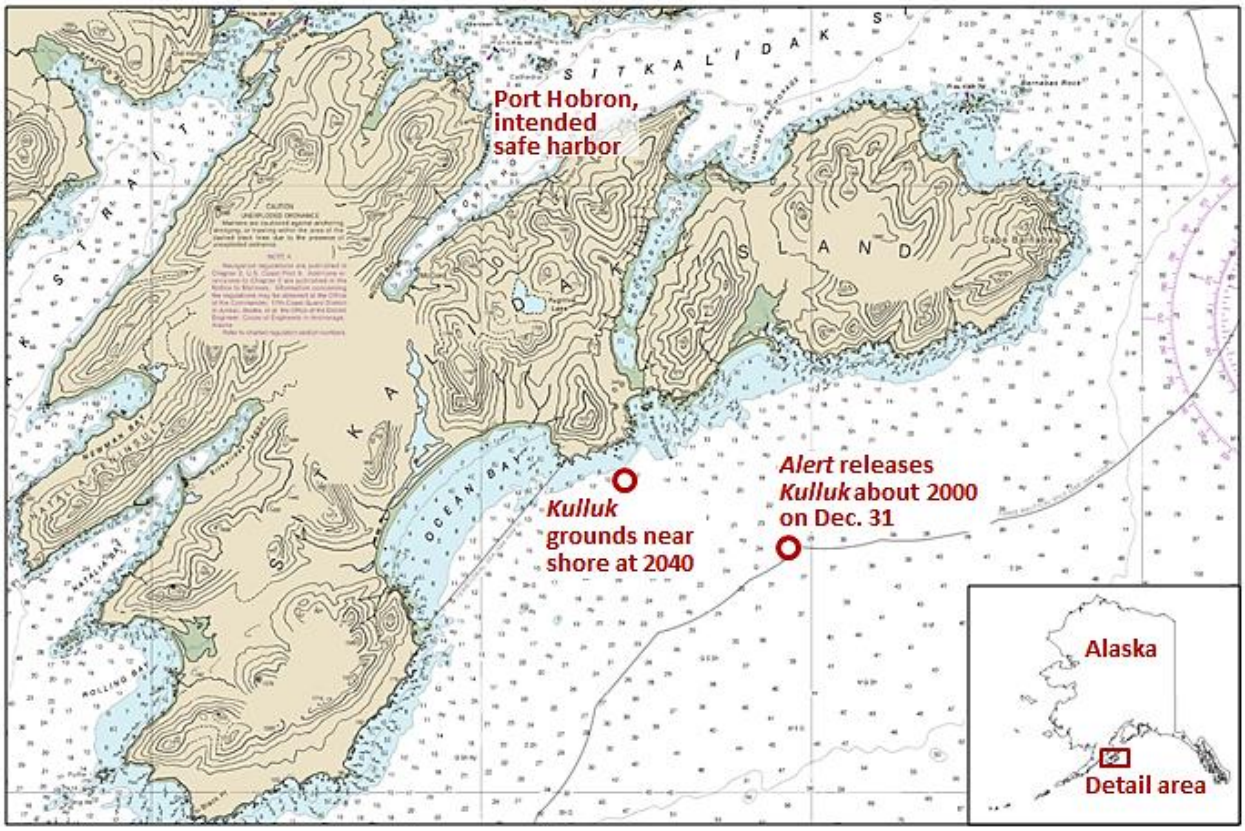
Vessel positions when the *Alert* released the *Kulluk* and location of the *Kulluk* grounding about 40 minutes later on December 31, 2012, near Ocean Bay, Sitkalidak Island, Alaska. (Excerpt from NOAA chart 16592)
