AIRCRAFT ACCIDENT REPORT

HUGHES AIR WEST DC-9, N9345
AND U.S. MARINE CORPS F-4B, 151459
NEAR DUARTE, CALIFORNIA
JUNE 6, 1971

NATIONAL TRANSPORTATION SAFETY BOARD
Washington, D. C. 20591
REPORT NUMBER: NTSB-AAR-72-26

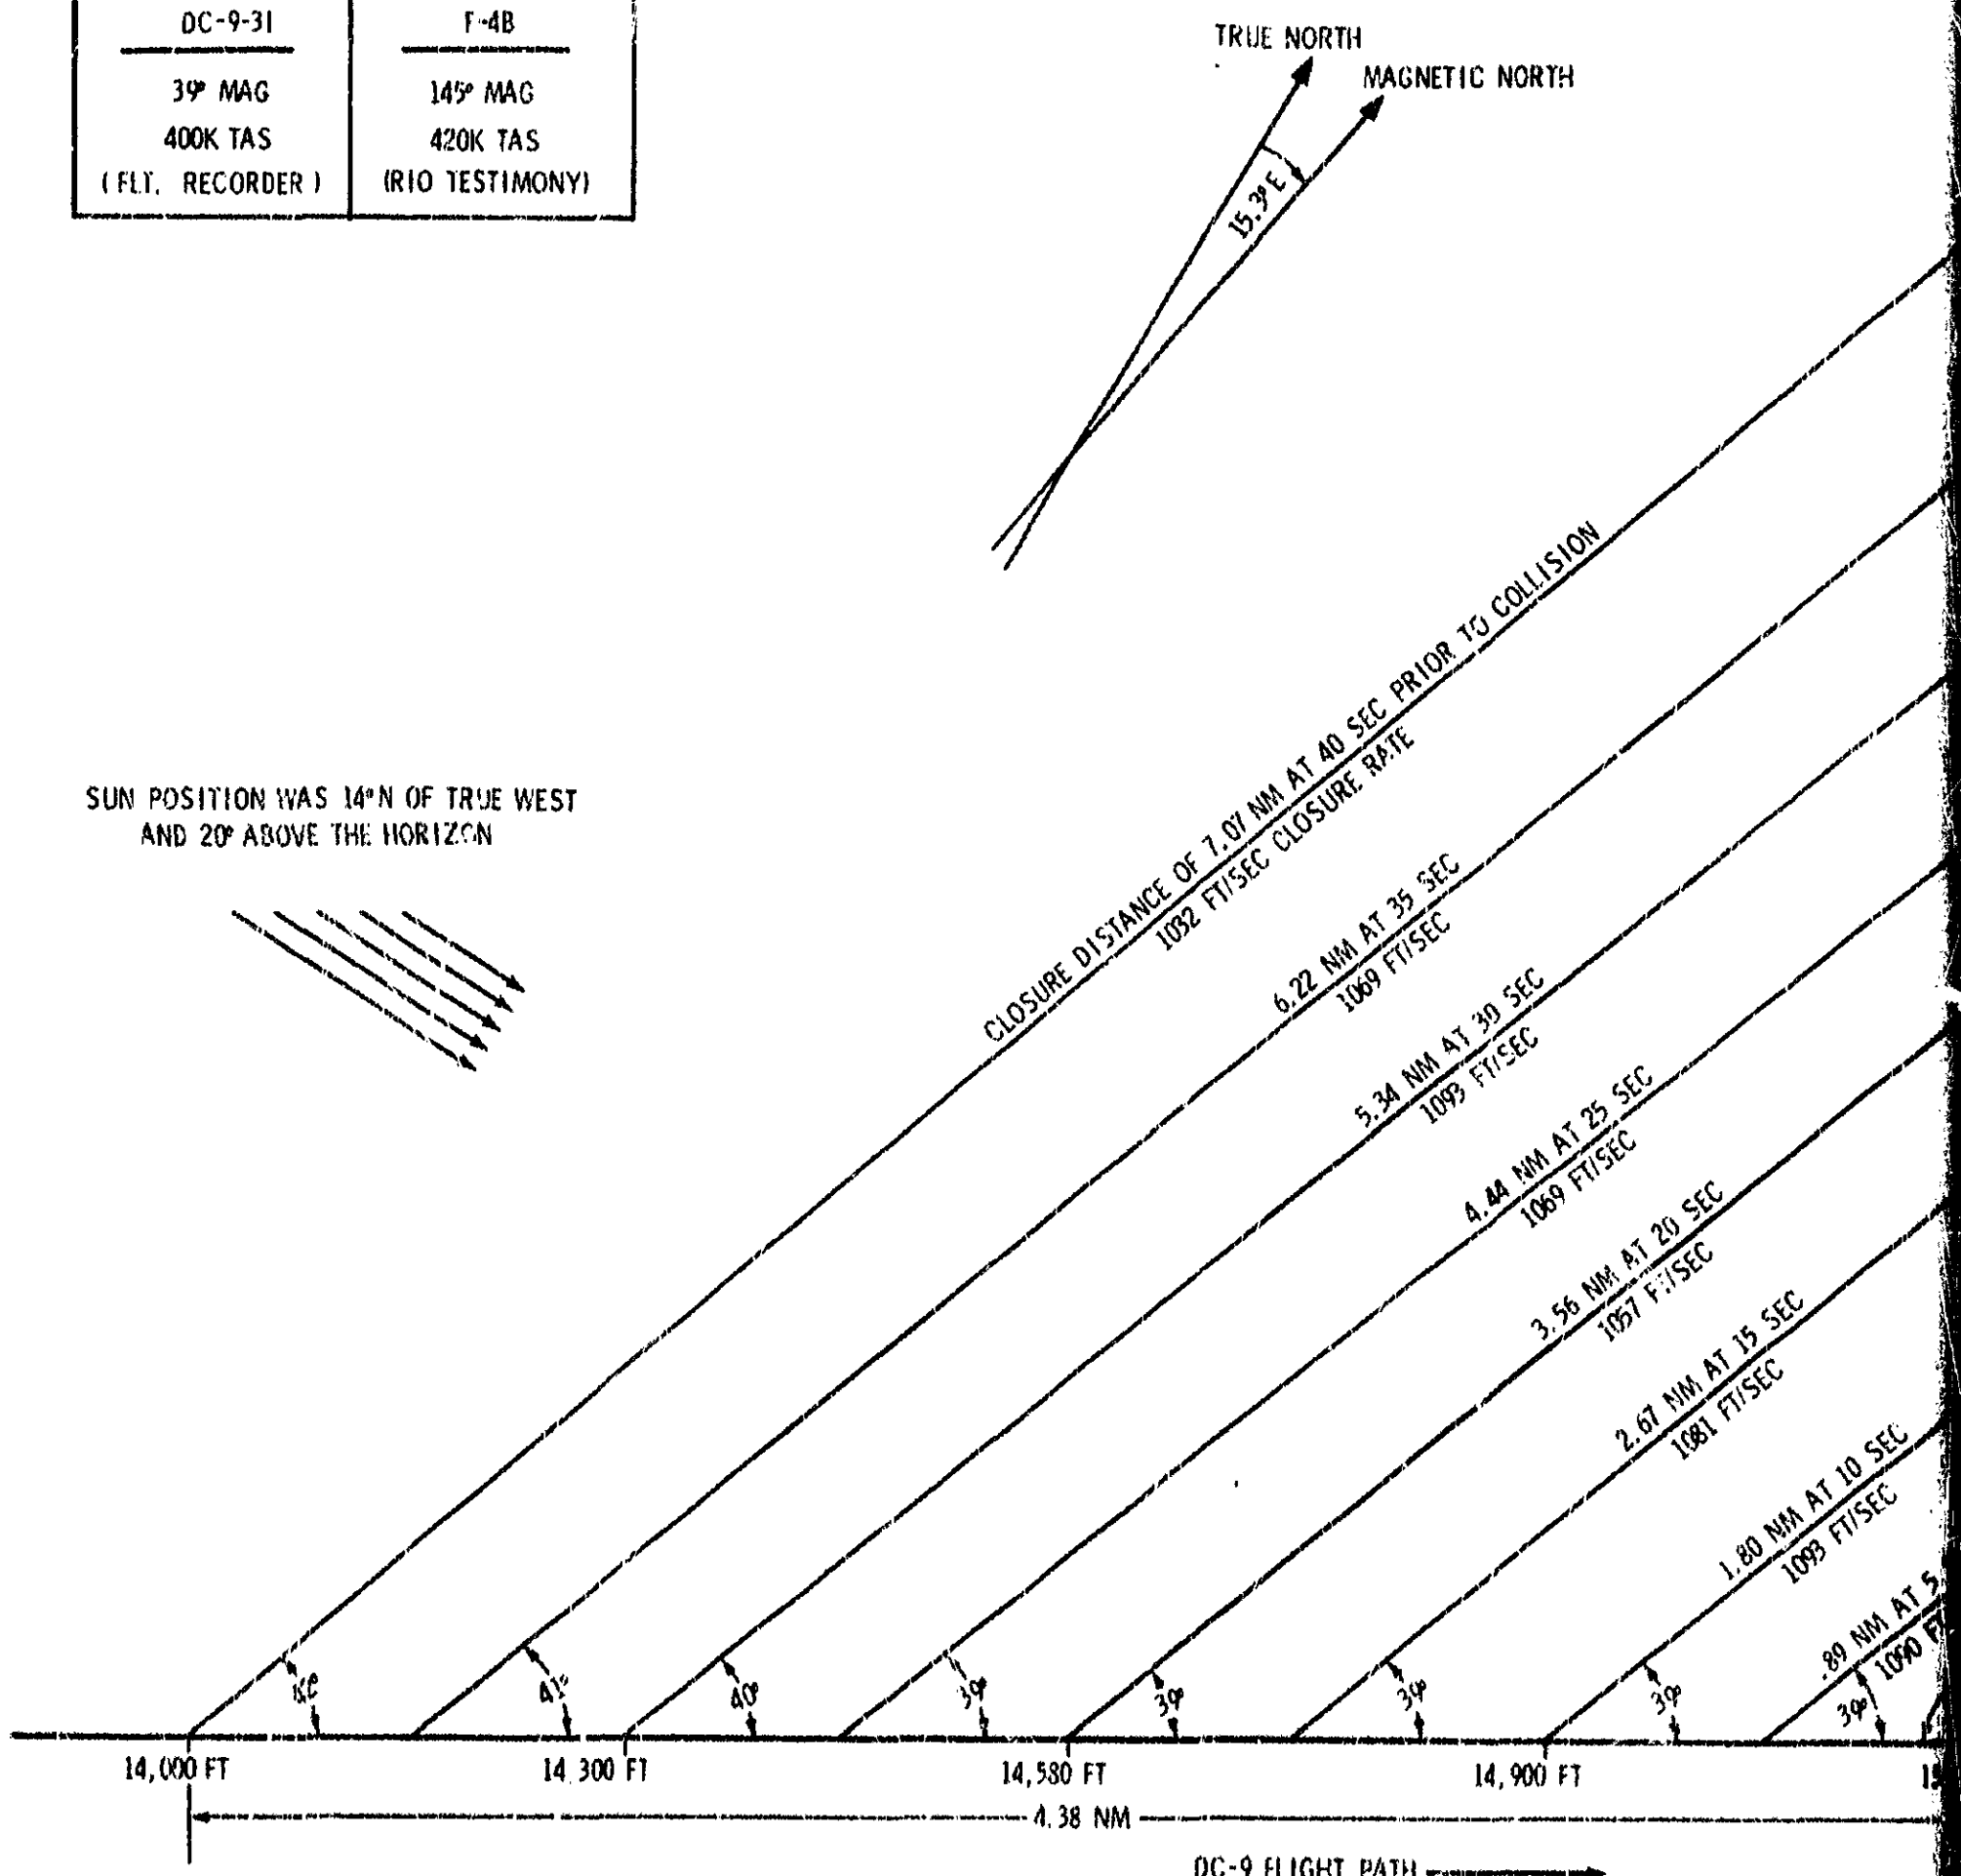
COMPUTED RANGES, BEARINGS, AND CLOSURE

PRIOR TO EVASIVE MANEUVER	
DC-9-31	F-4B
39° MAG	145° MAG
400K TAS	420K TAS
(FLT. RECORDER)	(RIO TESTIMONY)

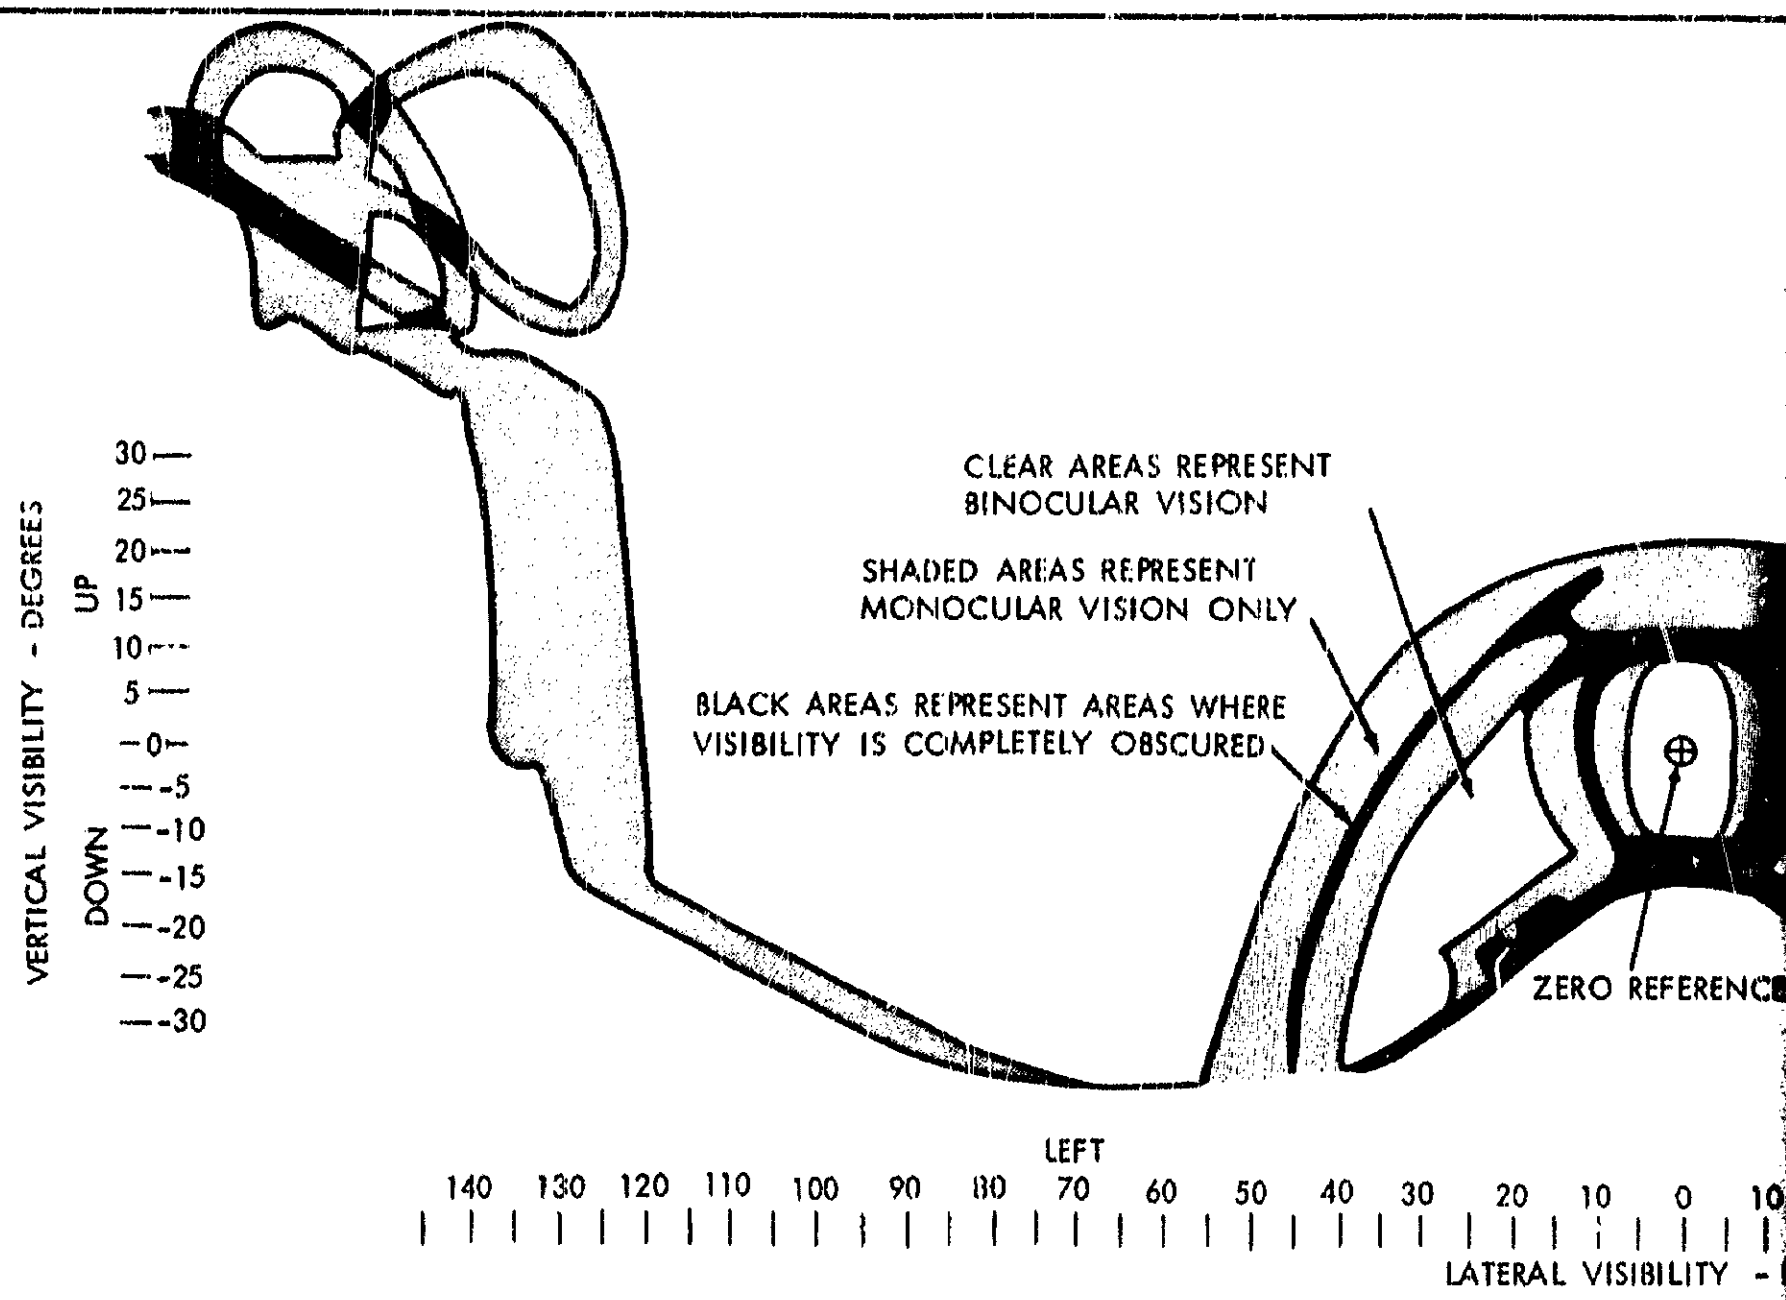
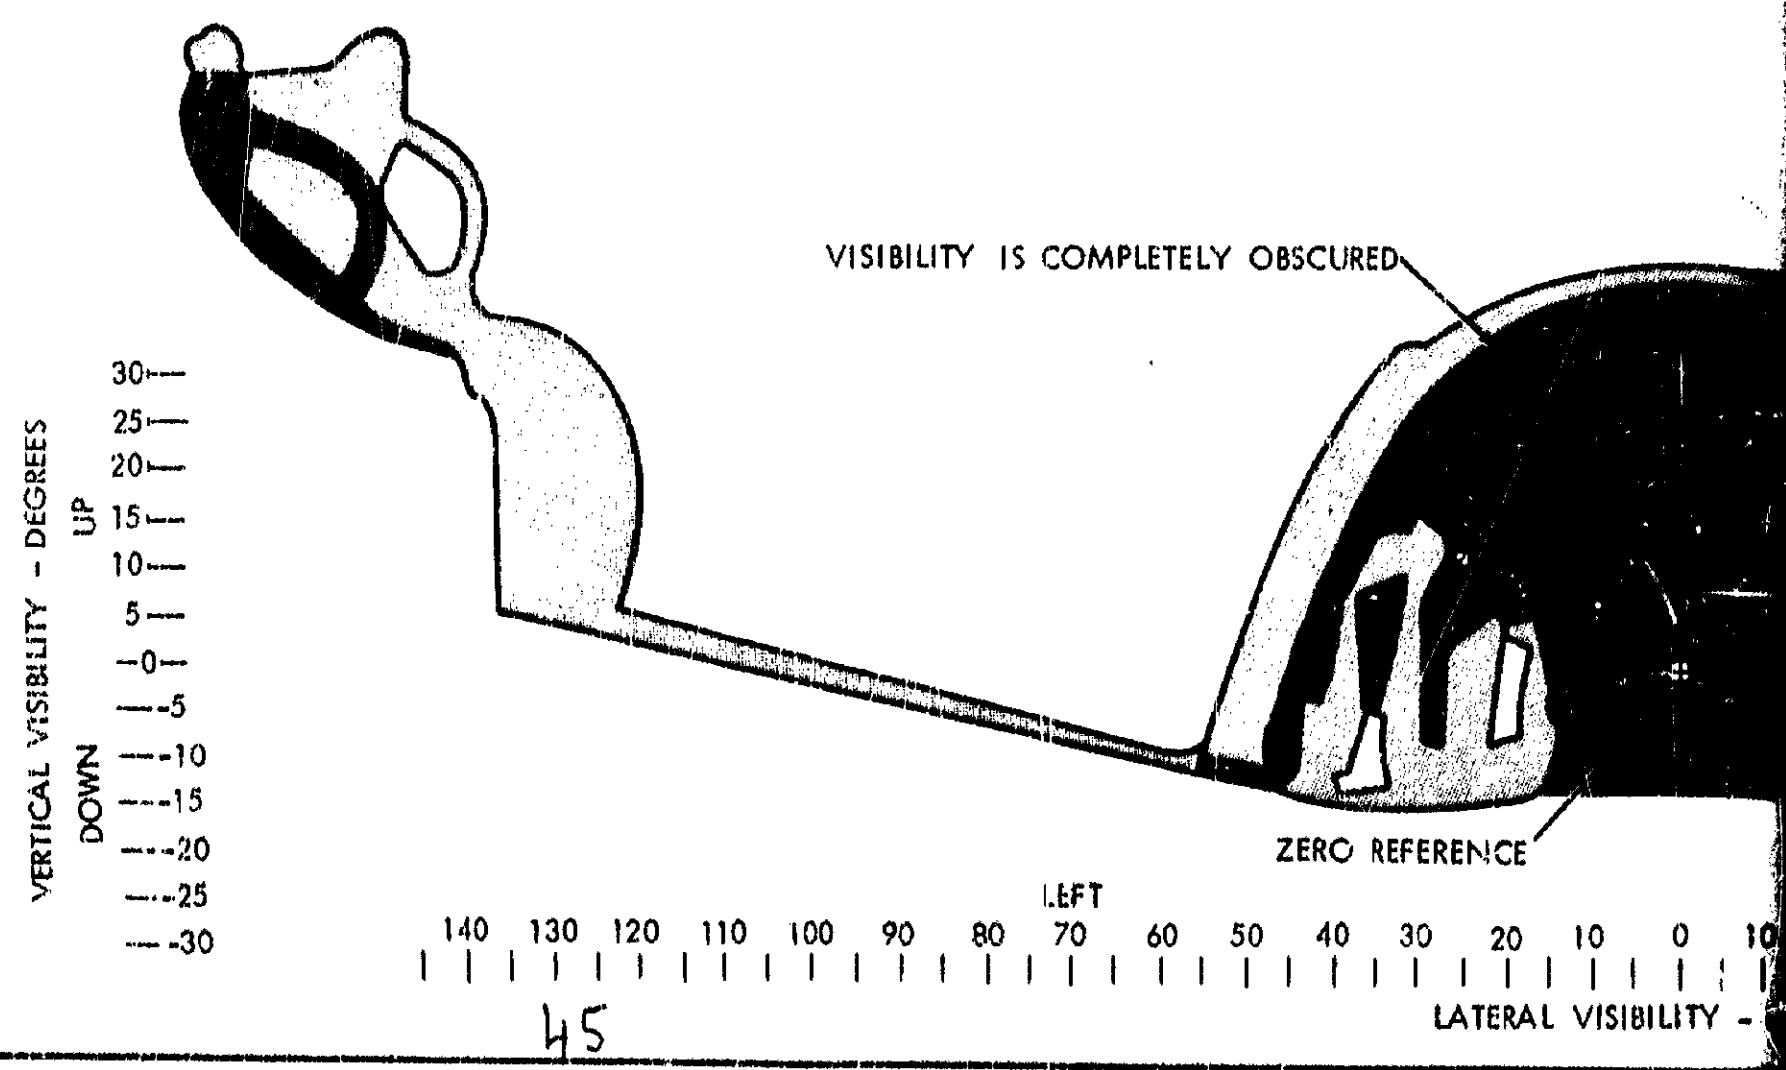
The Board further concludes that the visual cues for accurate assessment of the collision geometry by the pilot of BuNo458 probably were inadequate. Then, when target range had been reduced sufficiently to afford improved visual cues, the time remaining was so brief as to make

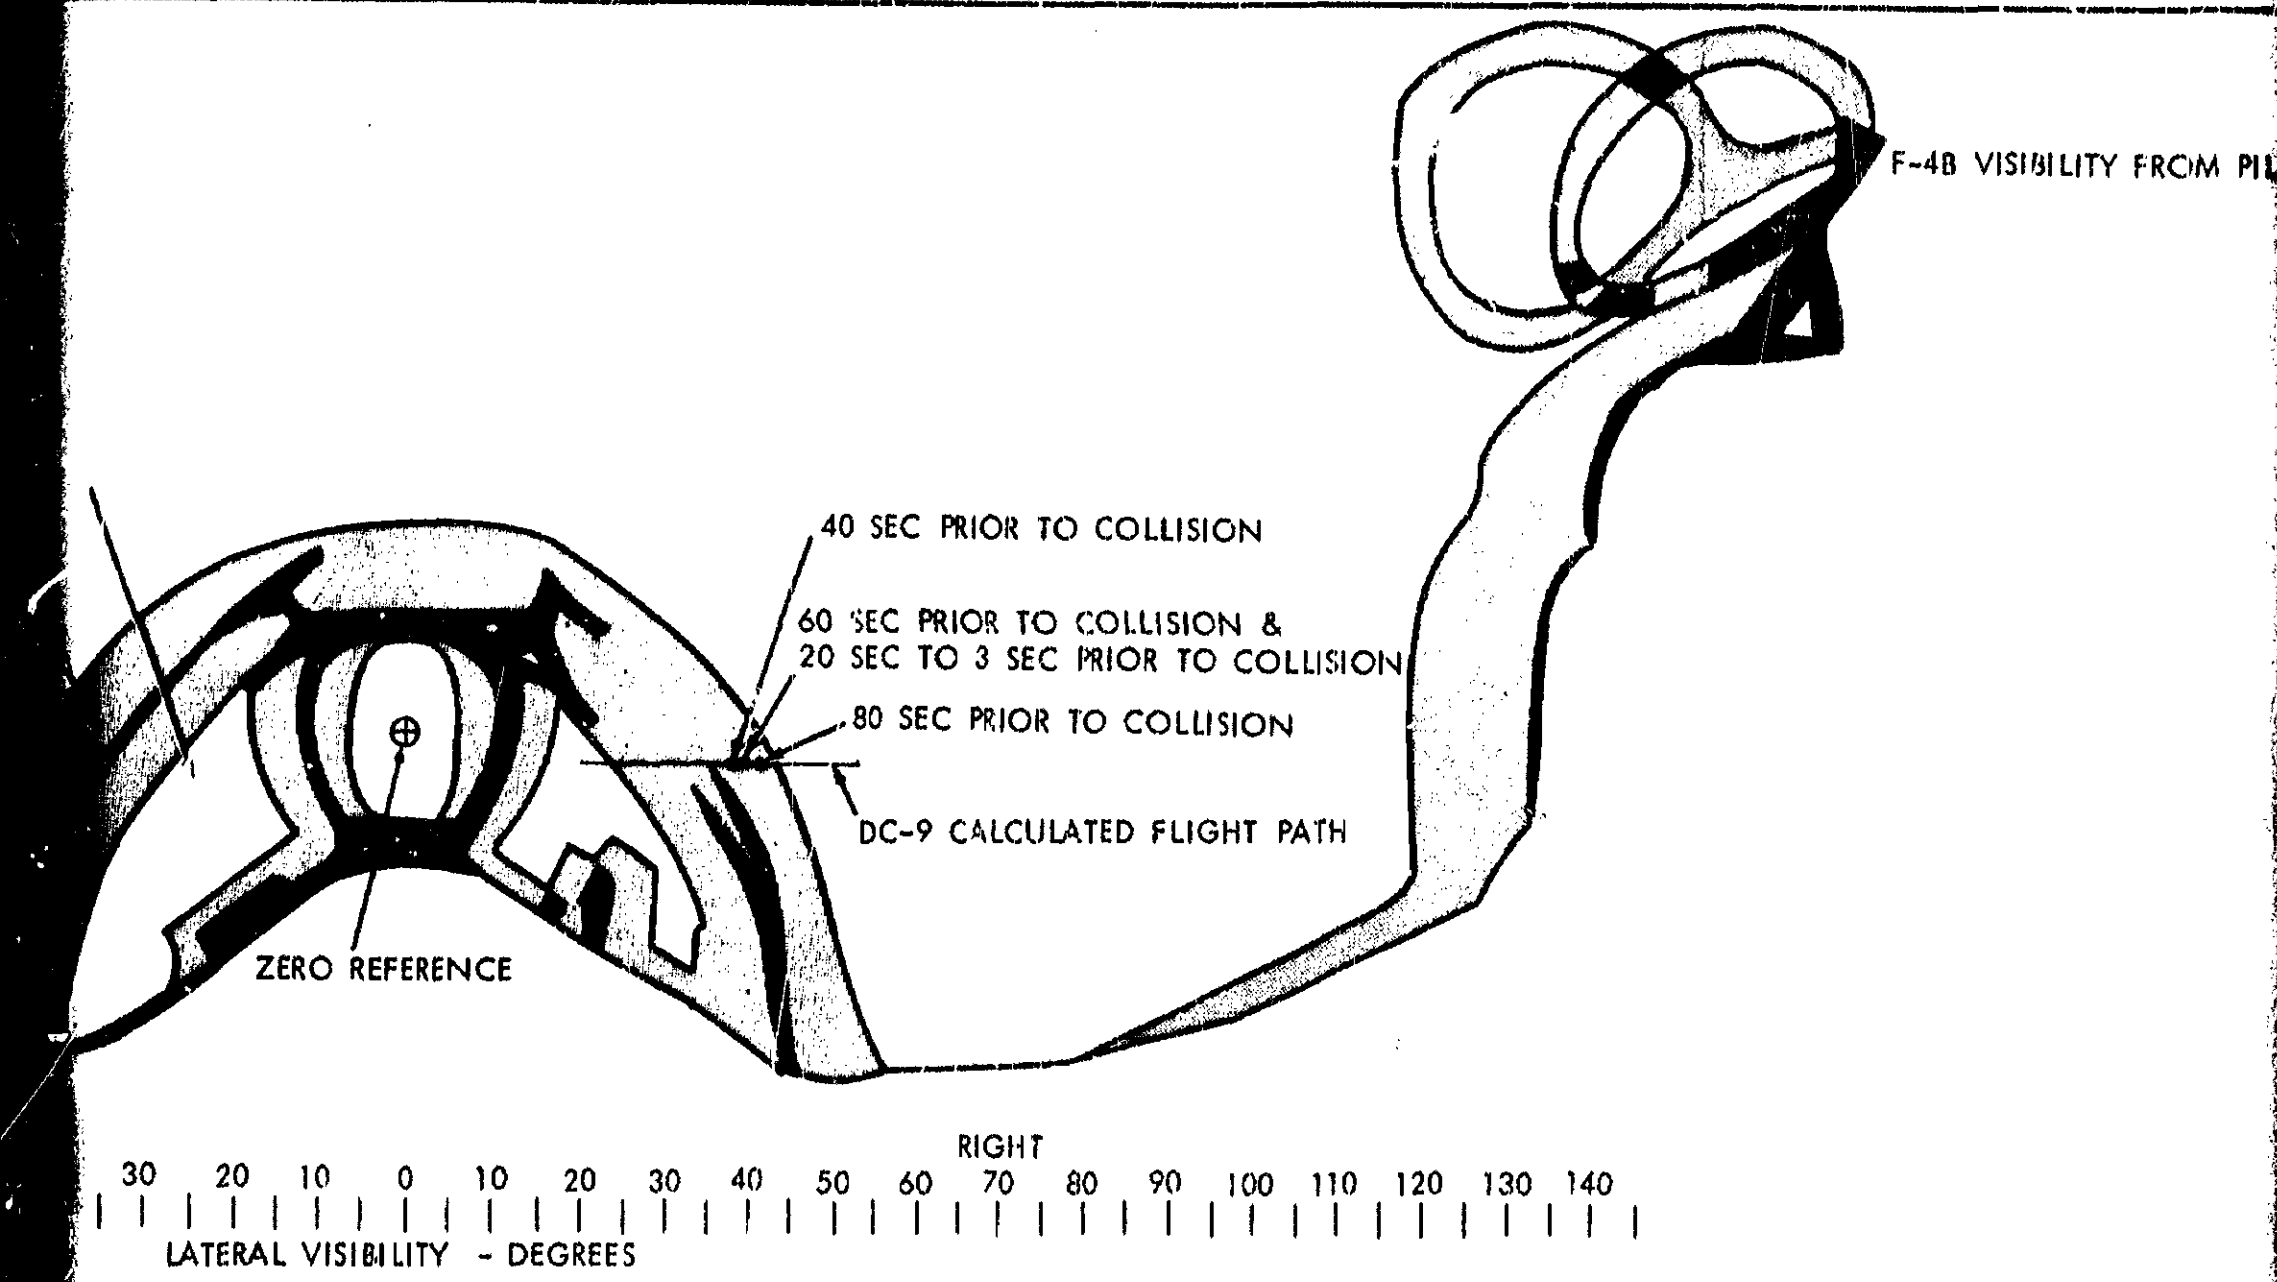
F-4B VISIBILITY FROM PI
40 SEC PRIOR TO COLLISION
60 SEC PRIOR TO COLLISION &
20 SEC TO 3 SEC PRIOR TO COLLISION
80 SEC PRIOR TO COLLISION
DC-9 CALCULATED FLIGHT PATH
ZERO REFERENCE
RIGHT
30 20 10 0 10 20 30 40 50 60 70 80 90 100 110 120 130 140
LATERAL VISIBILITY - DEGREES

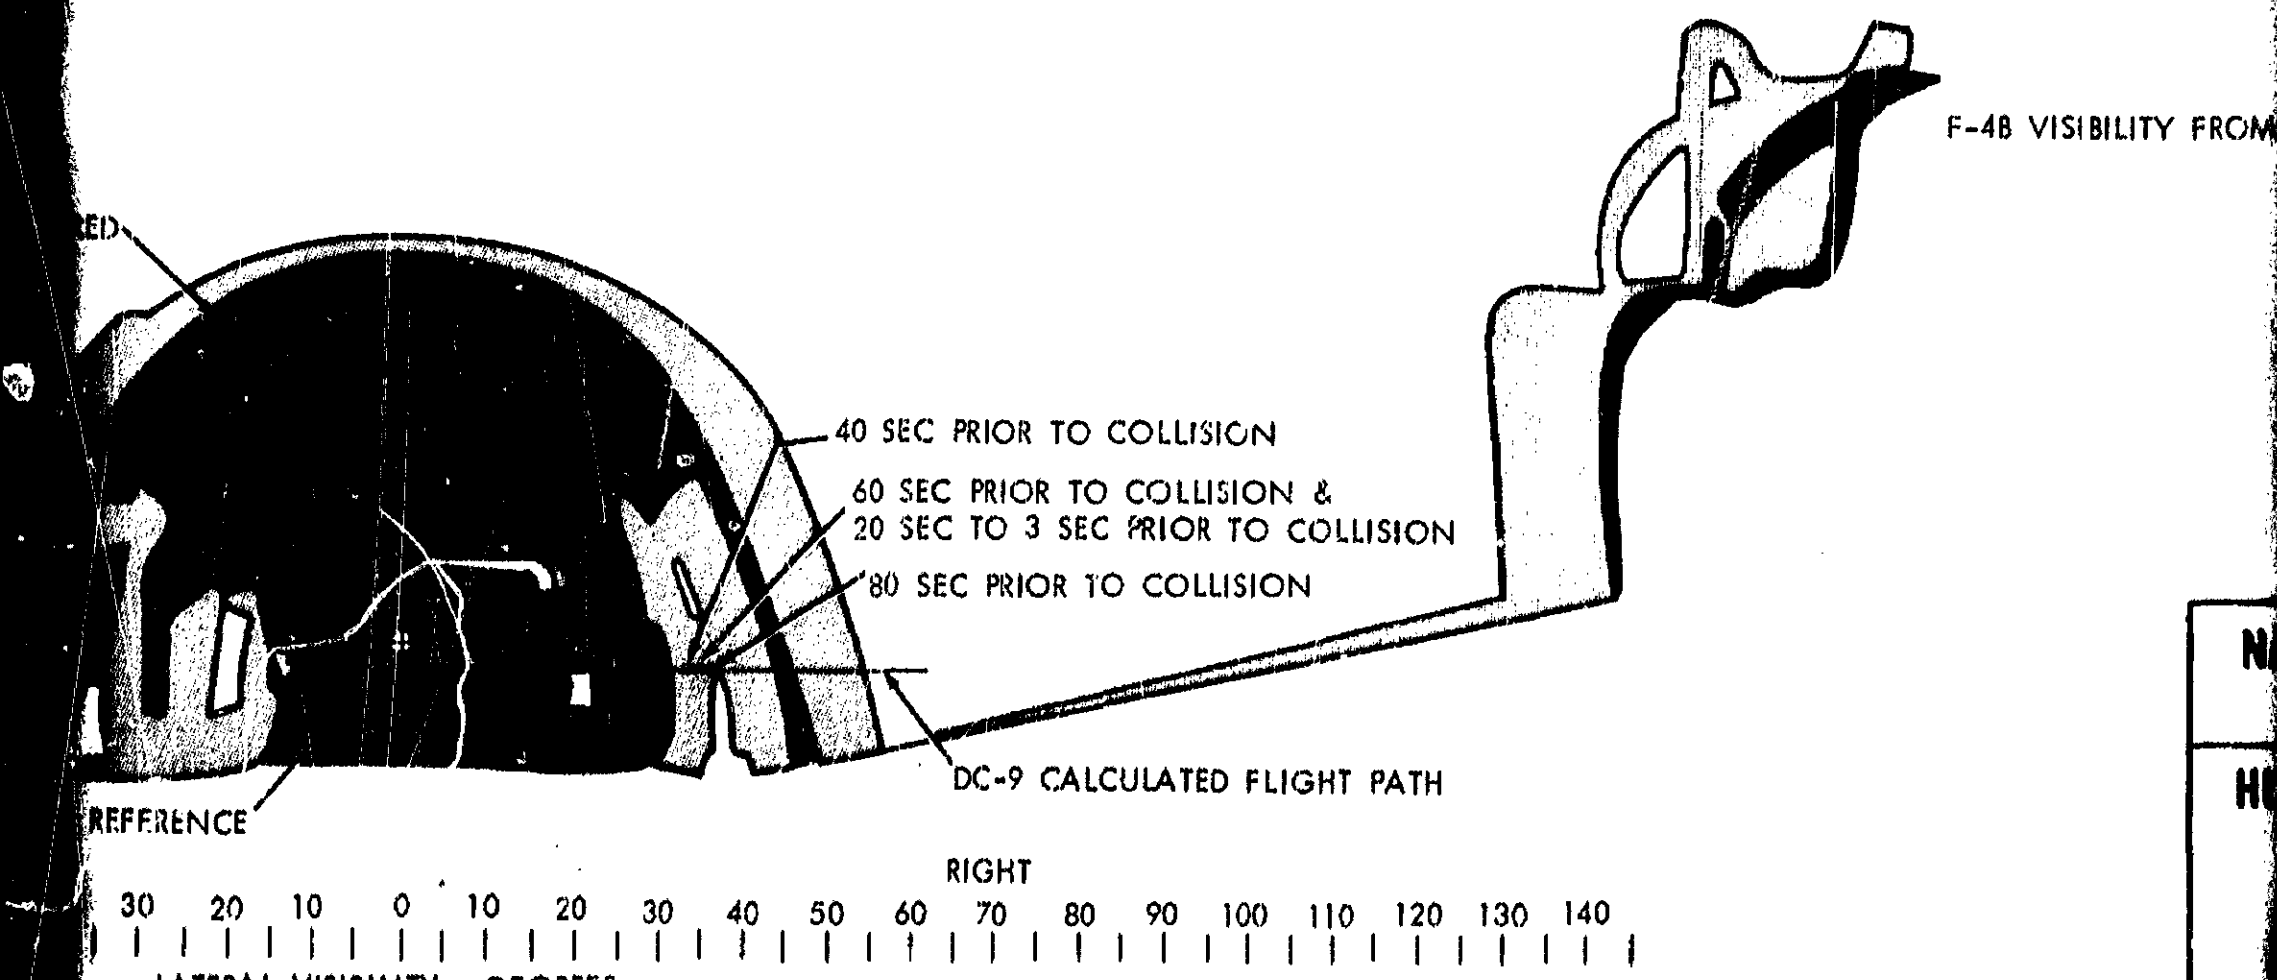
F-4B VISIBILITY FROM
40 SEC PRIOR TO COLLISION
60 SEC PRIOR TO COLLISION &
20 SEC TO 3 SEC PRIOR TO COLLISION
80 SEC PRIOR TO COLLISION
DC-9 CALCULATED FLIGHT PATH
REFERENCE
RIGHT
30 20 10 0 10 20 30 40 50 60 70 80 90 100 110 120 130 140
LATERAL VISIBILITY - DEGREES
