October 30, 2026 MIR-26-35

# Contact of Roll-on/Roll-off Vehicle Carrier *Morning Menad* with Dundalk Marine Terminal Dock

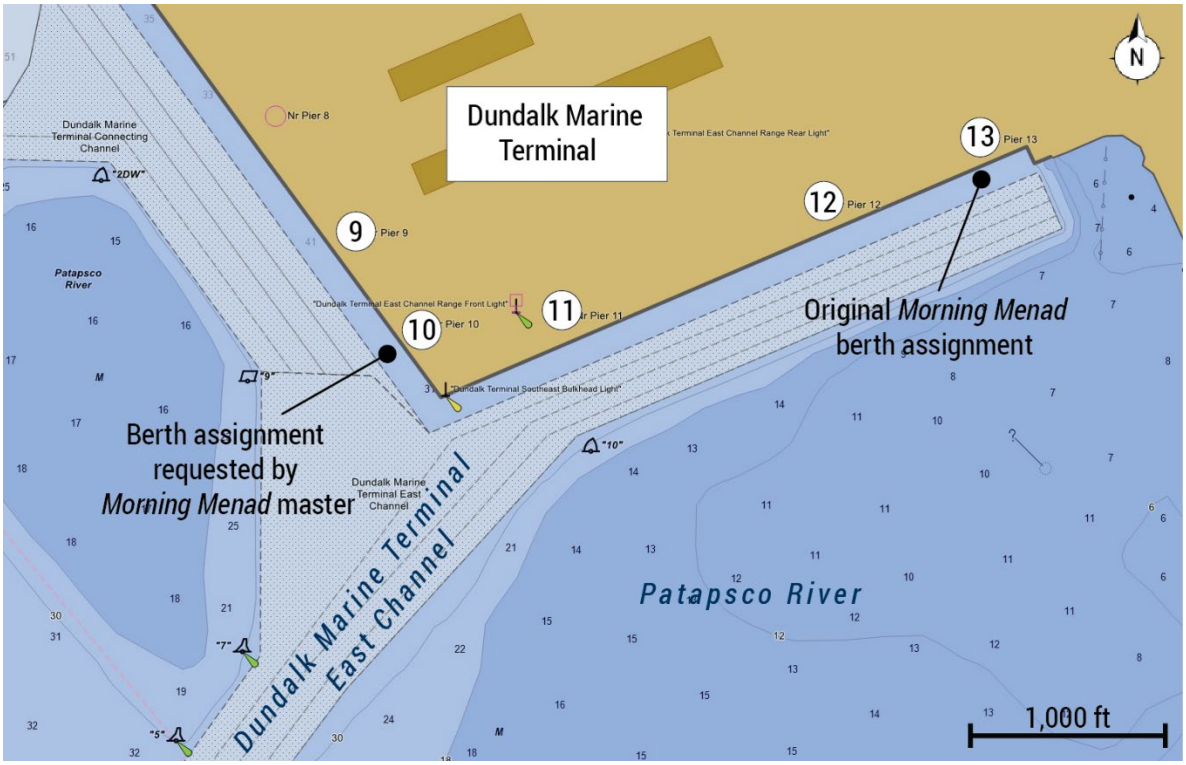
Pilot 1 discussed the maneuvering and docking plan with the master. About 0931, the master asked the pilots if the vessel could be docked at berth 10 instead of berth 13 due to the high-wind conditions, now averaging 37 knots with gusts to 47knots (see figure 3). Pilot 1 responded, "Can't make that determination" and stated that the master should call the ship's agent with that request.[5] The master tried twice, but he was unable to reach the ship's agent by telephone, and the pilots continued with the original plan to dock at berth 13.

**Figure 3.** Overhead view of the Dundalk Marine Terminal approach and piers. (Background source: National Oceanic and Atmospheric Administration Electronic Navigational Chart US5BALCB)

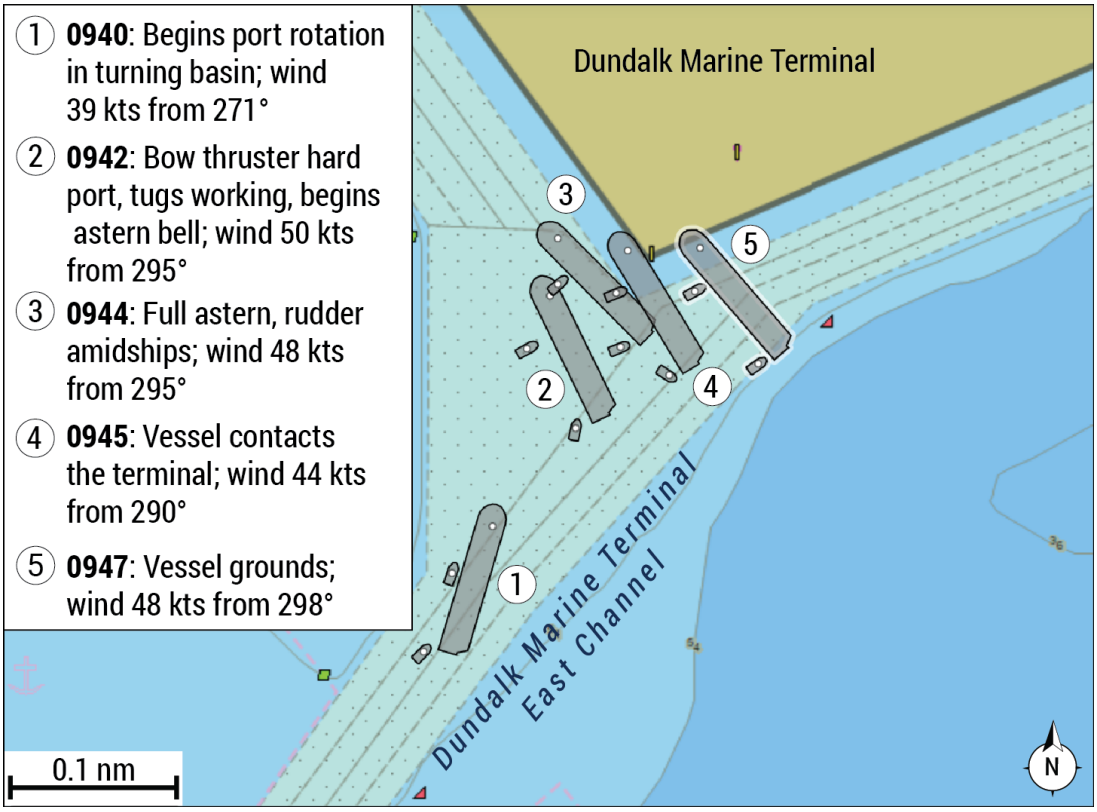
Realizing that the ship had been blown sideways by the wind and was closer to the pier than he had expected, pilot 1 gave increasing astern commands in an attempt to avoid contacting the corner of the facility. However, about 0945, while the *Morning Menad* was moving astern at 3 knots, the ship's bow contacted the corner of the terminal dock between berths 10 and 11 (see figure 4). The wind at the time was 44 knots from the west-northwest, broad on the *Morning Menad*'s port bow.

**Figure 4.** Locations and positions of the *Morning Menad* and two harbor assist tugs as the ship attempted a rotation to port in the turning basin and was pushed by the wind into the Dundalk Marine Terminal. (Background source: National Oceanic and Atmospheric Administration Electronic Navigational Chart US5BALCB as viewed on Made Smart)

To moor at berth 13, the *Morning Menad* had to stop, rotate about 150° in the turning basin next to the terminal, and back about five ship lengths into the slip. To rotate the vessel for the docking maneuver, Pilot 1 reduced the vessel speed and began to turn the bow to port and push the stern to starboard using the rudder, bow thruster, and tugs. On the casualty day, predicted westerly gale force winds first presented on the port quarter, but then the wind increasingly affected the ship as it rotated in the turning basin and the wind moved toward the beam. As the vessel turned to port, nearly on a northerly heading, westerly winds were acting on the port beam, resulting in the vessel's maximum sail area being subject to the wind load (force). The high winds on the port side rendered the tugs and the vessel's maneuvering capabilities insufficient, causing the vessel to move laterally to starboard, toward the pier, and eventually contact the pier. Had the ship been able to
