National Transportation Safety Board

Safety Recommendation

In reply refer to: A-98-125 and -126

On December 6, 1995, Pakistan International Airlines (PIA) flight 722, a Boeing 747-240 "Combi" airplane,[1] experienced an uncontained failure[2] in the low pressure turbine (LPT) area of the No. 2 engine, a General Electric Aircraft Engines (GE) CF6-50E2, shortly after takeoff from John F. Kennedy International Airport (JFK), New York.[3] The flightcrew reported that as the airplane was climbing through 1,000 feet, they heard a loud thud and grinding noise and that the airplane then yawed to the left. The flight engineer reported that immediately after he heard the thud, he noted that the No. 2 engine oil pressure and oil quantity gauges were both indicating zero. The flightcrew continued the climb and later shut down the No. 2 engine. The airplane returned to JFK and landed without further incident. None of the 240 passengers and 15 crewmembers on board were injured. The airplane was operating on an instrument flight rules (IFR) flight plan under the provisions of Title 14 Code of Federal Regulations (CFR) Part 129 as a regularly scheduled international passenger and cargo flight f

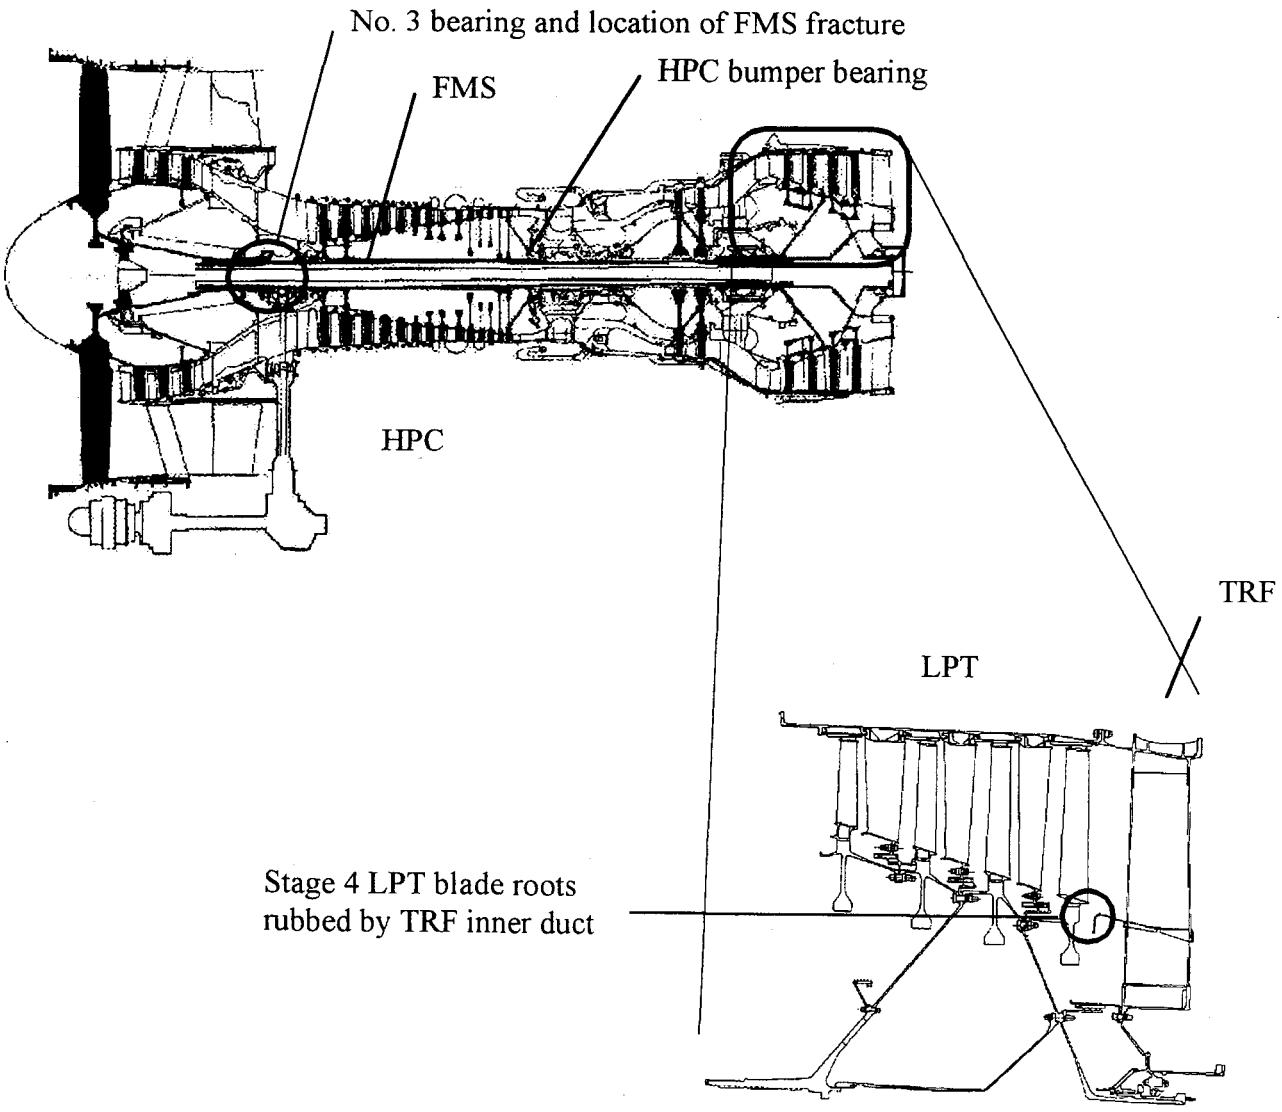
Figure 1. Cross section of CF6-50 engine and expanded view of LPT module

The examination of the No. 2 engine revealed that most of the LPT module was missing (see figure 1). The airplane had punctures to its left wing leading edge slats and to a landing gear door. In addition, the No. 1 engine had hard body impact damage[4] to 18 of the 38 fan blades, and the fan cowl had impact damage from the debris ejected from the No. 2 engine.

Disassembly of the engine, serial number (SN) 455-954, at GE's Engine Maintenance Center, Ontario, California, under the direction of the National Transportation Safety Board, revealed that the fan midshaft (FMS) was fractured circumferentially, just aft of the No. 3 (roller) bearing. Although the No. 3 bearing was damaged, the damage was typical of secondary damage that would have occurred late in the engine failure sequence.

Examination of the fractured FMS by the Safety Board's and GE's materials laboratories revealed a fatigue fracture with multiple origins on the outer diameter (OD) of the shaft that propagated inward. The examinations also revealed a color variation across the fracture surface and a reduction of the material hardness at the fracture in comparison to the other areas of the FMS and the engineering drawing specification, indicating that the part had been previously

overheated. In addition, SerMetel paint[5] was found on the surface of the fatigue fracture, suggesting that the crack existed but was not detected when the shaft had been painted following a previous repair.

The disassembly of the PIA engine showed that the center section of the FMS had become wedged into the high pressure compressor (HPC) bumper bearings. The design of the CF6-50 engine's FMS is such that the OD of the forward half of the shaft is greater than the inner diameter of the bumper bearing on the inside of the HPC rear hub. On the PIA engine, when the FMS fractured at its forward end, the rear section moved aft, and the larger diameter section of the shaft became wedged into the bumper bearing, limiting the rearward movement of the LPT

rotor. With the FMS wedged into the bumper bearing, the LPT rotor was then driven by the high pressure rotor, which has a rotational speed more than twice the rpm limit of the low pressure rotor. Additionally, two stage 4 LPT blade roots recovered from the core cowl had circumferential grooves on their rear faces. The grooves corresponded to the forward edge of the turbine rear frame (TRF) inner duct, indicating that additional structure had limited the rearward movement of the LPT rotor and meshing[11] action, thus permitting the rotor to overspeed. Several stage 1 LPT blades recovered from the wing slat area were rubbed on the rear faces of their roots and had the rear portions of the blade root serrations sheared consistent with the radial outward movement of the blades, suggesting that those blades were pushed out of the disk from the rear and separated under high-centrifugal loads.

> Require General Electric Aircraft Engines to modify the CF6-50 engine to eliminate the impediments to the aft translation of the low pressure turbine rotor that limits the amount of meshing that occurs in the event of a fan midshaft fracture. (A-98-125)
>
> Require General Electric Aircraft Engines to improve the ability of the CF6-50 and the CF6-80 series engines to prevent fractured low pressure turbine blades from being liberated through the engine cowling. (A-98-126)

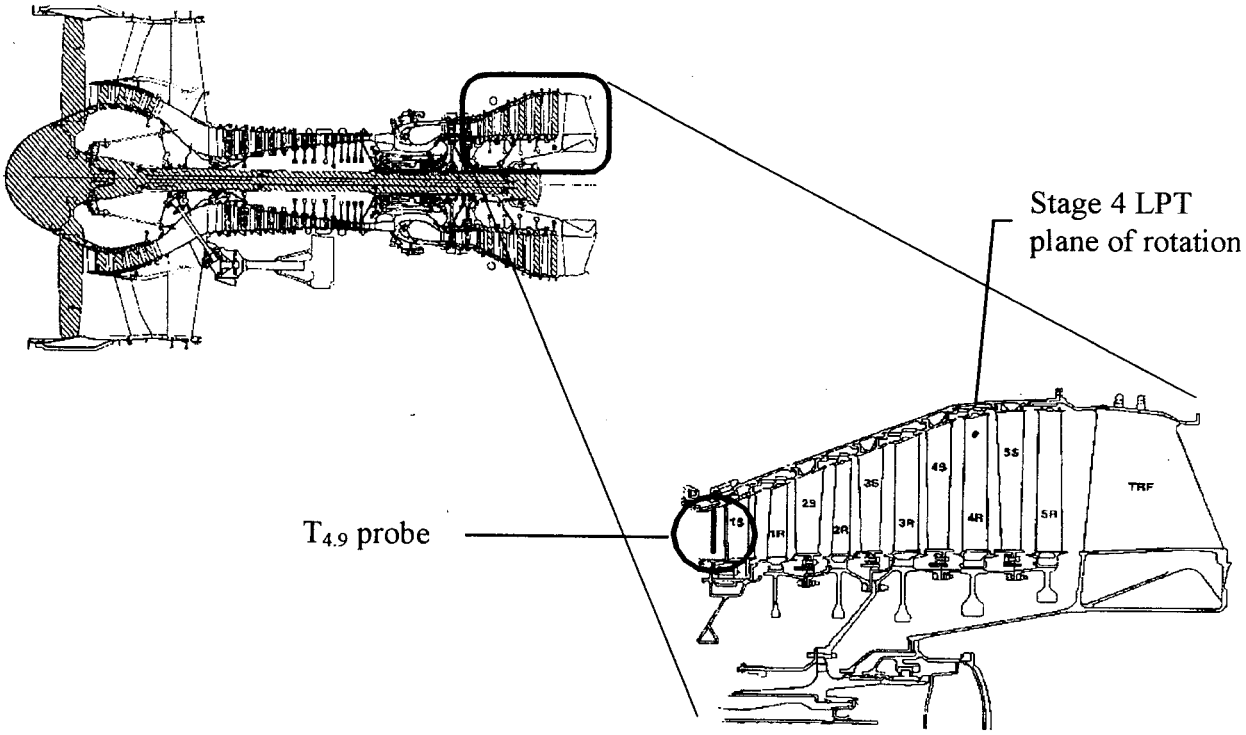
Figure 2. Cross section of CF6-80C2 engine and expanded view of LPT module

Examination of the No. 1 engine revealed that the core cowl had a 15-inch long (circumferential) by 6-inch wide (axial) hole in the plane of the stage 4 LPT rotor. There were numerous dents and impact marks on the underside of the left wing's inboard aileron and the outboard side of the inboard flap track fairing, both of which are directly aft of the No. 1 engine's exhaust.[14]

The engine was disassembled and examined under the direction of the Safety Board at Motoren-und Turbinen-Union (MTU), Hannover, Germany.[15] The disassembly revealed that the tip of one interturbine temperature ($T_{4.9}$)[16] probe had broken off and impacted one stage 1 LPT blade, causing a fatigue fracture of the airfoil near the blade tip shroud (see figure 2). All of the stage 2, 3, 4, and 5 LPT blades were found in their respective disks; however, all were fractured transversely across the airfoils at various lengths above the blade root platforms. The disassembly also revealed that the LPT case had a 17-inch by 2-inch wide hole in the stage 4 LPT plane of rotation. The damage to the LPT rotor was progressively worse along the gaspath, suggesting that the stage 1 LPT blade tip separated first, that all of the blades in the following stages were then fractured, and that the mass of material became larger as it progressed through the rotor, subsequently resulting in a case rupture in the stage 4 area.
