National Transportation Safety Board

Safety Recommendation

Date: February 22, 1999

In reply refer to: A-99-12 through -15

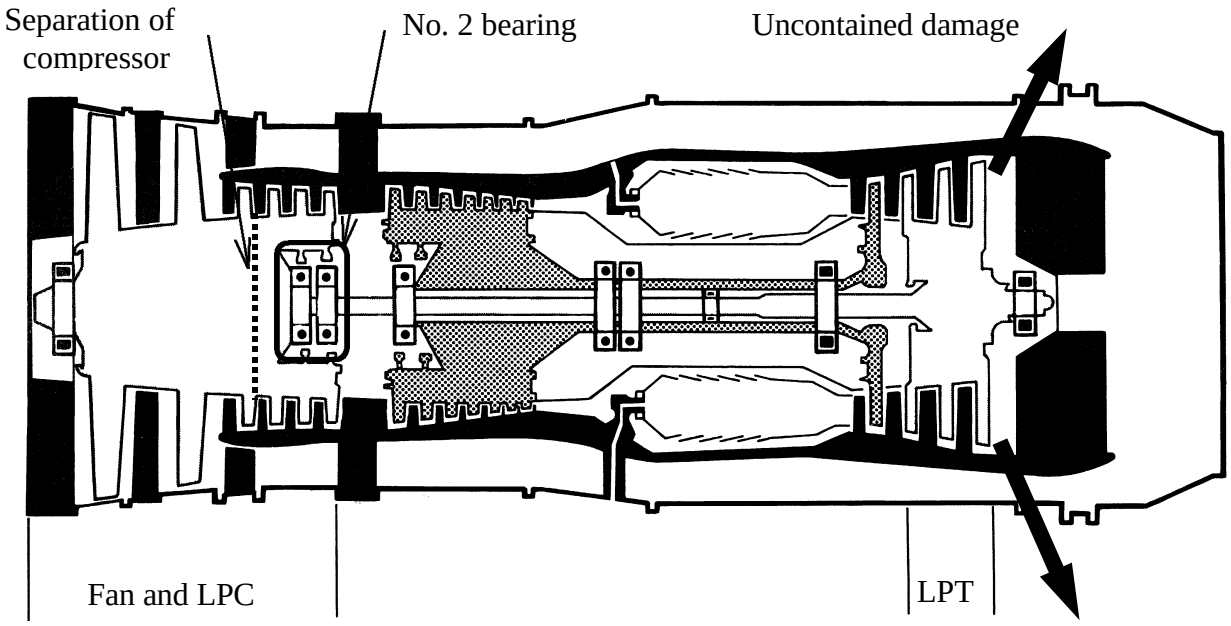
The JT8D engine's low pressure rotor system is made up of a two-stage fan, which consists of the 1st and 2nd stage fan rotors,[3] and a four-stage low pressure compressor (LPC), which consists of the 3rd, 4th, 5th, and 6th stage compressor rotors. The two-stage fan and four-stage compressor are joined to the three-stage LPT, which consists of the 2nd, 3rd, and 4th stage turbine rotors, by a drive shaft, all of which rotate as one unit under normal conditions (see figure 1). The examination of the incident engine revealed that the 1st and 2nd stage fan rotors and the 3rd stage compressor rotor rotated together but independently from the remainder of the low pressure rotor system from the 4th stage compressor rotor rearward. The examination also showed that the 2nd, 3rd, and 4th stage LPT disks were intact but that all of the LPT blades were fractured adjacent to the blade root platforms, and most of the LPT vanes were missing. Although the engine was outfitted with an LPT containment shield, as required by Airworthiness Directive (AD) 94-20-09, the containment shield was broken into three pieces, and the engine was cut in two just aft of the LPT by liberated LPT blades.[4]

Figure 1. JT8D engine

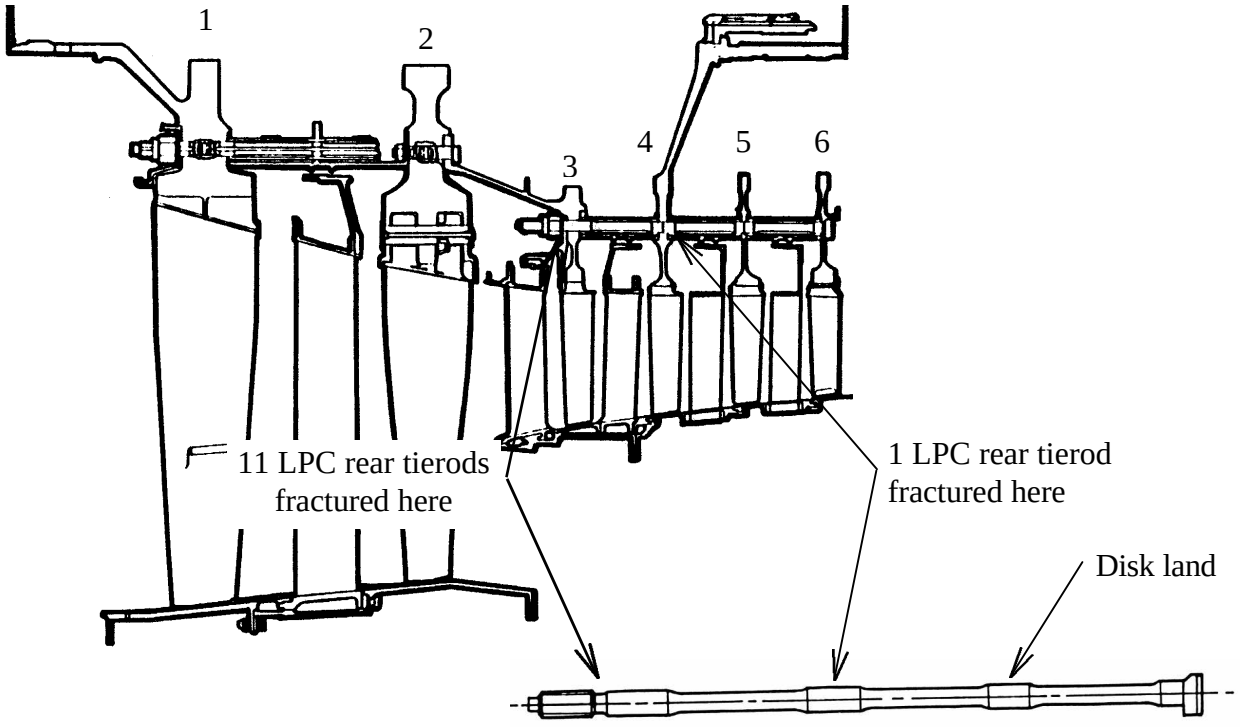
The 4 stages of the JT8D engine's LPC are held together by 12 long bolts, called LPC rear tierods, that pass through alternating disks and spacers (see figure 2). The disassembly of the Royal Airlines LPC revealed that one LPC rear tierod, part number (PN) 789550, was fractured transversely across the tierod's 4th stage compressor disk land.[5] The entire fracture face on the

tierod had surface corrosion, suggesting that the tierod had been broken for some time. Because of overstress, the 11 remaining LPC rear tierods were fractured at their forward ends between the 3rd stage compressor disk lands and the tierod nut threads. All six of the recovered tierod nuts and ends had numerous pockmarks on one side, and the tierod ends were bent away from the pockmarks. The pockmarks and bending damage suggest that after the initial tierod fractured and was liberated from the compressor, it tumbled around in the cavity at the front of the LPC and impacted the other tierod nuts and ends until they eventually fractured, causing the compressor to separate between the 3rd and 4th stage rotors and the engine to fail. Eleven equally spaced fan exit vanes had the imprints of the tierod nuts on the leading edge, indicating that the 11 remaining tierods fractured simultaneously when the engine failed.

Figure 2. Cross-section of the JT8D fan and LPC and view of an LPC rear tierod

The Safety Board's examination of the LPC rear tierod with the corroded fracture face revealed that a fatigue fracture originated from a small area of galling[6] on the 4th stage compressor disk land. On July 7, 1982, as a result of 33 LPC rear tierod fractures at the 3rd and 4th stage disk land locations that caused damage in JT8D engines, P&W issued Service Bulletin (SB) 5407.[7]

Require that all Pratt & Whitney JT8D-1 through -17AR engines be disassembled at the next shop visit and that the low pressure compressor rear tierods be removed, cleaned, stripped of any antigallant and nickel cadmium (nicad), non-destructively inspected, replated with nicad, coated with the antigallant, and reinstalled or that new tierods coated with the antigallant be installed. (A-99-12)

Require Pratt & Whitney to revise its JT8D engine manual to require that the low pressure compressor rear tierods be inspected with an appropriate non-destructive inspection method. (A-99-13)

Require a repetitive borescope inspection of Pratt & Whitney JT8D-1 through -17AR engines to check for fractured low pressure compressor (LPC) rear tierods and, if found, require the removal of those engines from service for repair. Periodic reinspections should continue until a non-destructive inspection of the LPC rear tierods is performed or the tierods are replaced. (A-99-14)
