# Safety Study - Crashworthiness of Large Poststandard Schoolbuses

(U.S.) National Transportation Safety Board
Washhington, DC

13 Mar 87

| 1. Report No. NTSB/SS-87/01 | 2. Government Accession No. PB87-917002 | 3. Recipient's Catalog No. |

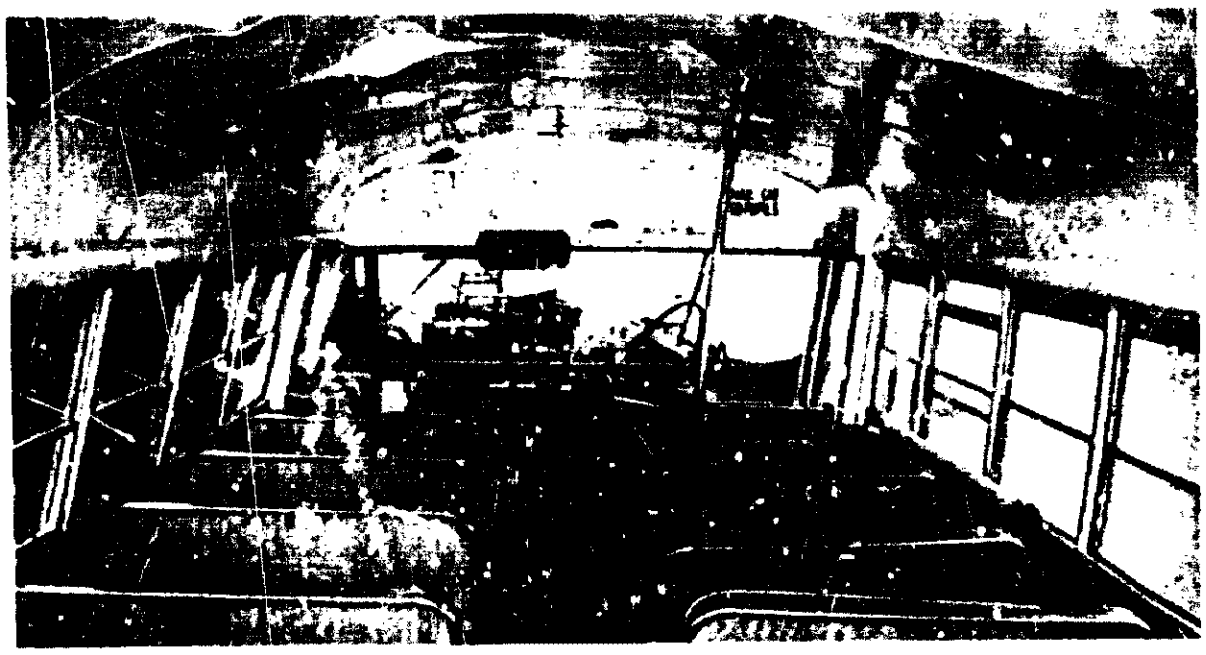
Figure 3.--Comparison of some of the aspects of prestandard versus poststandard schoolbuses.

The seats in schoolbuses manufactured before April 1, 1977, typically were lower backed and padded for comfort, not crash protection, as evidenced by the exposed metal frames.

In poststandard schoolbuses, these problems were corrected. Seats have higher backs, increased padding for crash protection, and are placed closer together. Seat anchorage strength was increased significantly.

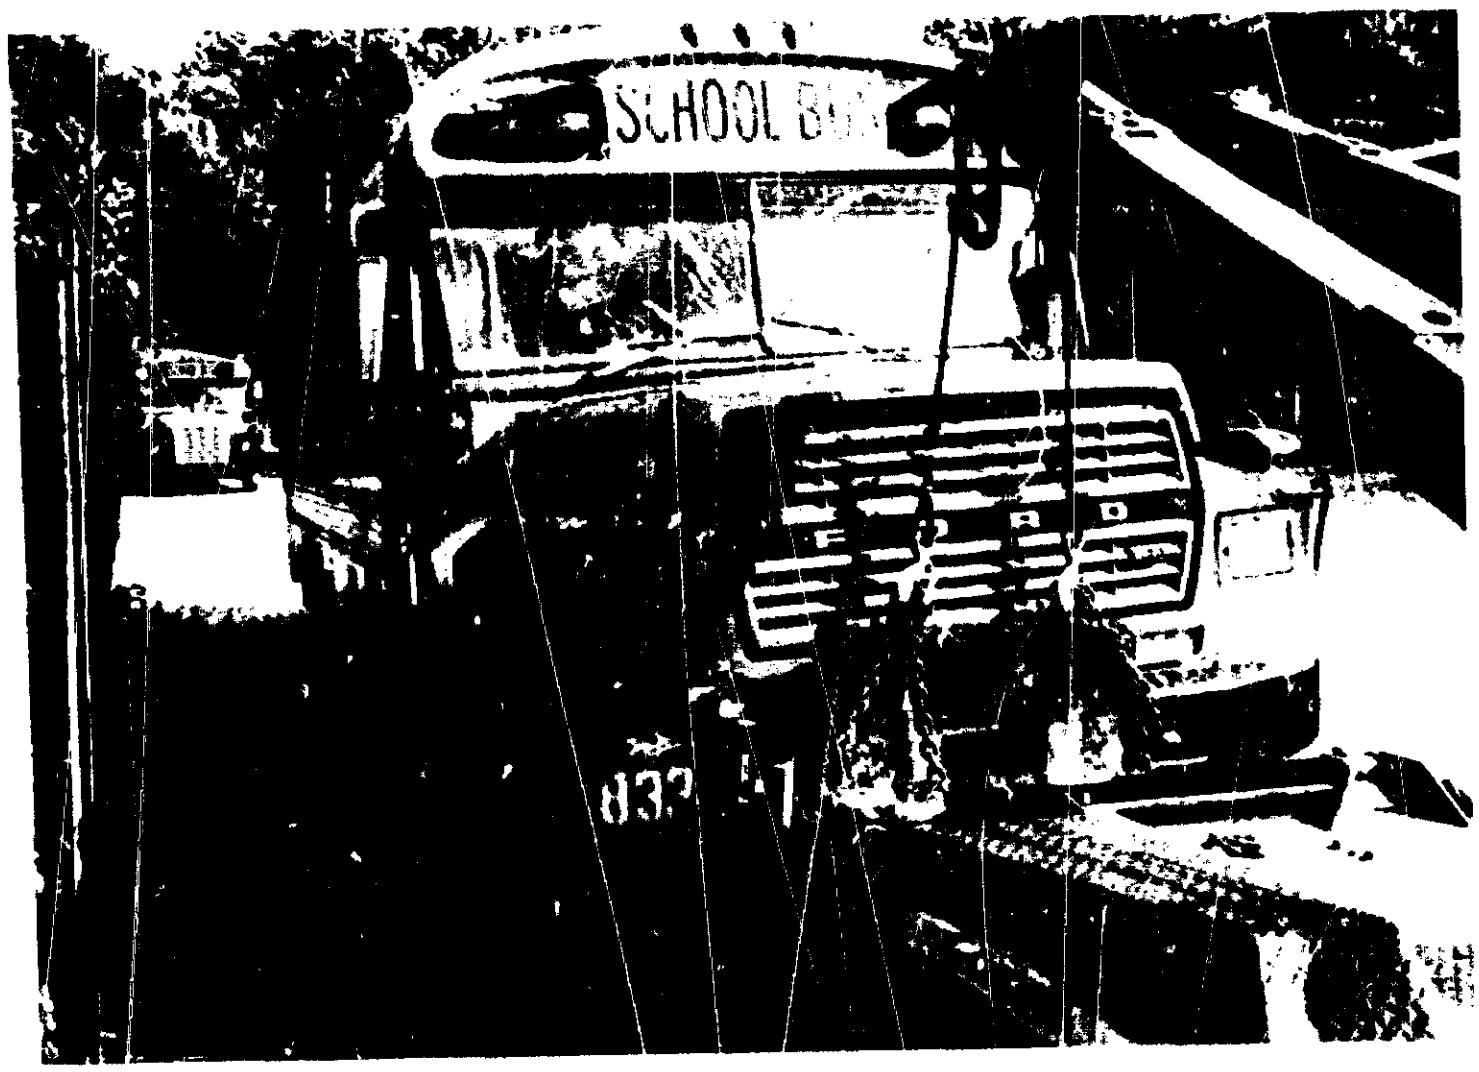
Figure 12.—The schoolbuses involved in noncollision rollovers in the study generally sustained little damage. The bus shown here (case 25) underwent a 270°-rollover down an embankment, in Point Pleasant, West Virginia, but maintained its structural integrity. Damage was minor and confined to the exterior, primarily the right front fender.

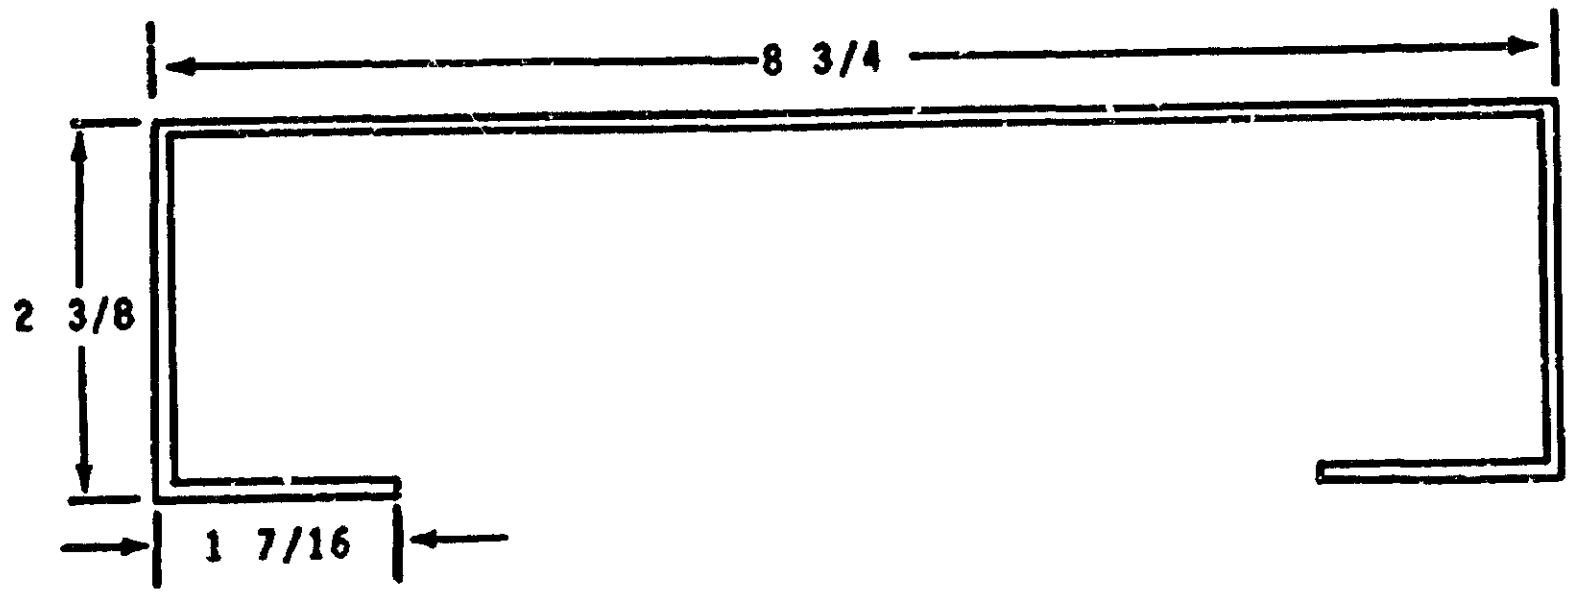
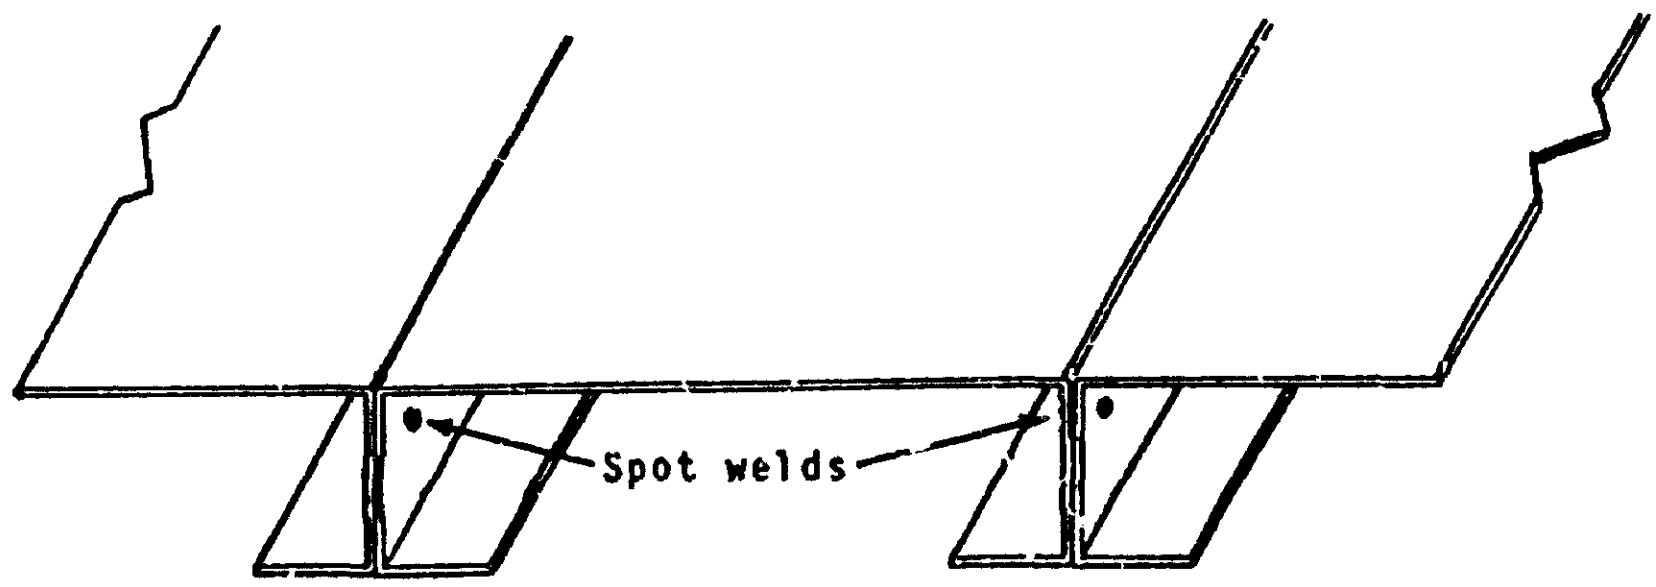
Figure 20.—Schoolbus floor construction in the Snow Hill, North Carolina, accident bus (case 14).

The schoolbus floor consisted of 0.075-inch-thick steel bent into C-shaped channels. The channels were joined together by an exterior steel "cap" around the outside perimeter of the floor, by welds along the flanges at each end, by welds on the underside of the floor structure, and by spot welds near the center of the flanges on each channel. (See figure 20.) The collision separated two of these floor channel sections at the floor joint near the seat legs of the fourth row of bench seats in front of the schoolbus drive axle. The floor separation created a triangular opening across the schoolbus floor which measured about 45 inches wide at the left sidewall. (See figure 21.)

Side view of C-shaped channel section.
Dimensions are in inches.

Side view of three C-shaped channel sections welded together.

> Strengthen the floor panel joints of all newly-manufactured schoolbuses to ensure that they comply with the requirements of Federal Motor Vehicle Safety Standard 221.

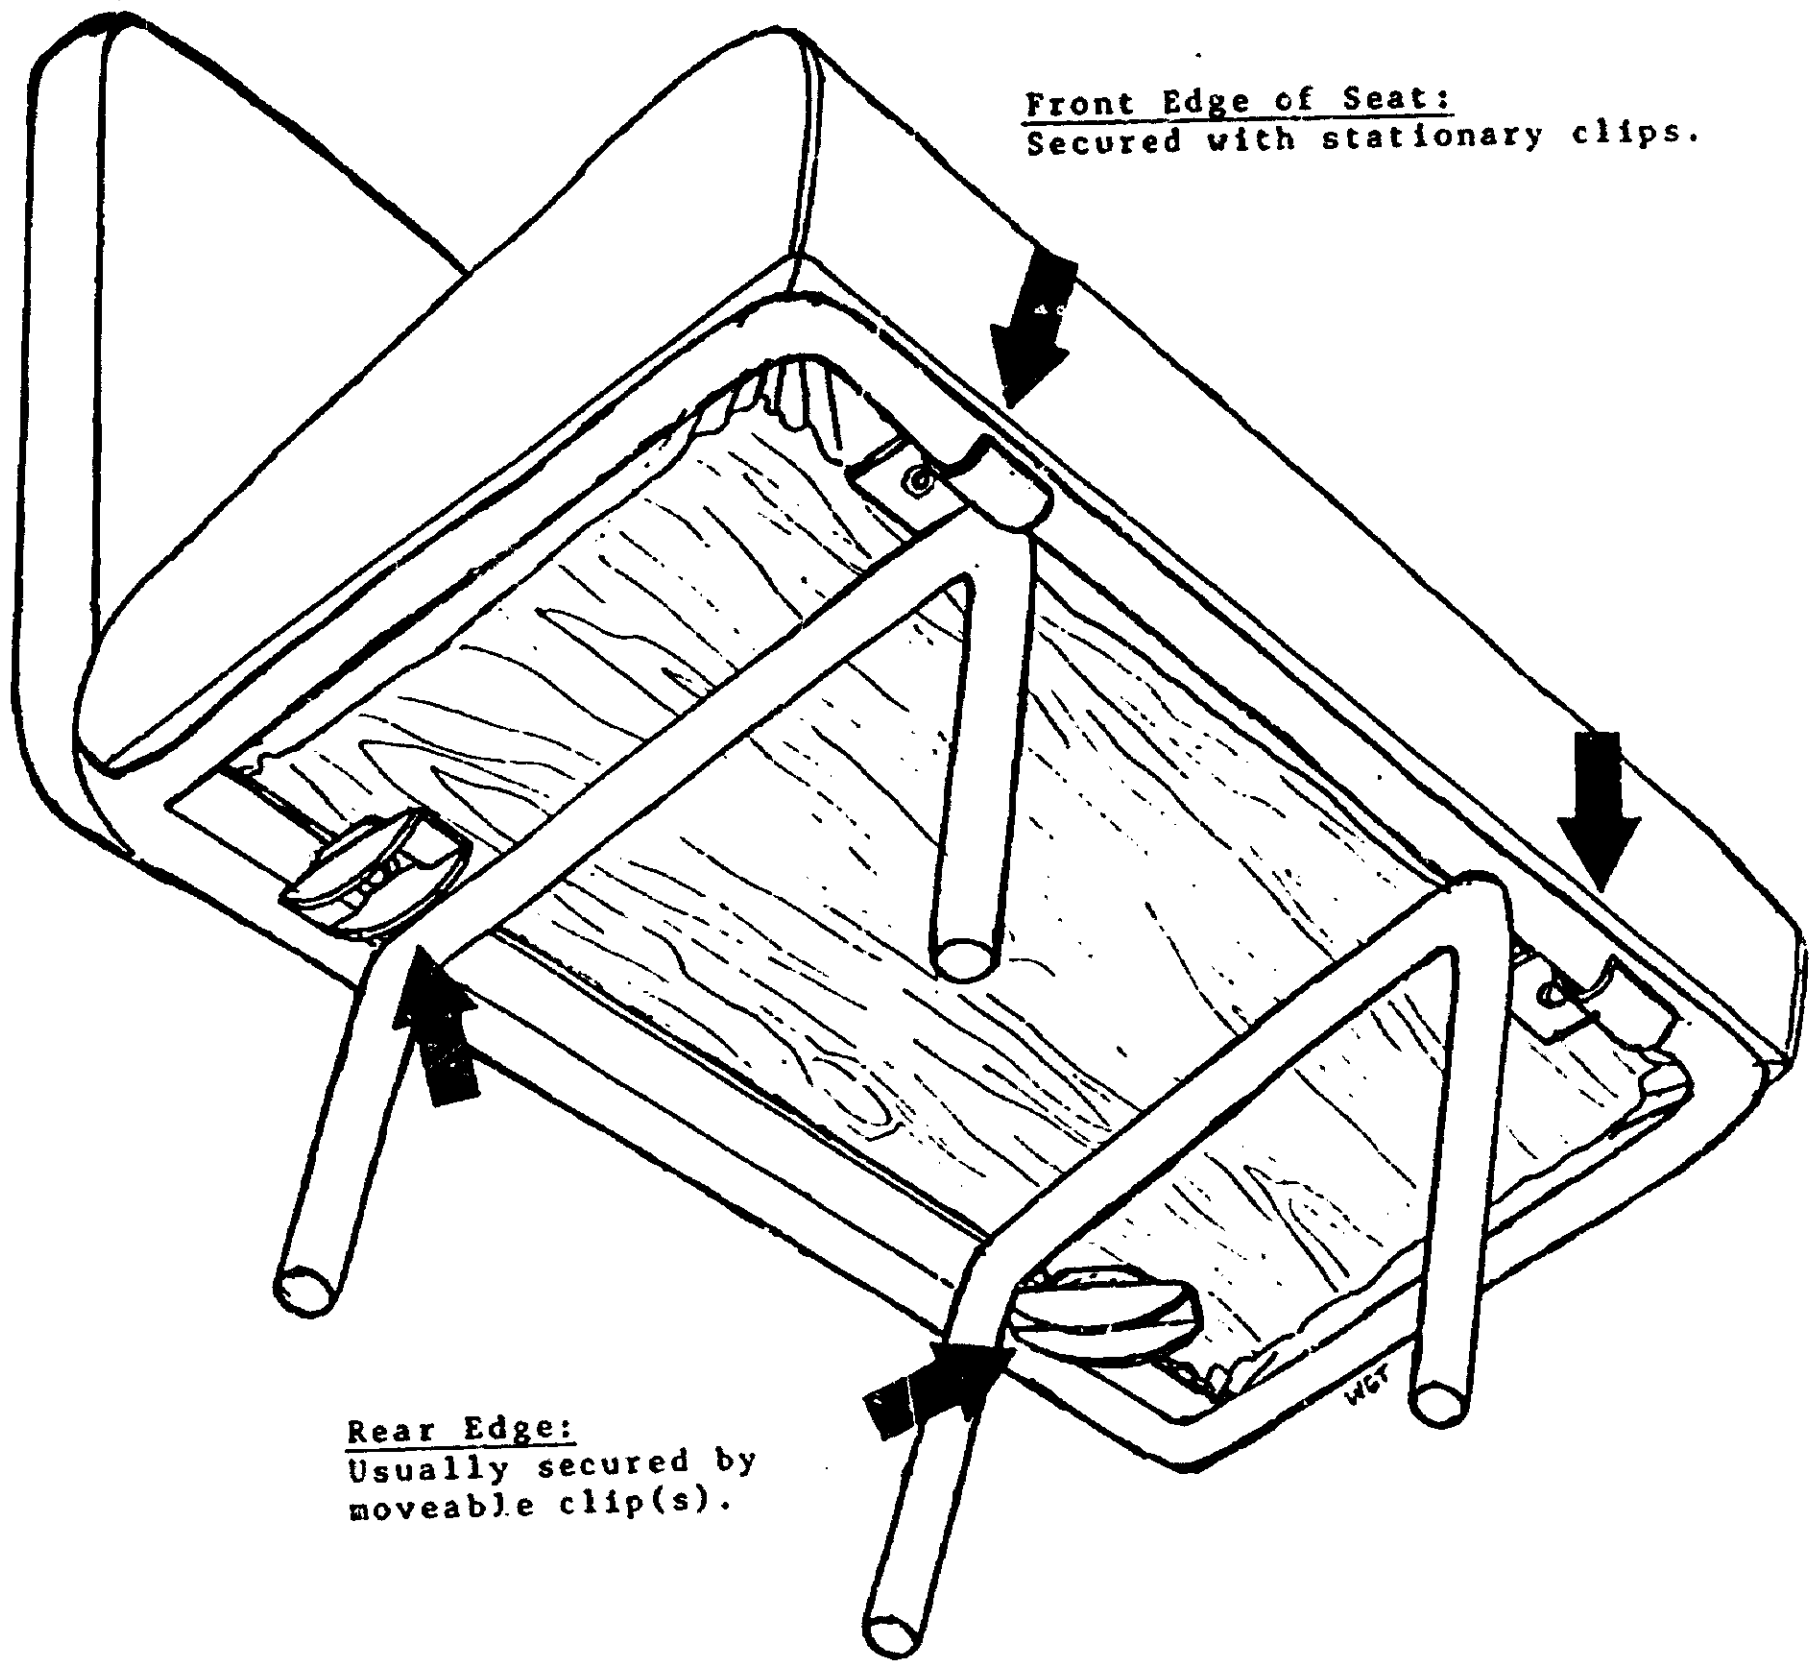
Figure 22.—Bottom cushion as viewed from the floor.

The problem of unsecured seat cushions is confined to the bottom cushion. The top cushions are permanently secured to the seat frame, whereas most of the bottom cushions can be flipped up or removed to facilitate bus cleaning and other types of maintenance. (See figure 22.)

The lack of a fail safe method of fastening bottom seat cushions is potentially dangerous for a variety of reasons. During an accident, particularly during a rollover, loose cushions can become missiles, tumbling about the bus and striking passengers. In addition, students can injure their backs and other parts of their bodies if they fall through the open seat frames or contact the exposed frame. (See figure 23.)

Schoolbus bottom seat cushions are attached to the seat frame by retaining clips on the front and rear of each cushion. The front clips are stationary; the rear clips usually are not. (See figure 22.) To install a seat cushion, the cushion is dropped perpendicular into the frame to engage the fixed front clip, then rotated toward the seat back, and the rear clip is put into place. Safety Board investigators found that attachment problems focused on the rear clips.

Following the accident, the Safety Board found that the bottom seat cushions of all passenger seats on the bus were unsecured but still resting on the seat frame. The system of attaching the seat bottoms on this bus consisted of three metal clips bolted to the plywood bottom of the cushion which were then fastened to the rails of the supporting seat frame. Two clips engaged the front rail, and the third clip rotated to lock the seat bottom in the frame. (See figure 25.) The Safety Board investigator found that all rear clips on the seats had rotated approximately 90° from the locked position. This allows the seat cushion to flip up and possibly become unhinged from the seat. In this crash, the accident dynamics were such that no seat cushion came loose. If the rollover had been more extreme, they could have come free.

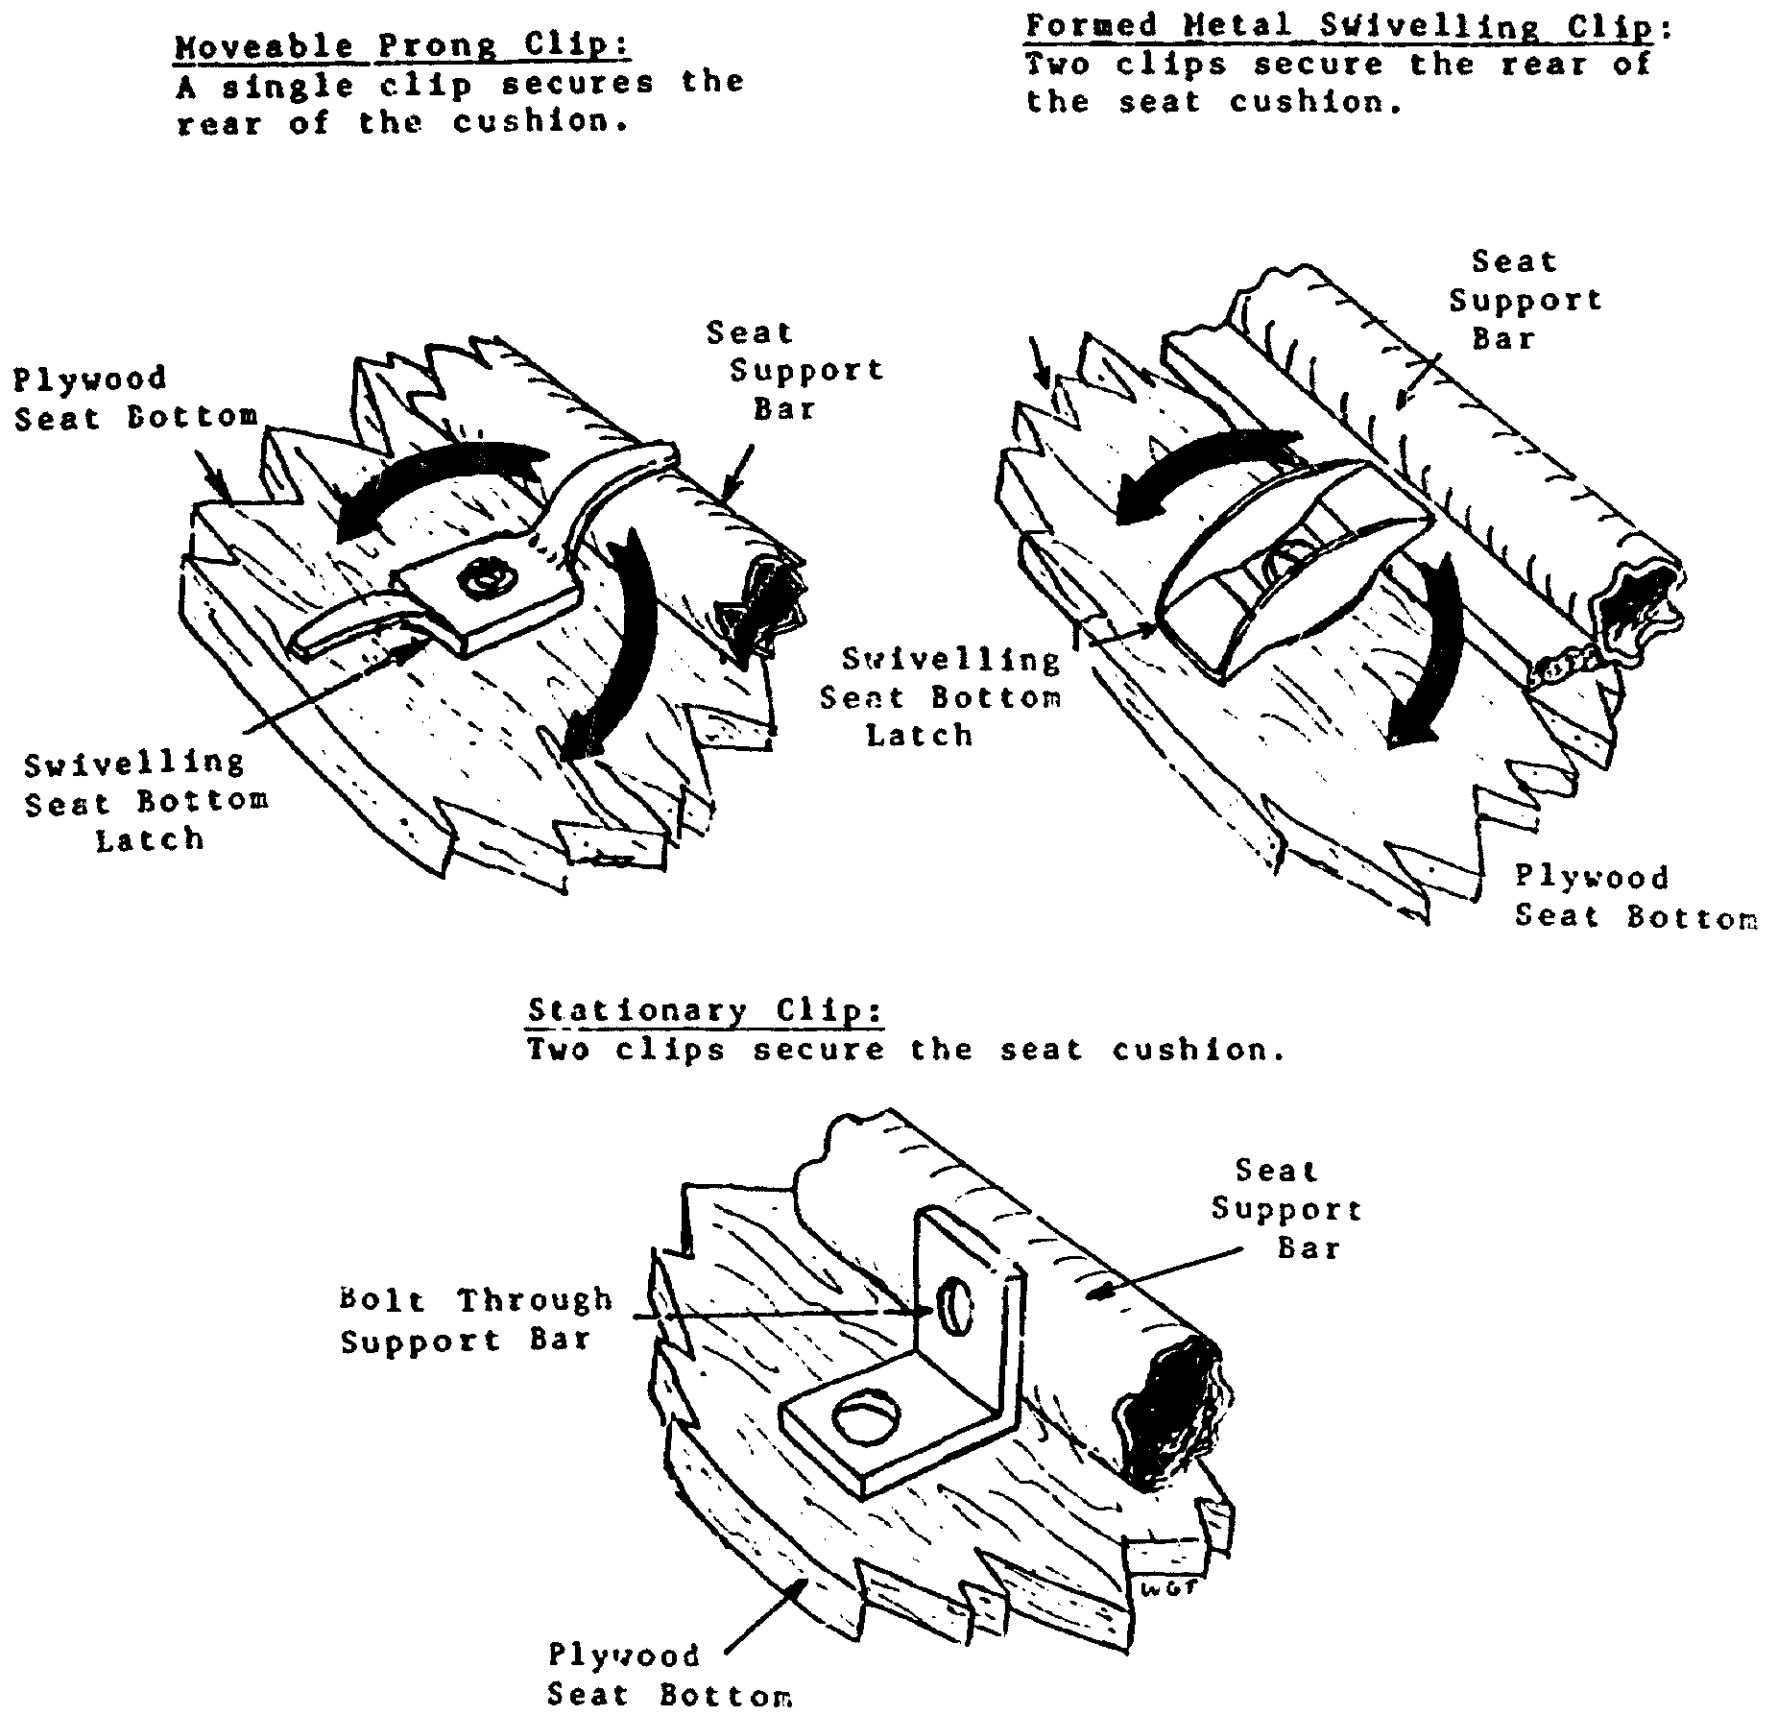
Figure 25.—Types of clips used to secure rear of seat cushion to frame.

Three types of hardware used to secure the rear of the seat cushion to the seat frame were seen in the cases investigated by the Safety Board. (See figure 25.) The first two used rotating clips which could be turned to fasten or unfasten the cushion. The clips differed in design: one used a single, two-pronged piece of thin metal which clipped over the tubular seat frame; the other used a pair of swivel type clips of a more rigid design to attach the bottom cushion to the seat. In some instances, the latter type may have failed to secure the seat cushion because the clips were not secured tightly and they swivelled to the open position. The third type of hardware was a nonswivelling clip bolted to the seat frame.

Consequences of failure to secure the seat cushions in a more extreme rollover accident is illustrated by an accident in Swink, Oklahoma (case 29). This accident involved a 1982 Wayne bus in which all of the seat cushion clips had been left unsecured in order to facilitate sweeping the bus floor. Seven of the seat bottom frame clips could never have been fastened because the stationary front clips had been bent backward.

When this bus made a 360°-revolution, every bottom seat cushion came loose and tumbled around the passenger compartment. Cushions struck three students and inflicted abrasions and lacerations. When the bus came to rest upright, the cushions littered the aisle and obstructed evacuation. Fortunately, no fire followed the crash and all students had time to climb over and around the seat cushions and evacuate the bus.

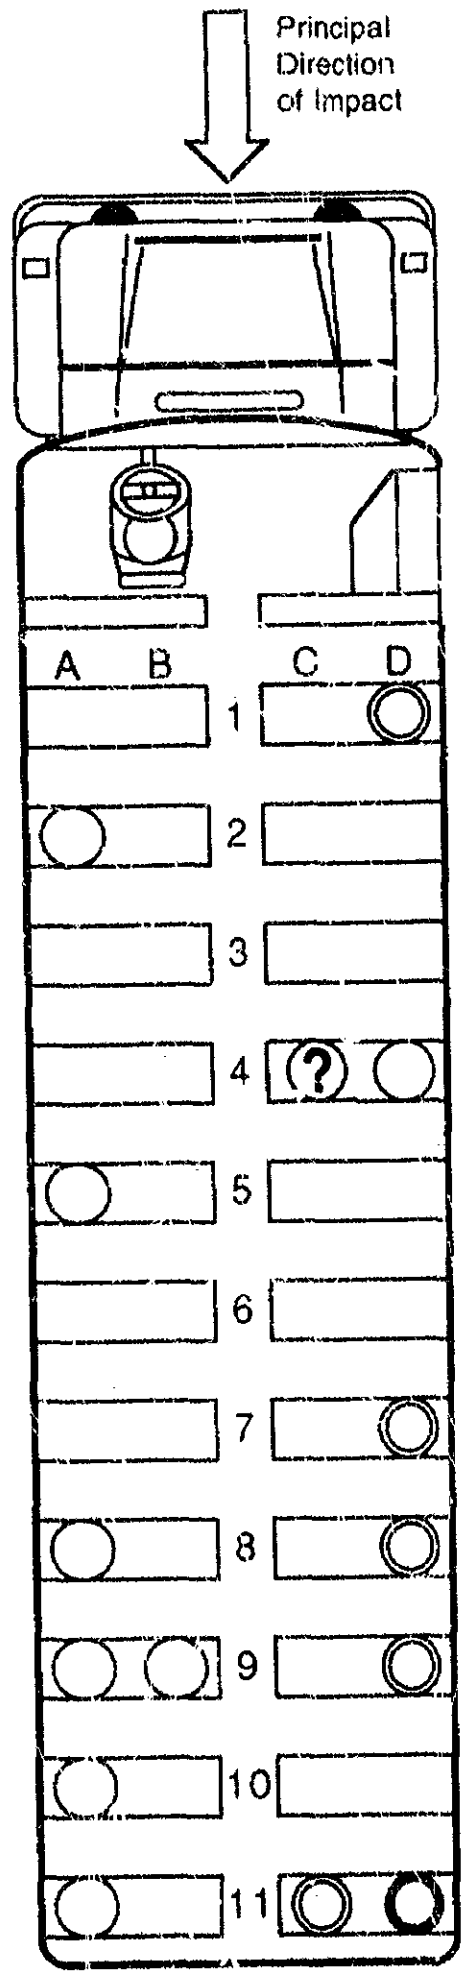
Carmel, New York
Case No. 1

Schoolbus Driver: Restraint use unknown. The driver told the Safety Board investigator she had her lap belt "partially on" before the accident occurred. (Some students also state she was belted.) This could mean that she had her lap belt buckled but not adjusted. The lap belt at the driver's position in this bus must be manually adjusted before the belt is properly "snugged up." The retractors on the belt are used for storage of the belt webbing when the lap belt is not in use; they are not emergency locking retractors. Regardless of whether the driver was originally unbelted or not properly belted, she did not remain in her seat when the schoolbus went off the road to the left. Had she been restrained in her seat, she might have regained control of the bus after the initial run-off, thus preventing the second run-off which precipitated the injuries and fatality.

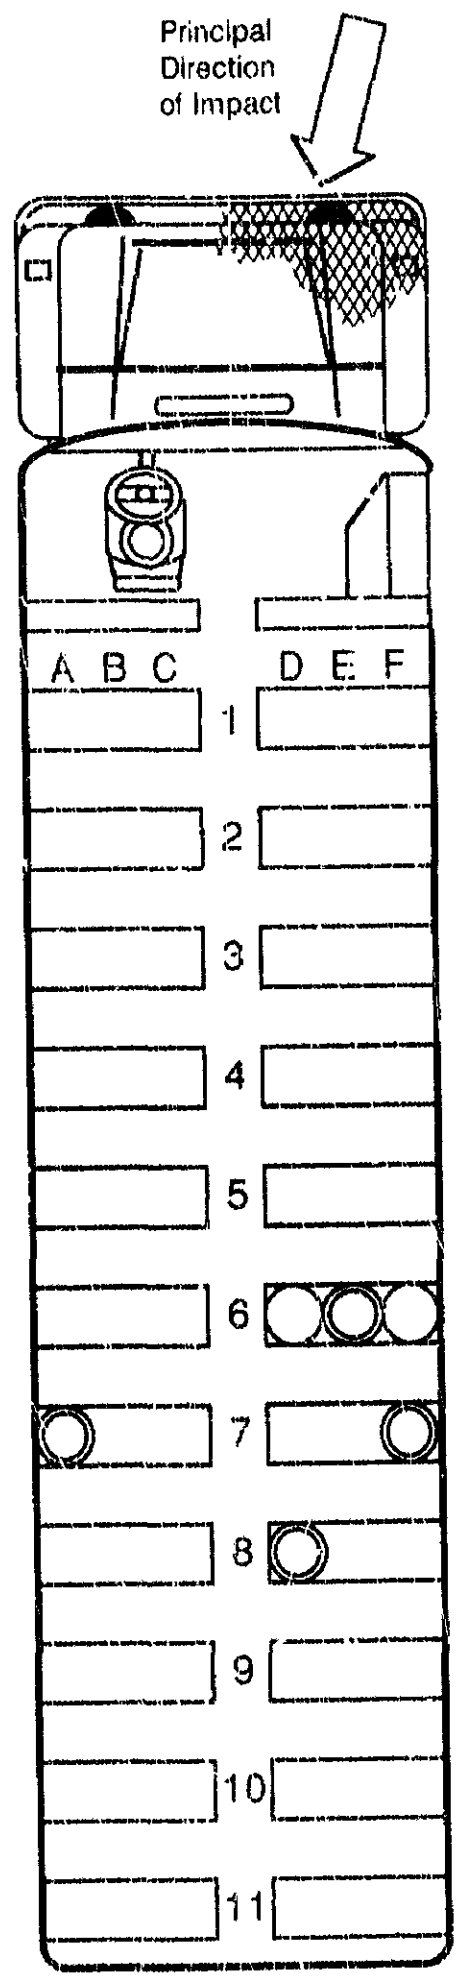
Cornelius, Oregon
Case No. 3

The lap belt system in the accident bus is equipped with a nonlocking retractor on the latchplate side to store belt webbing when the lap belt is not in use. Because it is nonlocking the retractor is there for convenience, not safety, reasons. Unfortunately, drivers may assume the retractor is an automatic or emergency locking retractor, i.e., one which locks so no additional belt can be played out. With the type of retractor installed with this system, the user must pull all webbing out of the retractor and tighten the belt manually before the belt is properly "snugged up." If this is not done, the lap belt will be too loose to provide proper restraint during crash.

**Driver**
F-42, MAIS 3
Dislocated and fractured right shoulder; AIS 1: fractured 7th rib on right side, laceration on right side of forehead, and a contusion on right lower leg.

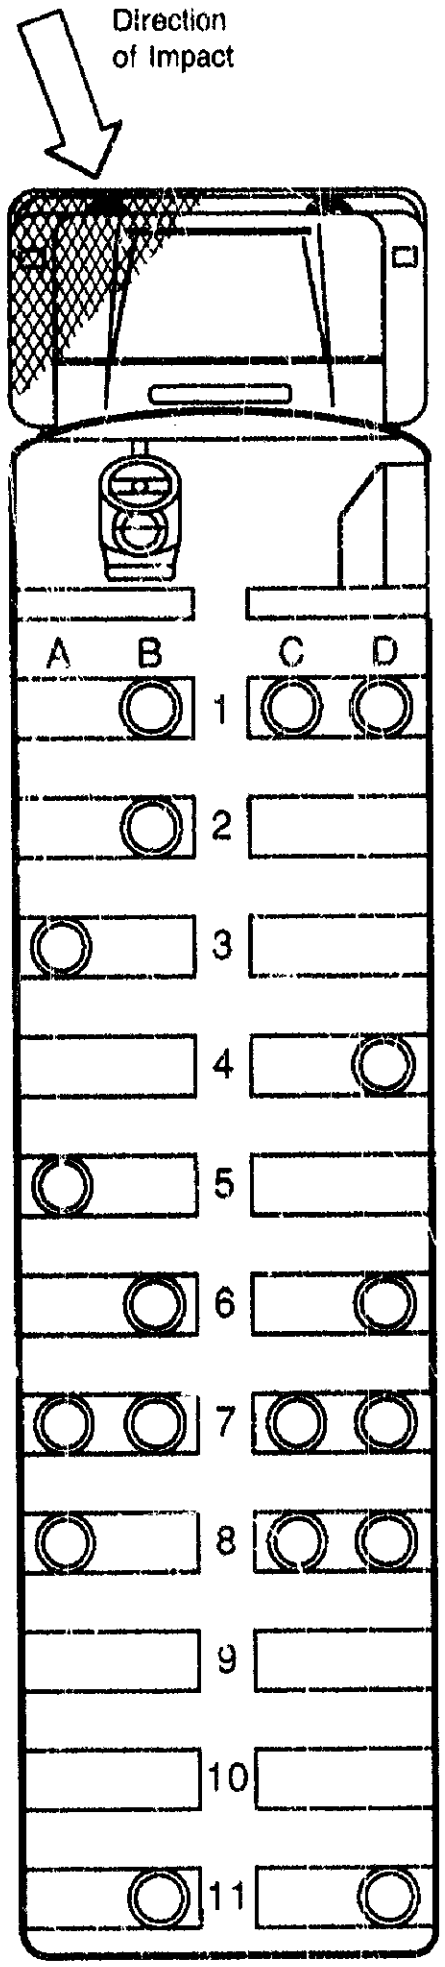
Tecumseh, Oklahoma
Case No. 7

Occupant Restraint Use and Injury : Occupants were unrestrained. Driver and passenger received minor injuries (AIS 1) to the head and upper torso.

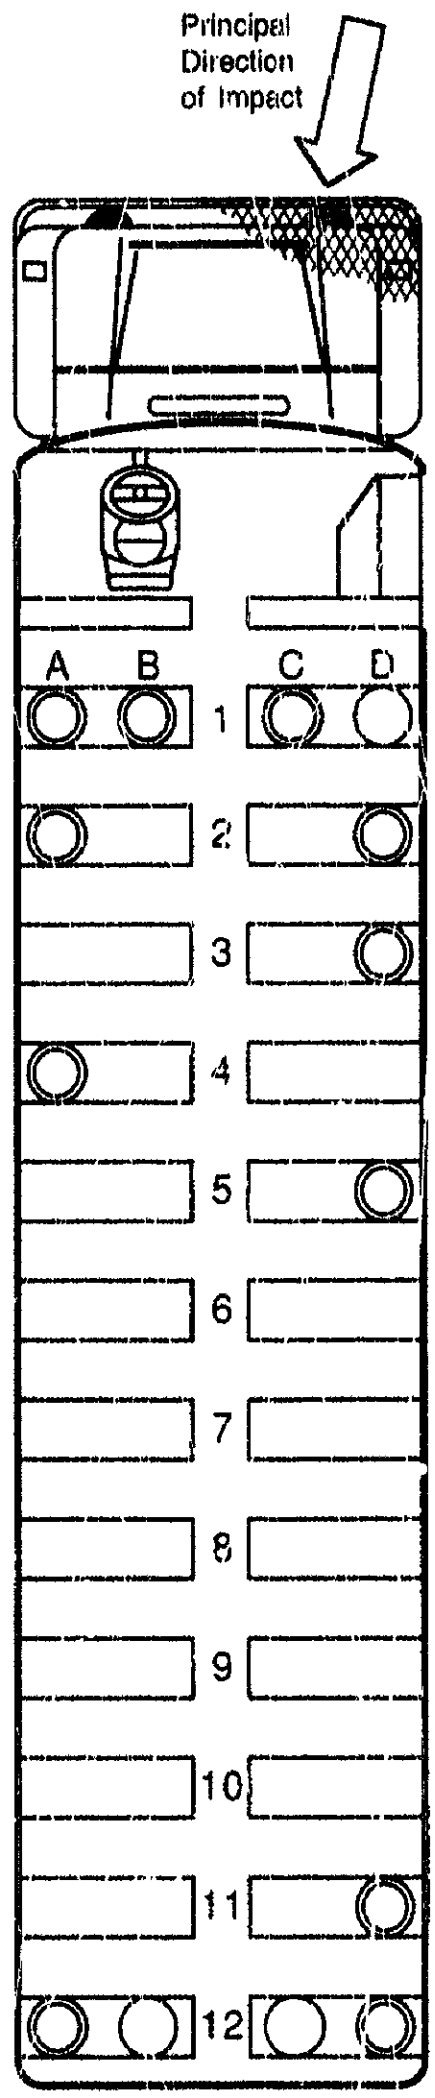
Laconia, New Hampshire
Case No. 9

Twelve of the 24 seats in the accident bus had bottom seat cushions with the rear lock either open or missing; 9 were missing rear lock. The seat cushions on eight seats came loose during this accident. It should be noted, however, no passenger was injured by loose seat cushions in this frontal impact accident.

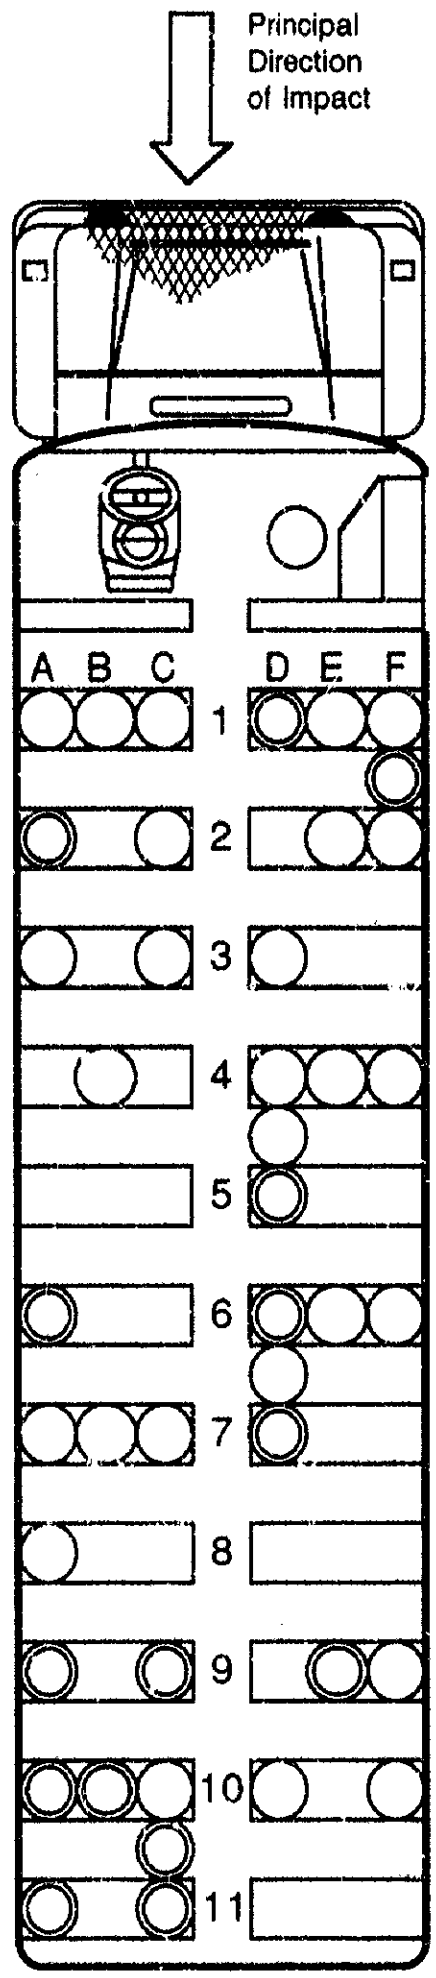
Frankston, Texas
Case No. 10

This schoolbus had been retrofitted with two rows (9 and 10) of prestandard passenger seats. Although the back cushion of the row 9 seat was deformed forward approximately 30° it does not appear that these prestandard seats contributed to the type or severity of occupant injury in this collision.

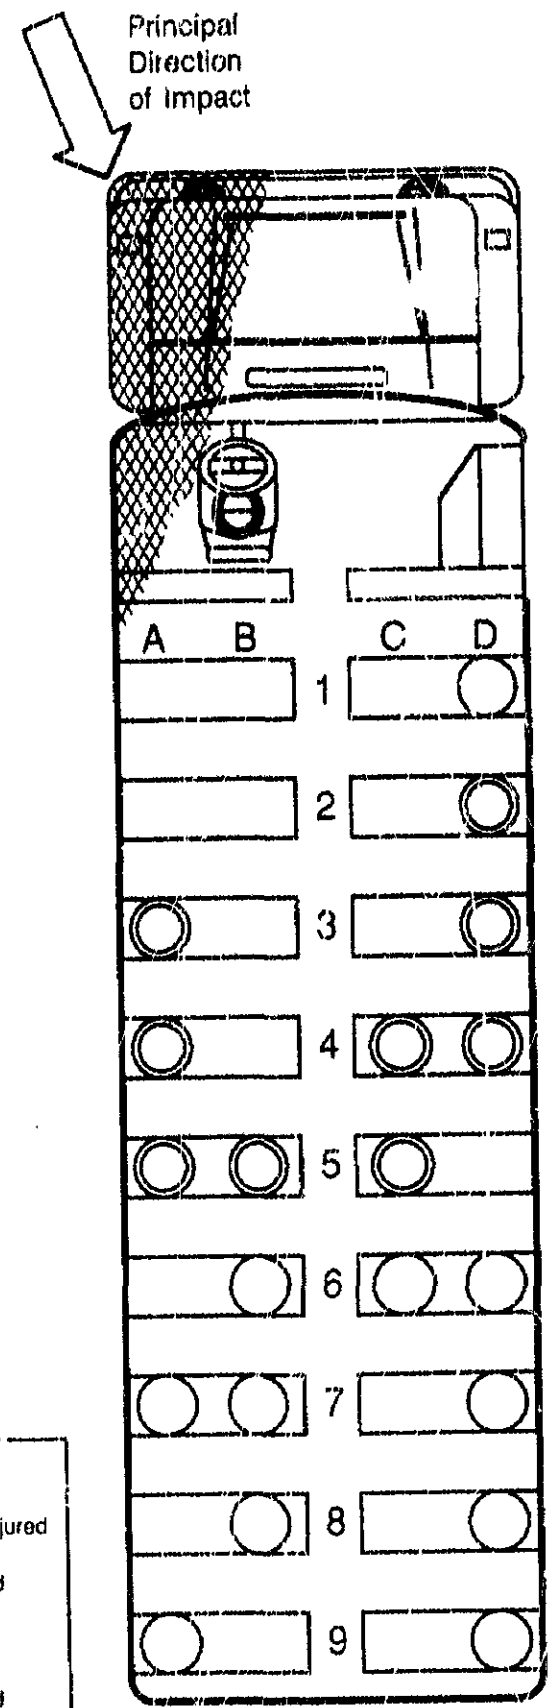
Palmyra, Nebraska
Case No. 11

The ceiling seam had an exposed sharp edge with potential for injury.

**Driver**
M-65, MAIS 5 (Fatal)
Chest and heart injuries

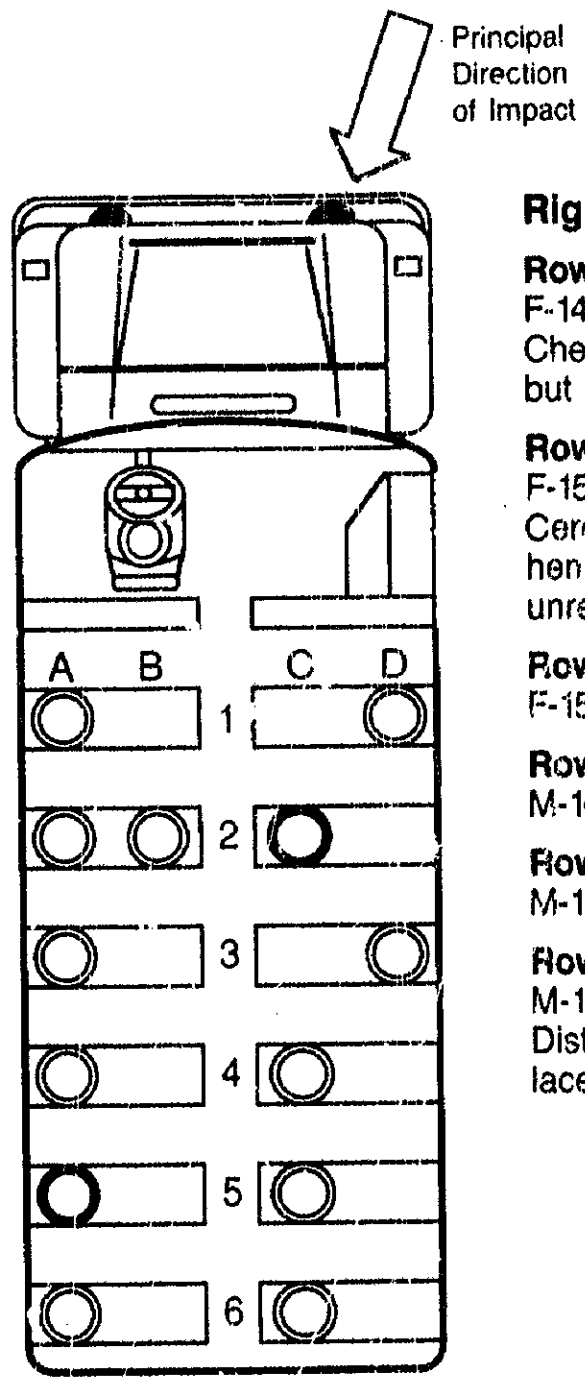
St. Louis, Missouri
Case No. 13

Schoolbus Driver: Available lap belt used.
Description of Injuries--Serious (AIS 3) injuries: cerebral concussion, fractured right ulna and laceration of the forehead and right eye. The driver was seated outside the area of direct crush. The bus body surrounding his seat was severely damaged but the seat itself was untouched.

**Driver**
M-26, MAIS 3
Cerebral concussion, fractured right ulna, laceration of forehead and right eye.

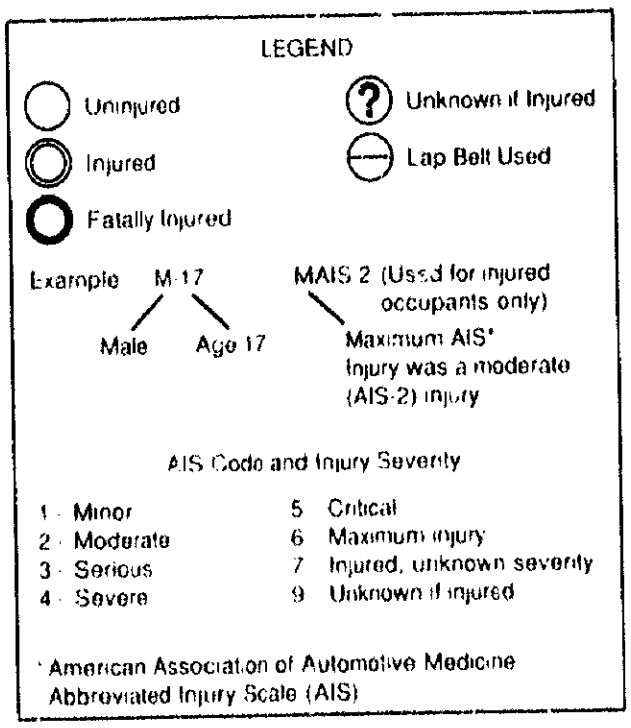
**Special Notes:**
The passenger in Row 4D sustained abrasions and contusions from contact with a musical instrument sitting on the seat and from a fall to the floor.

The bus was first struck by the truck tractor and then by its jack-knifing trailer.

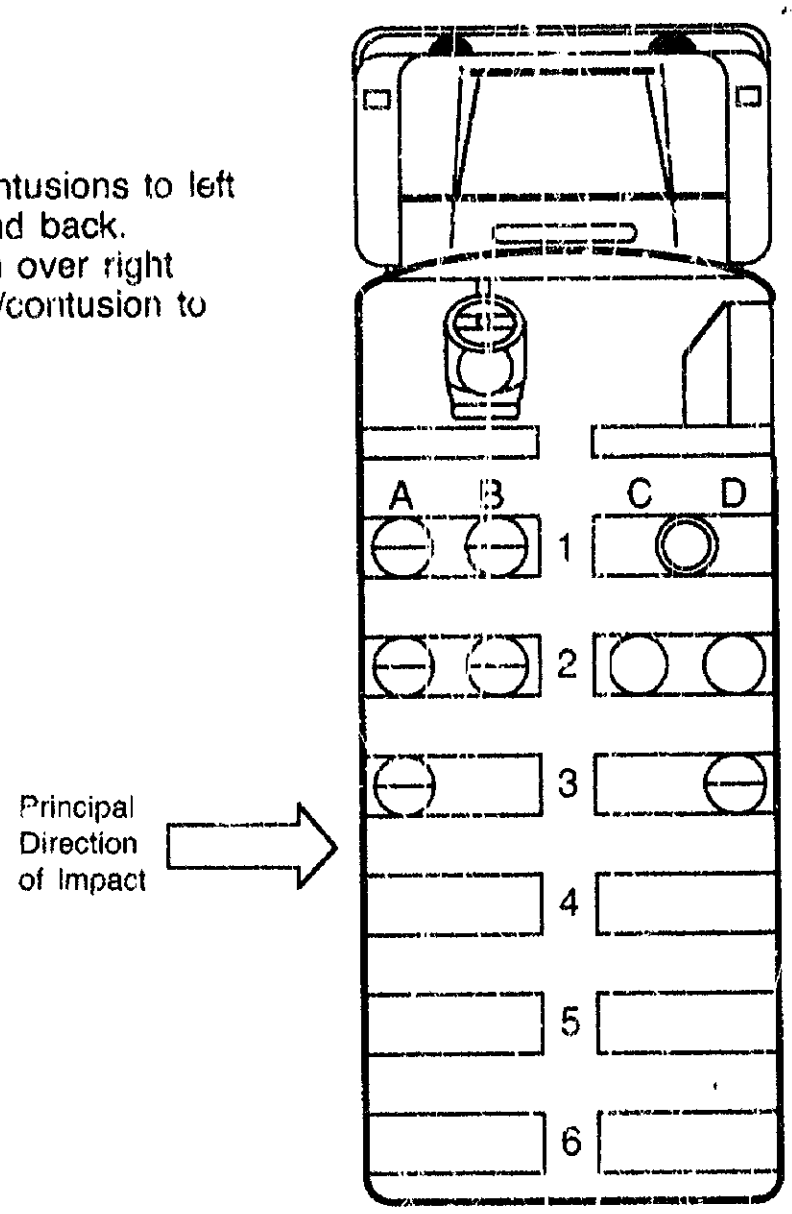
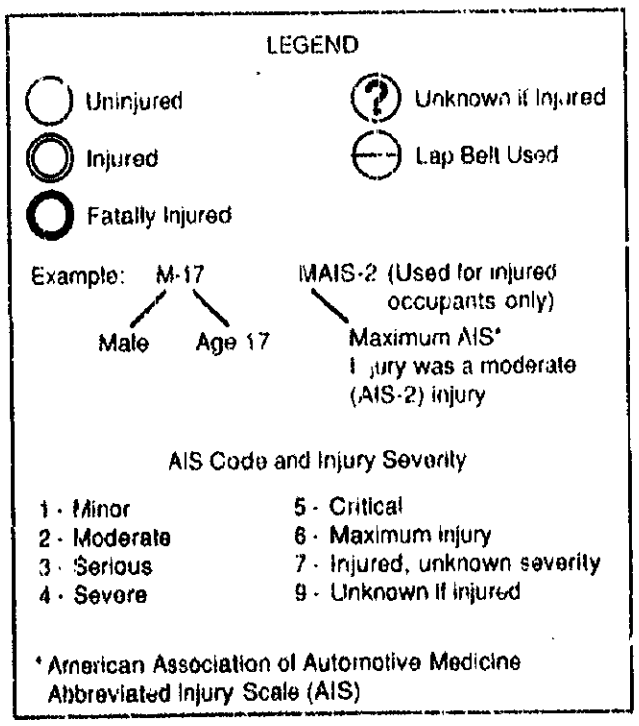
**Driver**
F-26, MAIS 2
Mild concussion, contusions to left forearm, right leg and back. Laceration/contusion over right eyebrow. Laceration/contusion to left temple.

**Row 1C-D**
F-25, MAIS 1

**Special Note:**
It is uncertain whether the passengers in Row 2C and D were restrained. (In report text tables, however, these passengers are included among the restrained.)

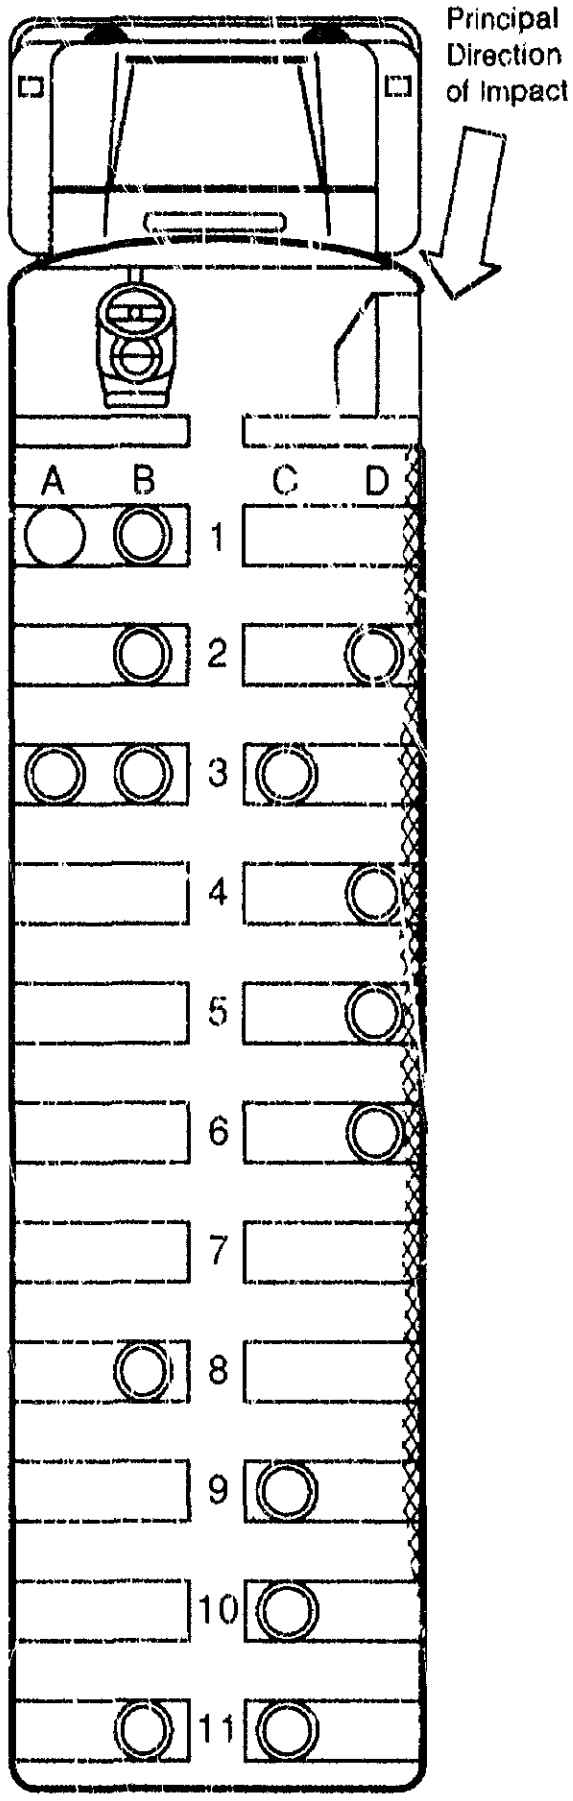
**Row 11B**
M-17, MAIS 2
Compression fracture of the thoracic spine. laceration left check, contusion left forearm, abrasion right knee; injuries sustained from seatback and left sidewall and windows.

**Row 2D**
M-8, MAIS 2
Fractured right clavicle.
