# Safety Study - Crashworthiness of Large Poststandard Schoolbuses

(U.S.) National Transportation Safety Board
Washhington, DC

13 Mar 87

| 1. Report No. NTSB/SS-87/01 | 2. Government Accession No. PB87-917002 | 3. Recipient's Catalog No. |

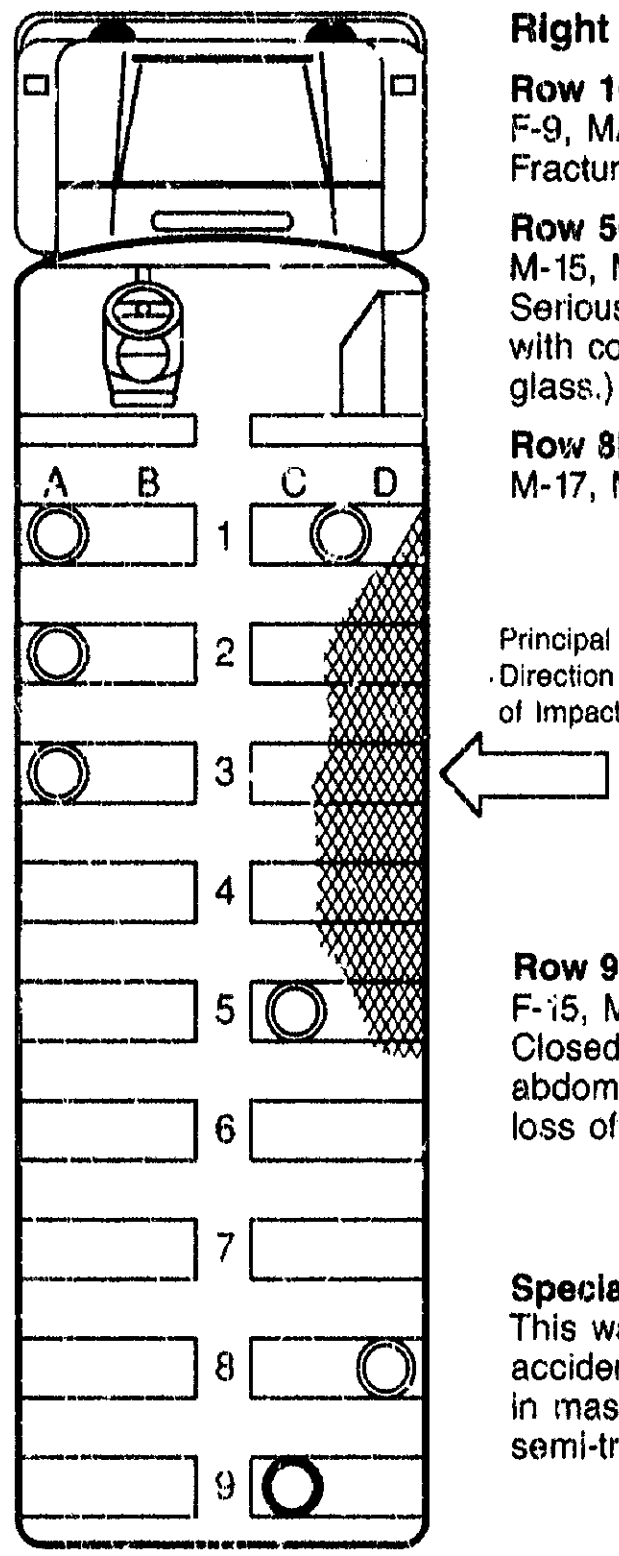
**Row 2A**
M-9, MAIS 2
Concussion

**Row 1C-D**
F-9, MAIS 2
Fractured left clavicle.

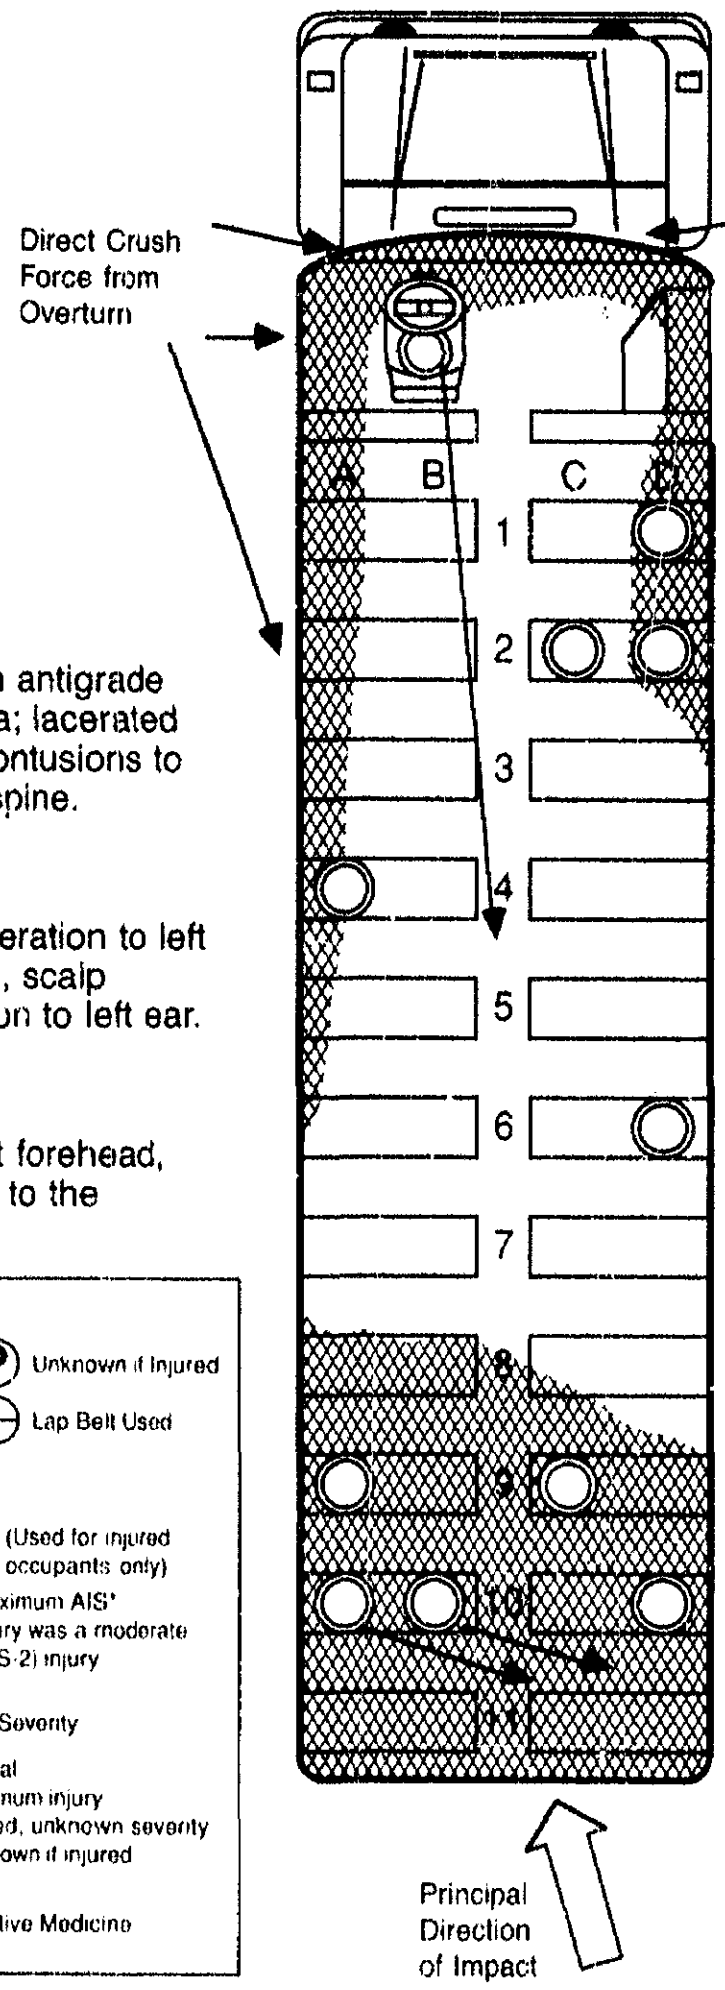
**Row 9A**
M-14, MAIS 3
Cerebral contusion with antigrade and retrograde amnesia; lacerated scalp; abrasions and contusions to left shoulder; strained spine.

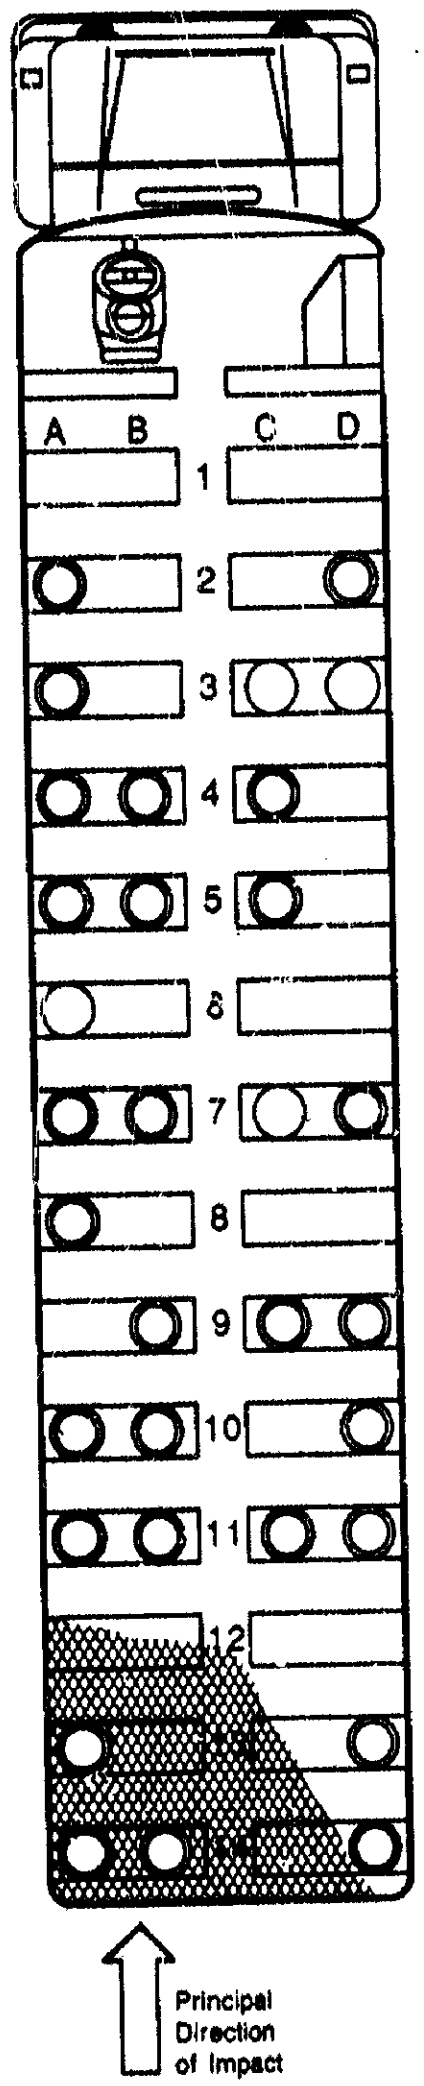
**Row 14B**
M-17, MAIS 3
Bilateral femoral fractures, scalp and facial lacerations, left 2nd, 3rd, and 4th metatarsals fracture.

**Row 2D**
F-21, MAIS 2
Distal clavicle fracture.
