PB91-917002
NTSB/SS-91/01

SAFETY STUDY

TRANSPORT OF HAZARDOUS MATERIALS BY RAIL

ADOPTED: MAY 16, 1991
NOTATION: 5488

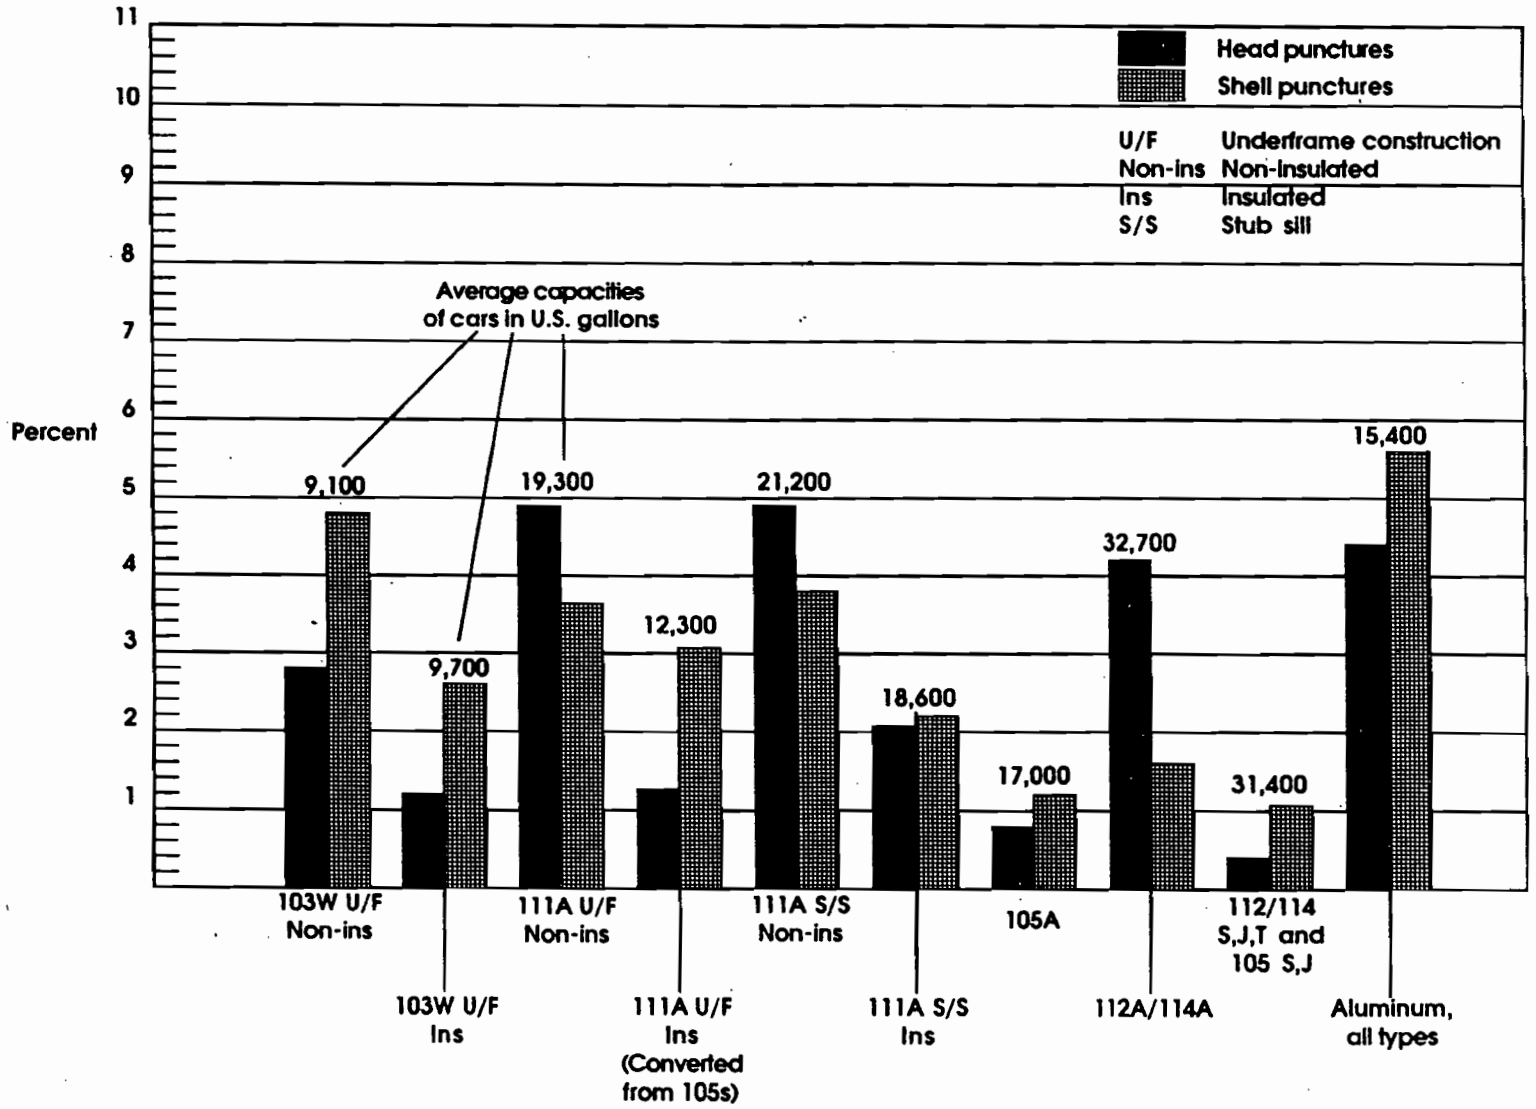
The RPI and AAR, in their 1990 study that analyzed the performance of the DOT-111A tank cars and other tank cars (RPI and AAR 1990a), reported a greater incidence of head and shell punctures in DOT-111A (insulated and non-insulated), DOT-112A/114A, and aluminum tank cars (fig. 1)--none of which have the improved tank head resistance protection and/or thermal protection as required for the DOT-112S, J, and T tank cars, the DOT-114S, J, and T tank cars, and for the DOT-105S, J, and T tank cars (see footnote 5). The incidence of head and shell punctures in tank cars damaged in accidents to the total number of tank cars damaged in accidents during a 22-year period (1965-86) is also shown in figure 1.

Figure 1.--Incidence of head and shell punctures to total number of tank cars damaged in accidents, 1965-86. (Source: Railway Progress Institute and Association of American Railroads 1990a.)
