Honeywell

September 25, 2008

Re: NTSB ID: DEN08MA116F, N407MJ & N407GA, Bell 407's
Equipment examination at Honeywell

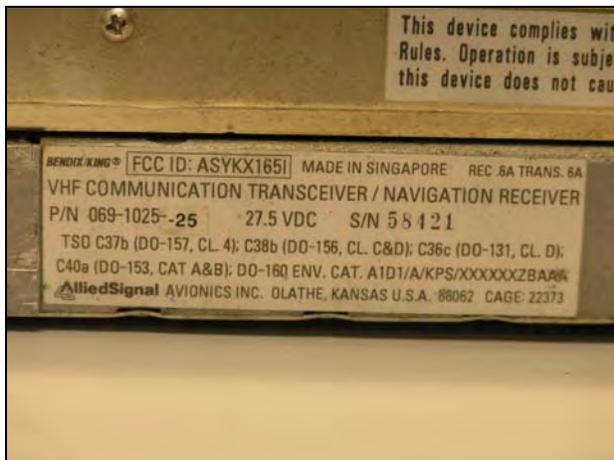
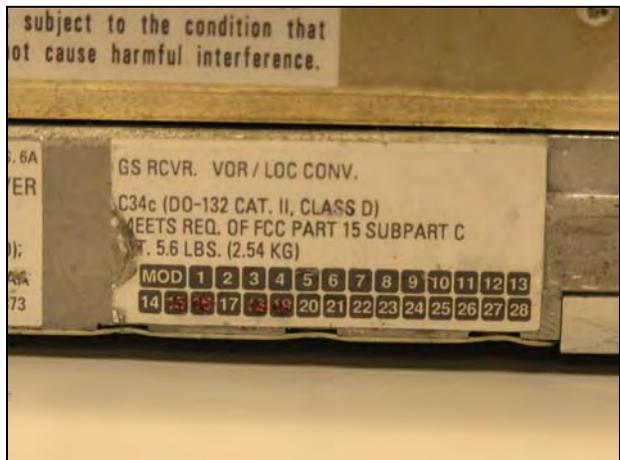
KX 165, S/N 58421 dataplate

The bezel and display assembly were severely damaged which precluded powering the unit. The micro-processor containing the non-volatile memory was removed from the accident unit and installed into a host unit. The following frequencies were displayed when the host unit was powered:

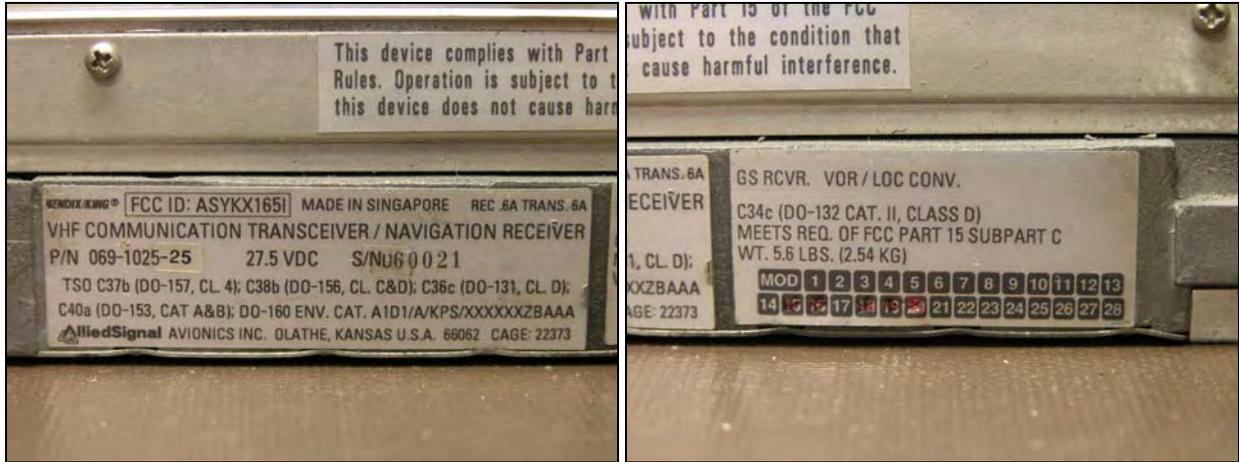
KX 165, S/N 60021 dataplate

3. **KX 165 navcom, P/N 069-1025-25, S/N 60021, Mods 15, 16, 18, 19, 20 (N407GA -- top navcom in stack)**
Unit bezel/knobs were fire damaged and the display was broken; minor impact damage present on unit chassis. The frequency flip-flop buttons were cut off and the volume switch knobs were removed to facilitate bezel removal. The bezel and damaged display were removed. A new display was installed. After unit power was applied, the following frequencies were displayed:
