PARTY SUBMISSION OF NASCAR, INC.  
To the National Transportation Safety Board

Regarding the Accident Involving  
Cessna 310R, N501N

Sanford, Florida

NTSB# NYC07MA162

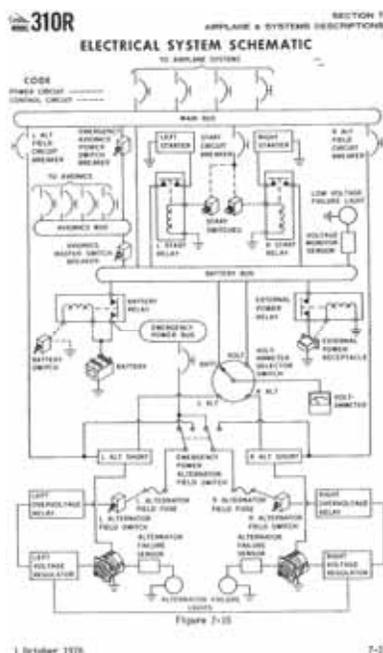
**Figure 2.**  
Electrical schematic  
diagram from  
Manufacturer's POH

The aircraft avionics, including the aircraft's nav/com radios, receive electrical power through an avionics buss routed through the "main buss" shown at the top of Figure 2. An electrical plug, with burned and beaded electrical wiring, found in the post crash investigation was determined by the manufacturer to be of a type which would have been installed as part of the original wiring from the avionics buss to the nav/com radios.

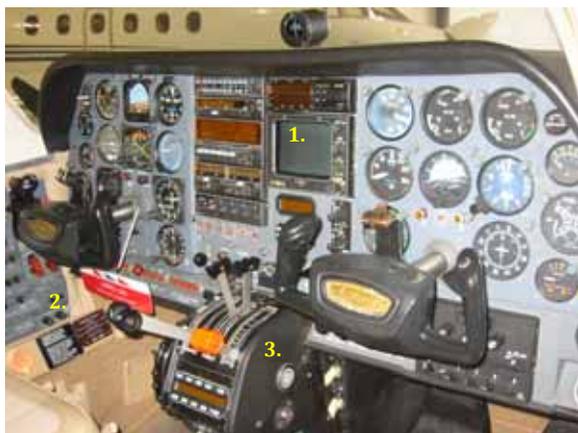
**Figure 4.**

1. Radar Display Unit
2. Circuit Breaker Panel
3. Throttle quadrant

The throttle quadrant (see Figures 4. and 5.) contains the levers for the pilots to operate the aircraft engines, containing controls for the throttles, the fuel mixture, and the propeller pitch for each of those engines. The pilot logging the discrepancy physically placed the discrepancy notice on top of these levers, and it would have been impossible for the pilots on the accident flight to have started the aircraft or, indeed, to have flown it at all, unless they physically moved this discrepancy note. (See Figure 6. below)

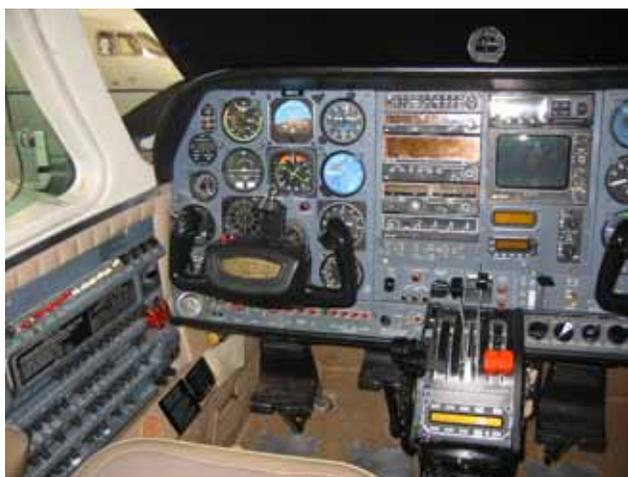
**Figure 5.**

<sup>10</sup> See Section II.A. above. The circuit breaker pulled to deactivate the radar was in the bottom row of the circuit breaker panel shown in Figures 2., 3. and 4.

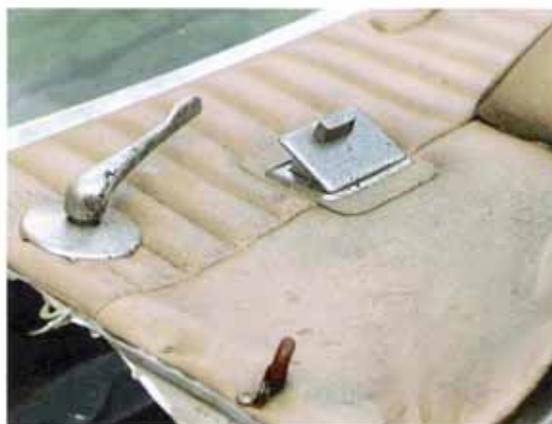
**Figure 15.**  
Deposits on cabin door

sooting. The panel does contain soot deposits, but these are primarily on the left of the glareshield panel, and are consistent with burning other than from the radar display unit. It is consistent with burning near where the engine instruments are installed.<sup>19</sup> The cabin door, which would have been located at the right-hand (co-pilot's) seat, was also undamaged by fire. See Figure 14 below. Investigators noted black clumped residue at the midpoint of the door and below, indicating deposits from the cabin electrical fire. (Figure 15.) Although these deposits have not yet been analyzed by the Board, they visually appear to be a similar material to the sooting deposits on the glareshield panel shown in Figures 10., 11. and 12. No such deposits were found near the radar display either on the metal glareshield panel or on the vinyl glareshield eyebrow.
