**ATTACHMENT 18 – Mn/DOT MEMORANDUMS DOCUMENTING CRACKS IN
THE NORTH APPROACH SPAN GIRDER NEAR PIER 9 FROM OCTOBER 1998
THROUGH NOVEMBER 2000**

Subject: Bridge No. 9340
Cracks in North Approach Span Girder Near Pier 9

Subject: BR 9340 - Cracks in Approach Span Girders, North End of Bridge Near Pier 9

Re: Bridge No. 9340 - Load Test Results

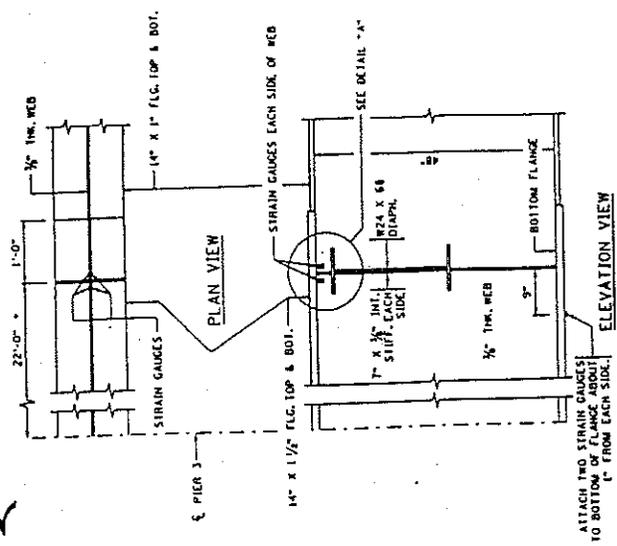
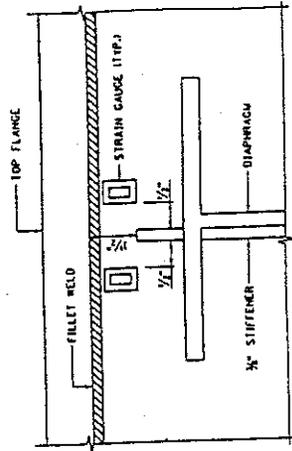
DETAIL OF 4" PLACEMENT OF STRAIN GAUGES

ATTACH TWO STRAIN GAUGES TO BOTTOM OF FLANGE ABOUT 1" FROM EACH SIDE.

ATTACH STRAIN GAUGES TO WEB AND BOTTOM FLANGE IN POSITIONS SHOWN. STRAIN GAUGES ON WEB SHOULD BE AS CLOSE AS POSSIBLE TO THE TOP OF THE FILLET WELD. DO NOT PLACE ON WELD FILLETS.

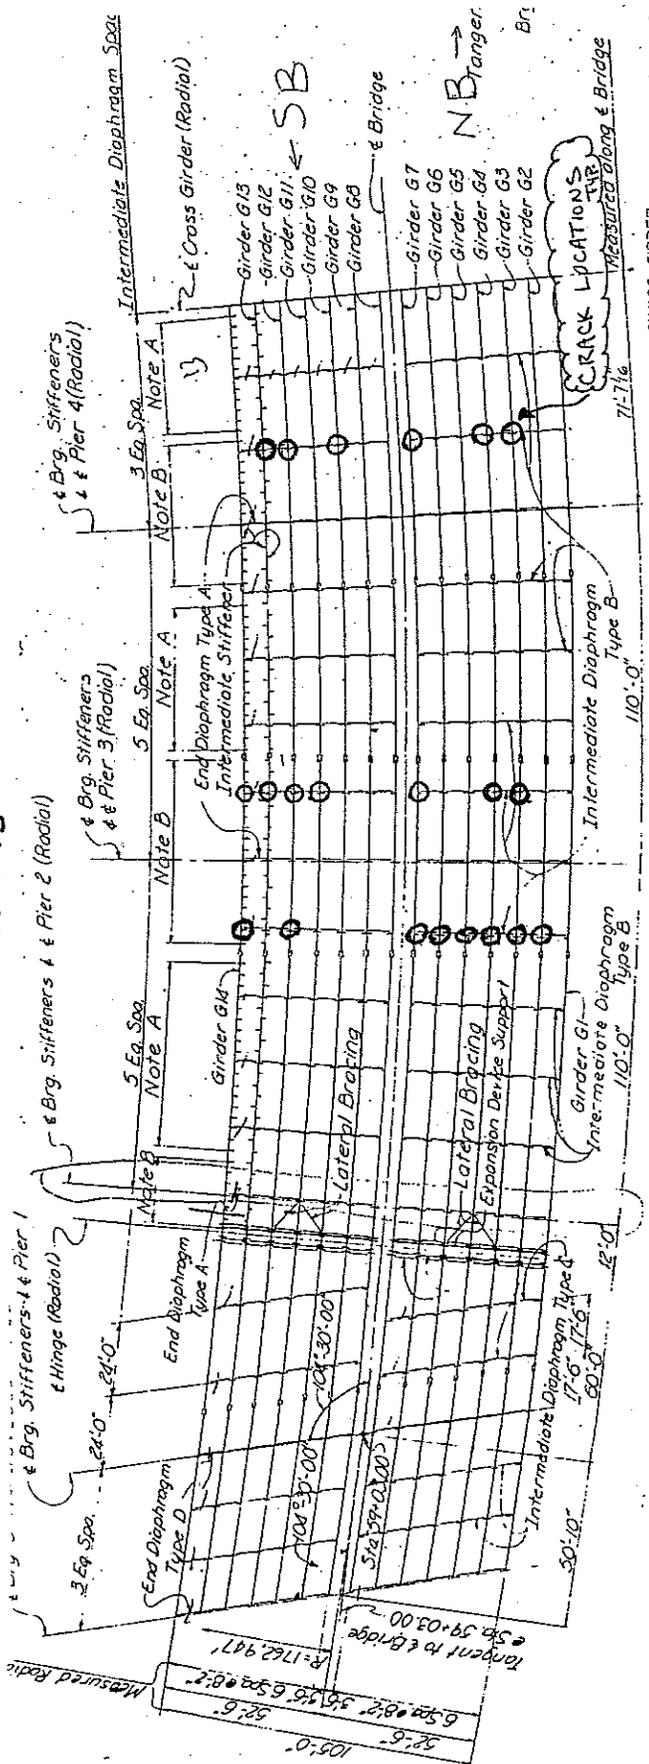
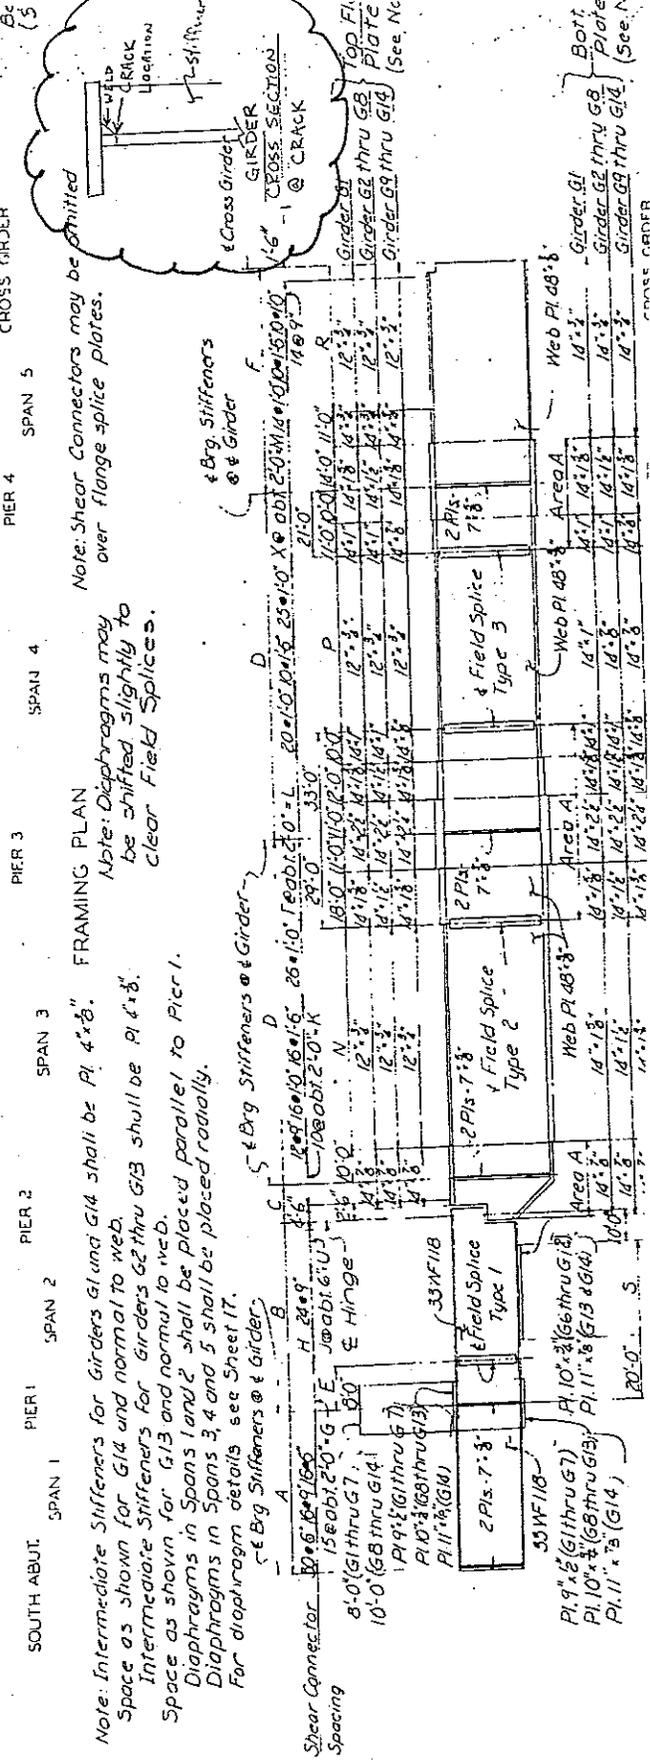
South End of Bridge

21 Crack Locations
