**ATTACHMENT 16 – URS CORPORATION FATIGUE EVALUATION BRIDGE
9340 35W OVER MISSISSIPPI RIVER INITIAL INSPECTION REPORT DATED
JUNE 9, 2003
(100 pages)**

**Fatigue Evaluation
Bridge 9340
35W Over Mississippi River**

Mn/DOT

June 9th - June 13, 2003

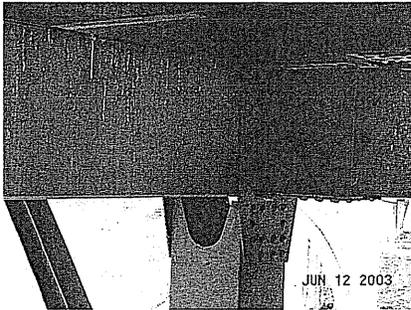
<u>PHOTO</u>	<u>LOCATION</u>	<u>DESCRIPTION</u>
8-26	Pier U20	West face Looking northeast
8-27	U19 connection	West face Looking southeast Good connection
8-28	U19 connection	East face Looking southwest Good condition
8-29	U19 to U20 inside box 8' ± to U19	Looking south
8-30	U19 to U20 inside box 8' ± to U19	Looking north
8-31	U18 to connection	East face Looking southwest Good condition
8-32	U19	East face Looking northwest
9-1	U19	West face Looking northeast Good condition
9-2	U18	West face Looking south Good condition

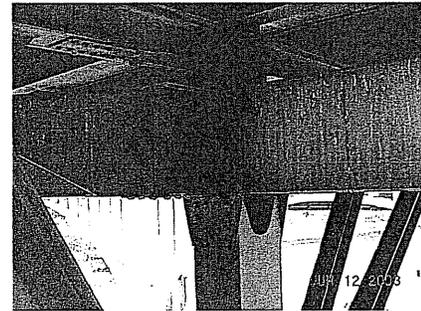
<u>PHOTO</u>	<u>LOCATION</u>	<u>DESCRIPTION</u>
9-11	U6 Connection Good condition	West face Looking southeast
9-12	U7	Connection good condition West face Looking northeast
9-13	Not Used	
9-14	U7 Connection	East face Looking southwest Good condition
9-15	U8 Connection	West face Looking northeast Good condition
9-16	U7 to U8 East truss inside box 14' + U7 near center	Looking south
9-17	U7 to U8 East truss inside box 14' ± U7 near center	Looking south
9-18	U7 to U8 East truss inside box 14' ± U7 near center	Looking north

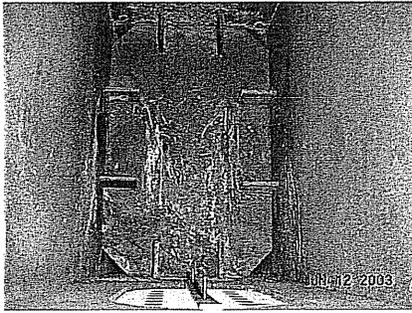
<u>PHOTO</u>	<u>LOCATION</u>	<u>DESCRIPTION</u>
9-19	U7 to U8 East truss inside box 14' ± U7 near center	Looking north
9-20	U7 to U8 East truss inside box 14' south U8	Looking south
9-21	U7 to U8 East truss inside box 14' south U8	Looking north
9-22	U8 connection	East face Looking northwest Some rust Drain connection
9-23	U8 East truss	East face Looking southwest
9-24	U8 East truss	West face Looking southeast
9-25	U10 East truss connection	Good condition West face Looking southeast
9-26	U10	East face Looking west U of M Sensors

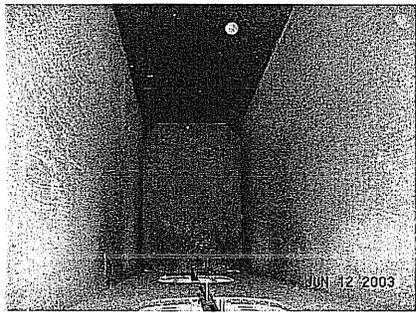
<u>PHOTO</u>	<u>LOCATION</u>	<u>DESCRIPTION</u>
9-27	U9 to U10 inside box 15' ± south U10	Looking south
9-28	U9 to U10 inside box 15' ± south U10	Looking north
9-29	U10	West face Looking northeast
9-30	U9 Connection	Good condition West face Looking southeast
9-31	U9	East face Looking southwest
9-32	U9	East face Looking northwest
10-1	East truss U8 to U9 Inside box	Looking south
10-2	East truss U8 to U9 Inside box	Looking south
10-3	East truss U8 to U9 Inside box	Looking north

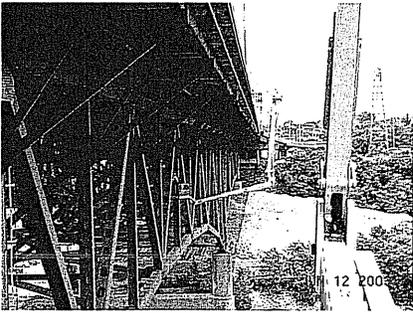
<u>PHOTO</u>	<u>LOCATION</u>	<u>DESCRIPTION</u>
10-4	U8	West face Looking southeast
10-5	U8	West fact Looking southwest Upper lateral bracing Flaking rust
10-6	Pier 6 Expansion bearing assembly	East face Looking west Flaking rust No apparent movement
10-7	Pier 6 Expansion bearing assembly	East face Looking west Flaking rust No apparent movement
10-8	Pier 6 Expansion bearing assembly	East face Looking northwest Connection flaking rust
10-9	Pier 6 Expansion bearing assembly	West face Looking northeast Flaking rust on vertical and lower bracing
10-10	Pier 6 Expansion bearing assembly	West side Looking southeast

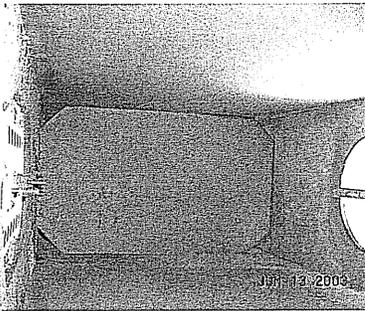
<u>PHOTO</u>	<u>LOCATION</u>	<u>DESCRIPTION</u>
11-8	L12 to L14 10' ± north L13 Inside box	Looking north
11-9	L13 Lower lateral bracing Connection	Flaking rust Deck drain above
11-10	L13 to L14 Inside box 12' ± south U14	Looking south Crack noted in 98
11-11	Not Used	Looking north
11-12	L14 connection Action Shot	
11-13	Not Used	
12-1	L14 East face Looking northwest	Good condition
12-2	L14 West face Looking southeast	
12-3	L14 West face Looking south

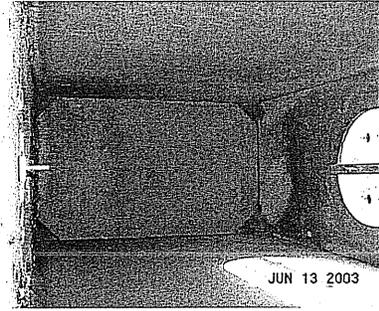
<u>PHOTO</u>	<u>LOCATION</u>	<u>DESCRIPTION</u>
12-4	L14 to L15 Inside box 4' south L15	Looking south
12-5	L14 to L15 Inside box 4' south L15	Looking north
12-6	L15 connection	East face Looking west Good condition
12-7	L15 connection	West face Looking east
