# NATIONAL TRANSPORTATION SAFETY BOARD

MATERIALS LABORATORY STUDY

Report No. 08-118

Place : Minneapolis, Minnesota  
Date : August 1, 2007  
Vehicle : I-35W Bridge  
NTSB No. : HWY07MH024  
Investigator : Mark Bagnard

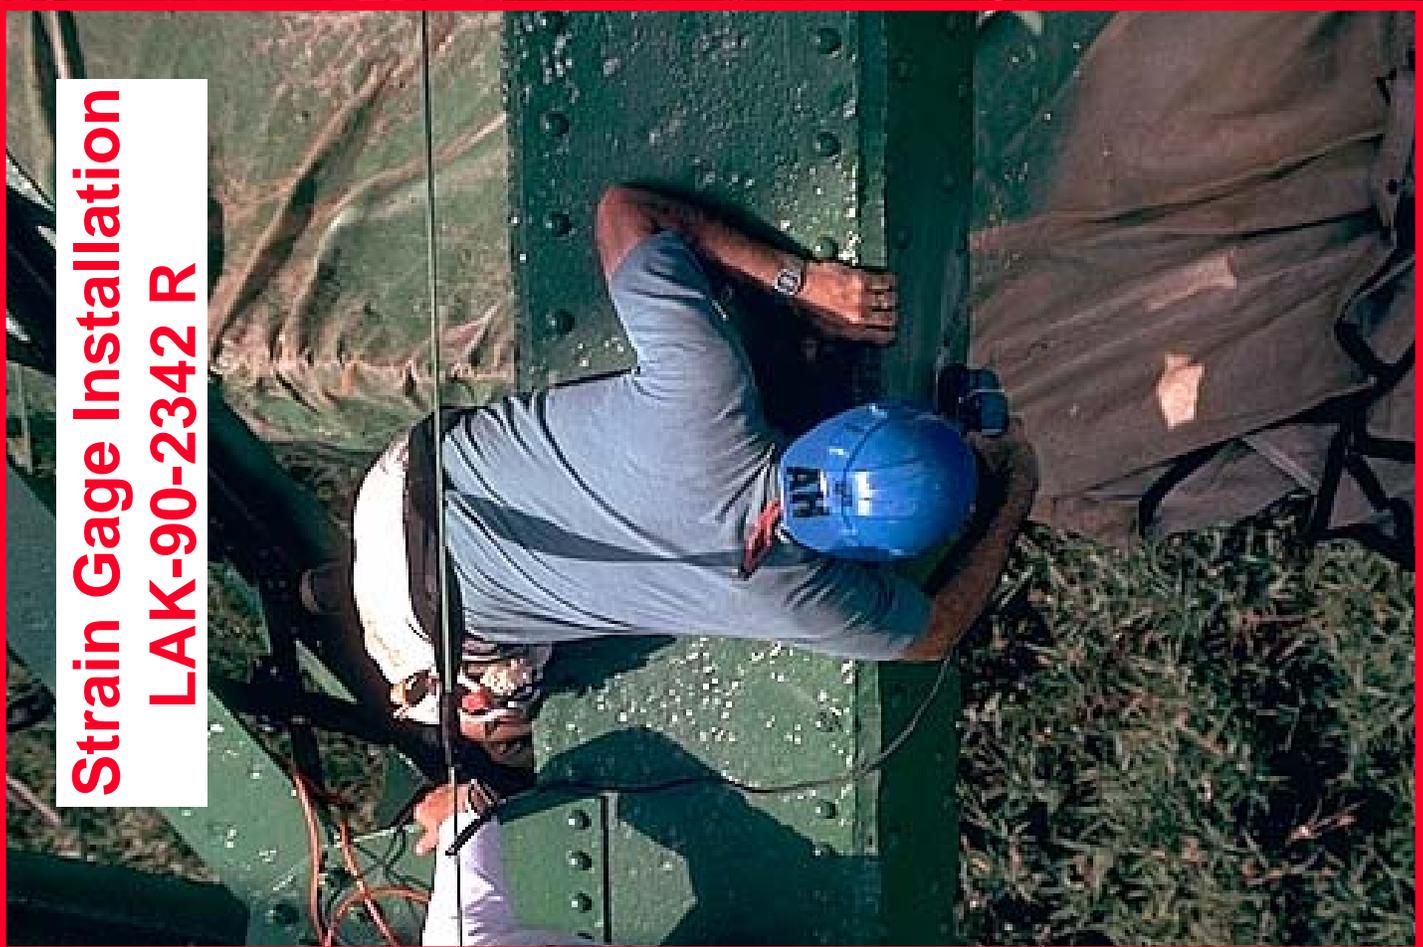
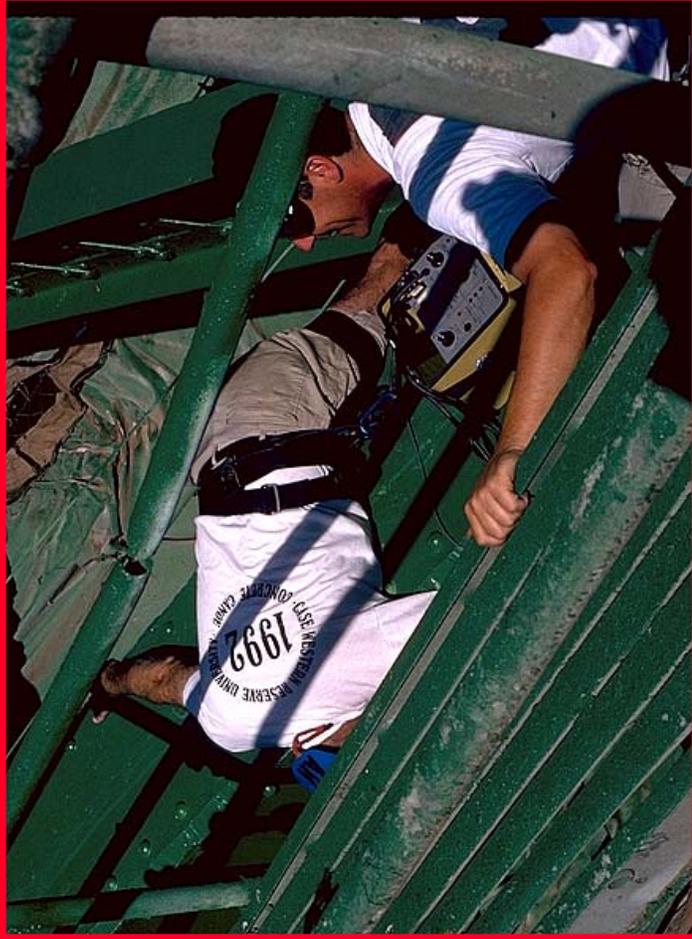
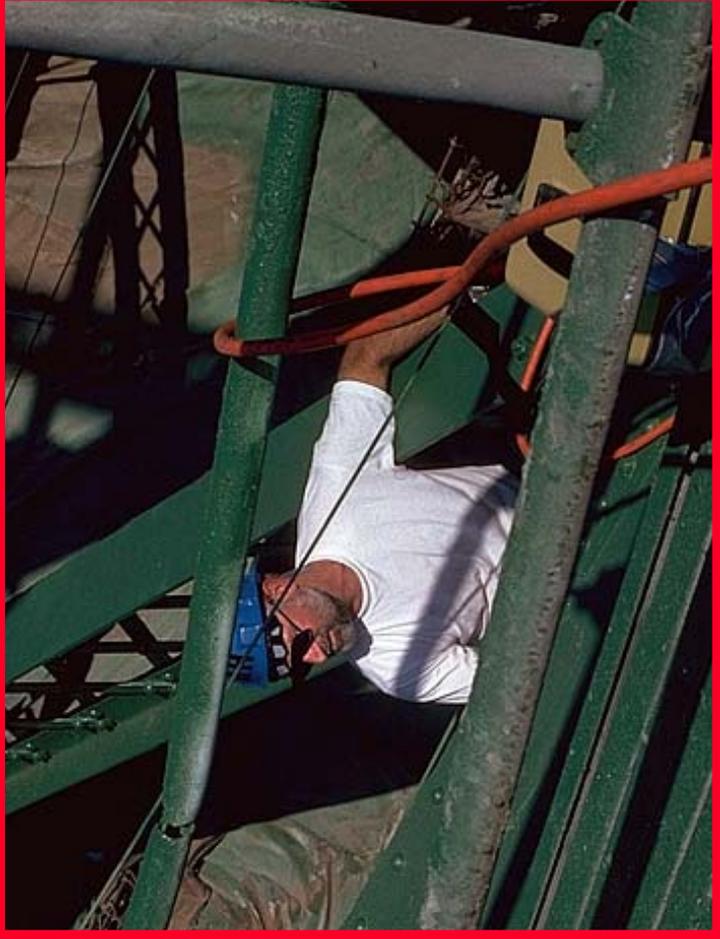
**Strain Gage Installation  
LAK-90-2342 R**

As part of the repair/retrofit process, all 5 main structural members connecting to joint L8', in both the north and south trusses, were instrumented with strain gages. Each member had 4 strain gages, positioned near each of its corners, at a section near the midspan of the member. In addition to these 40 strain gages on the main members, each of 8 post-tensioned rods, anchored at joint U7' and running down to joint L8' (in order to provide supplemental support in each of the trusses) were also instrumented with strain gages prior to the tensioning operations.

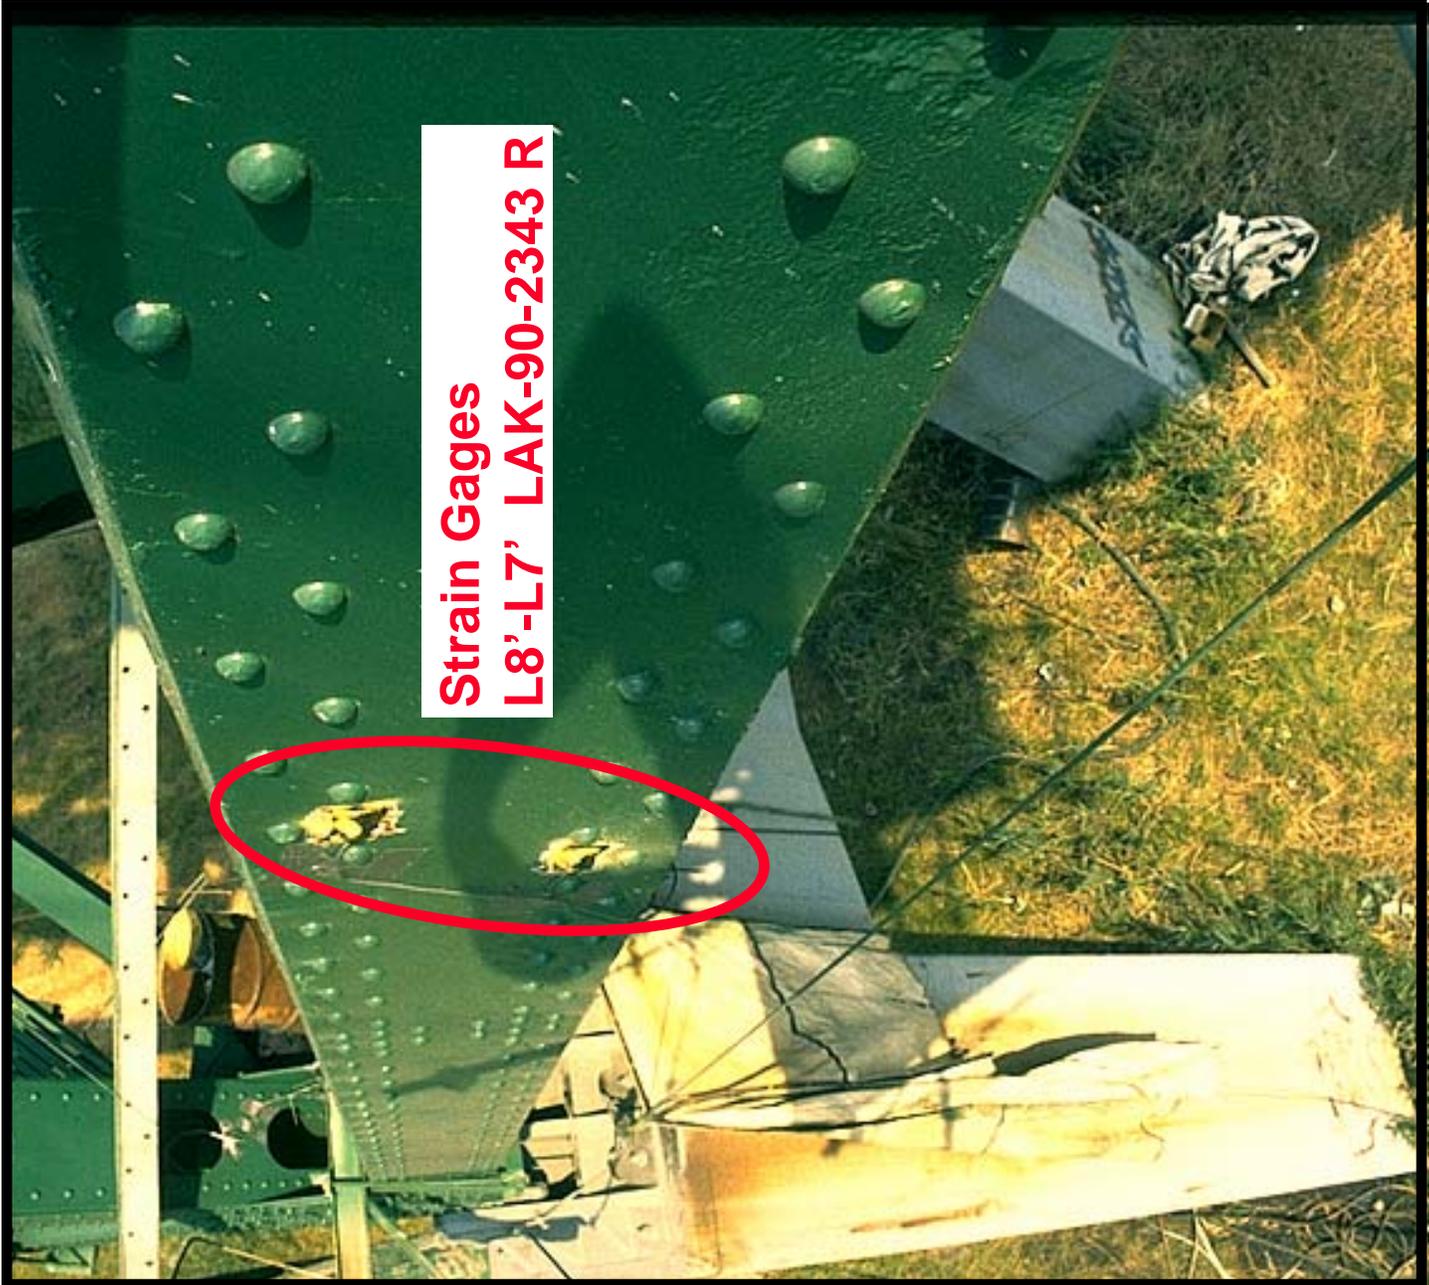
**Instrumentation Locations South Truss  
LAK-90-2342 R**

**Strain gages  
Member L8'-U7'**

**South Temperature  
Sensor**

**Strain gages  
Member L8'-U8'**

**Strain gages  
Member L8'-U9'**

**Failed Joint L8'**

**Strain gages  
Member L8'-L7'**

**Strain gages  
Member L8'-L9'**

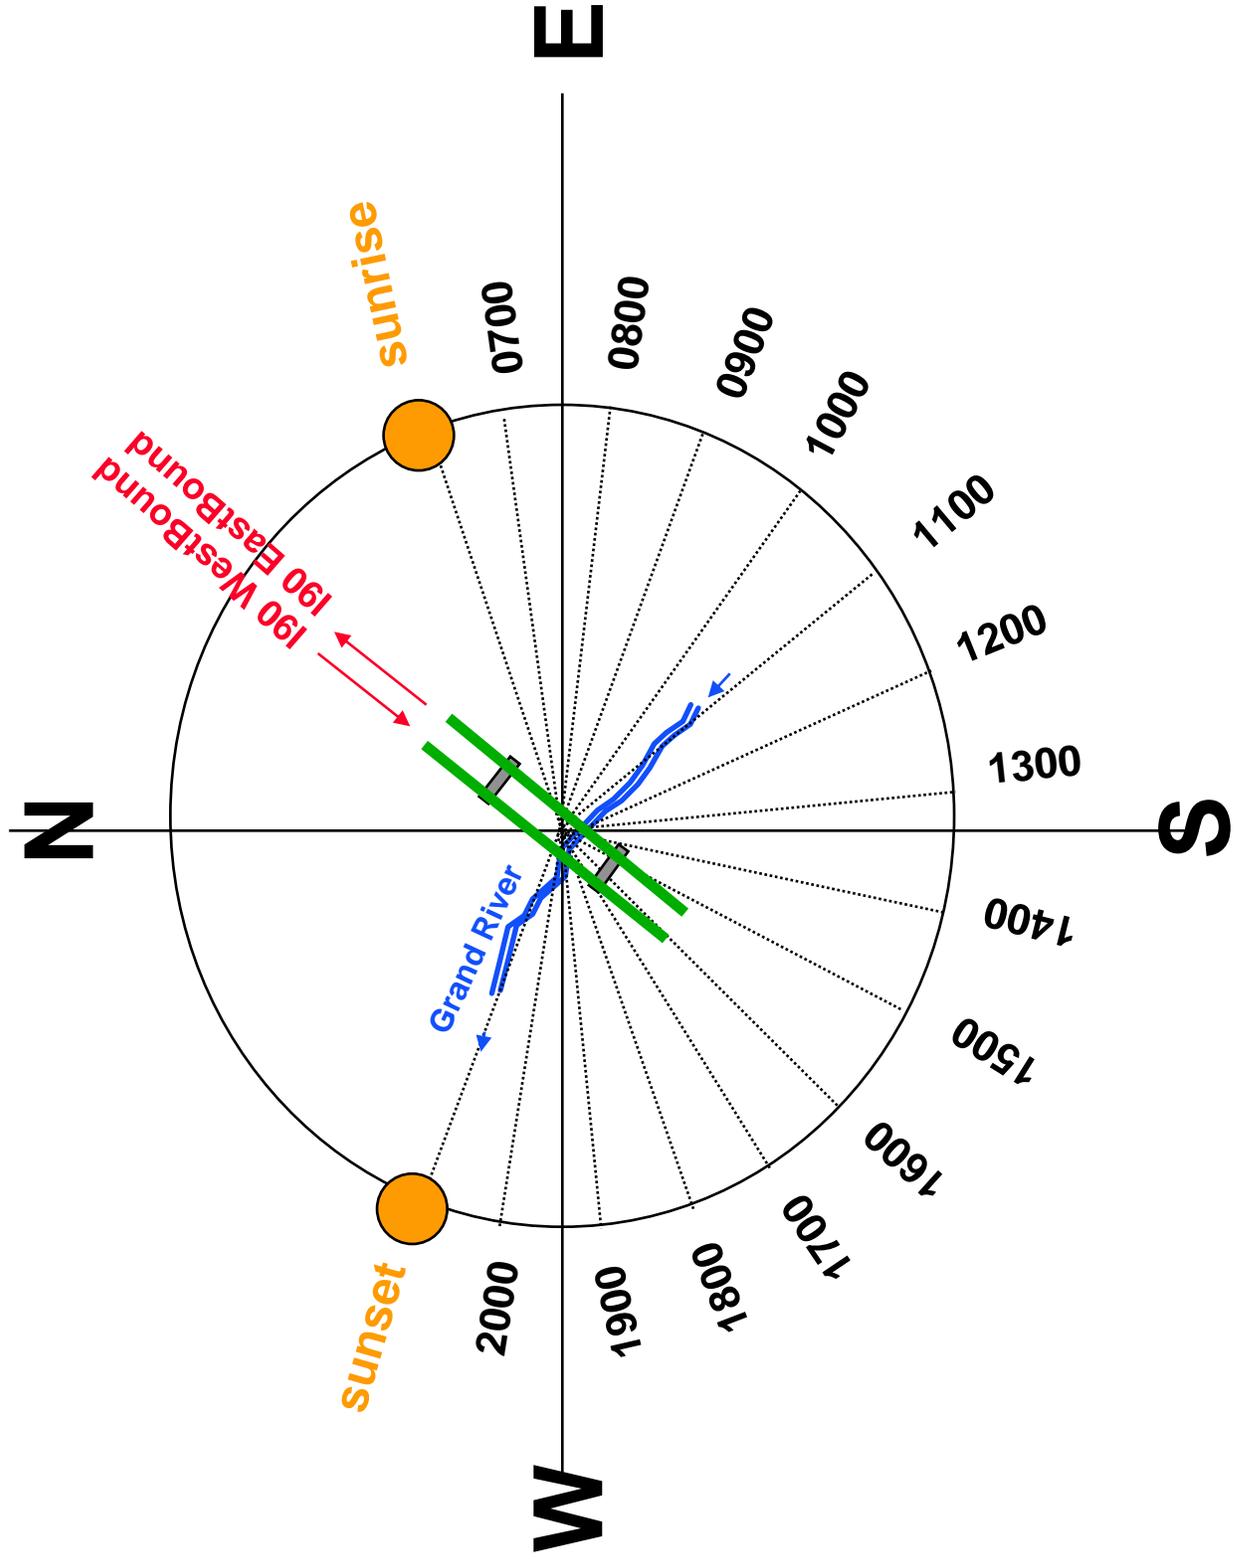
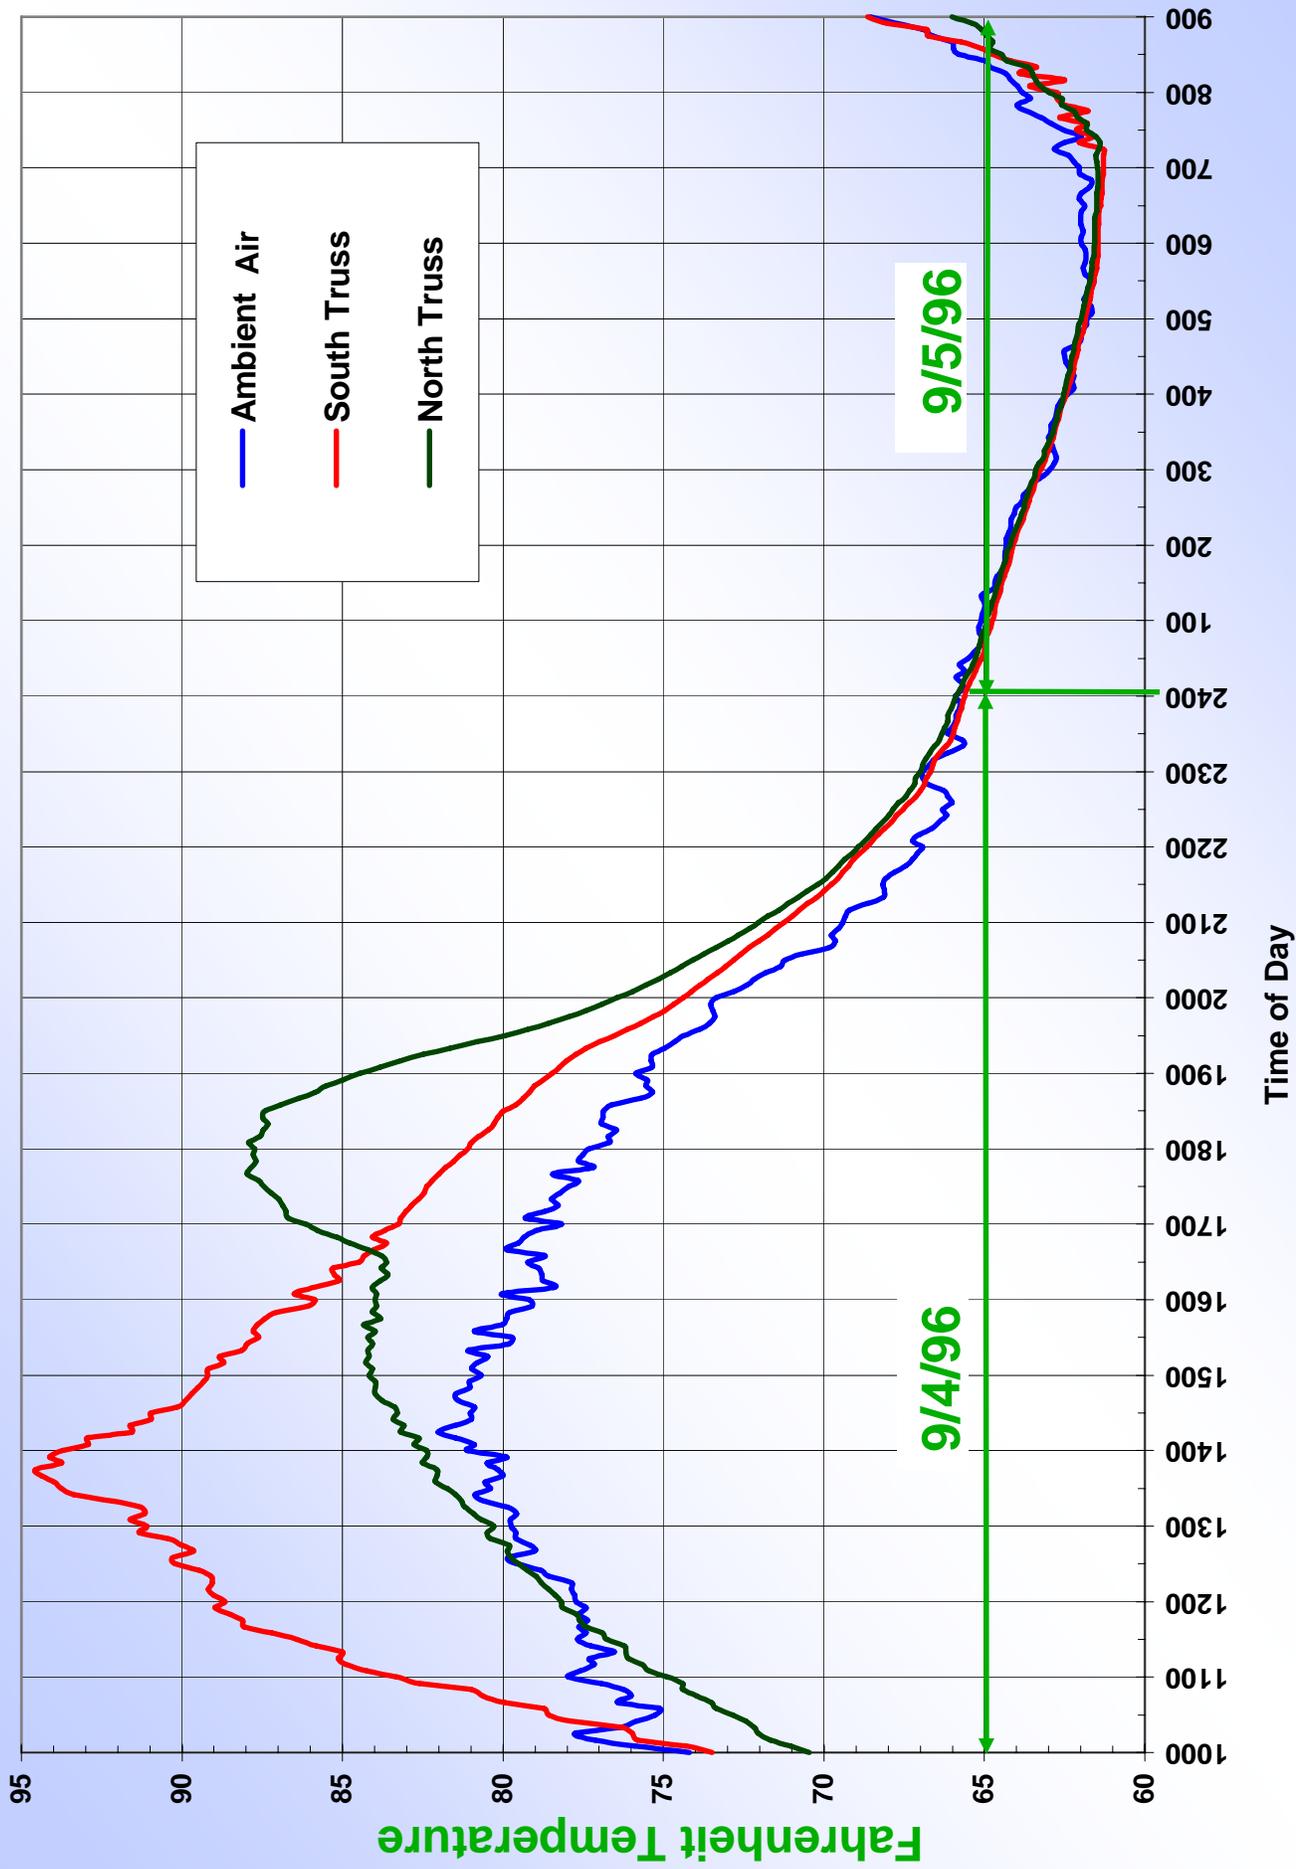
Typical Daily Temperature Fluctuations Measured on LAK-90-23242 R

Three temperature sensors were also installed. One sensor was located on the deck to monitor ambient air temperatures. One sensor was placed against an exposed face of the south truss and covered by insulation, in order to monitor steel temperatures on the south truss. A third sensor was similarly located and covered on the north truss.

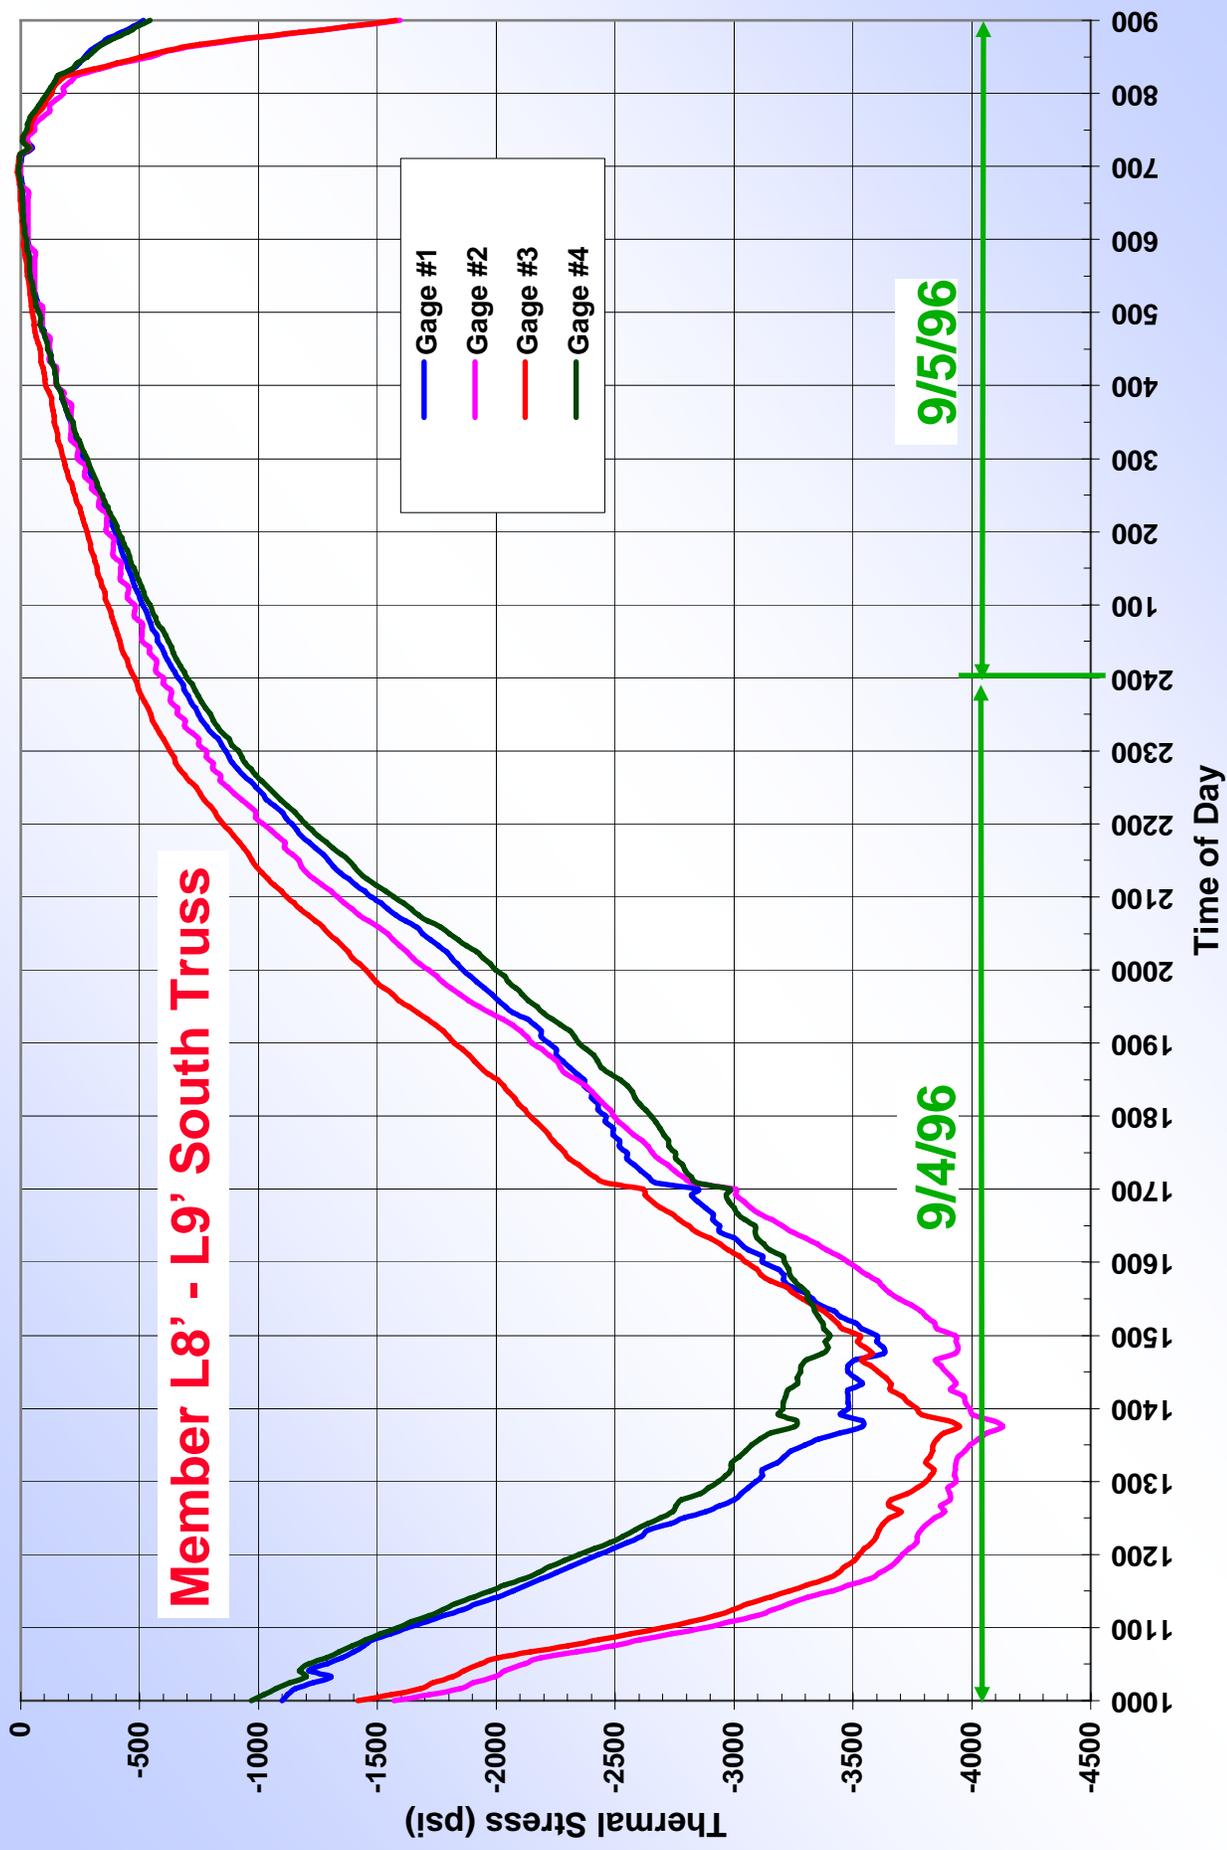
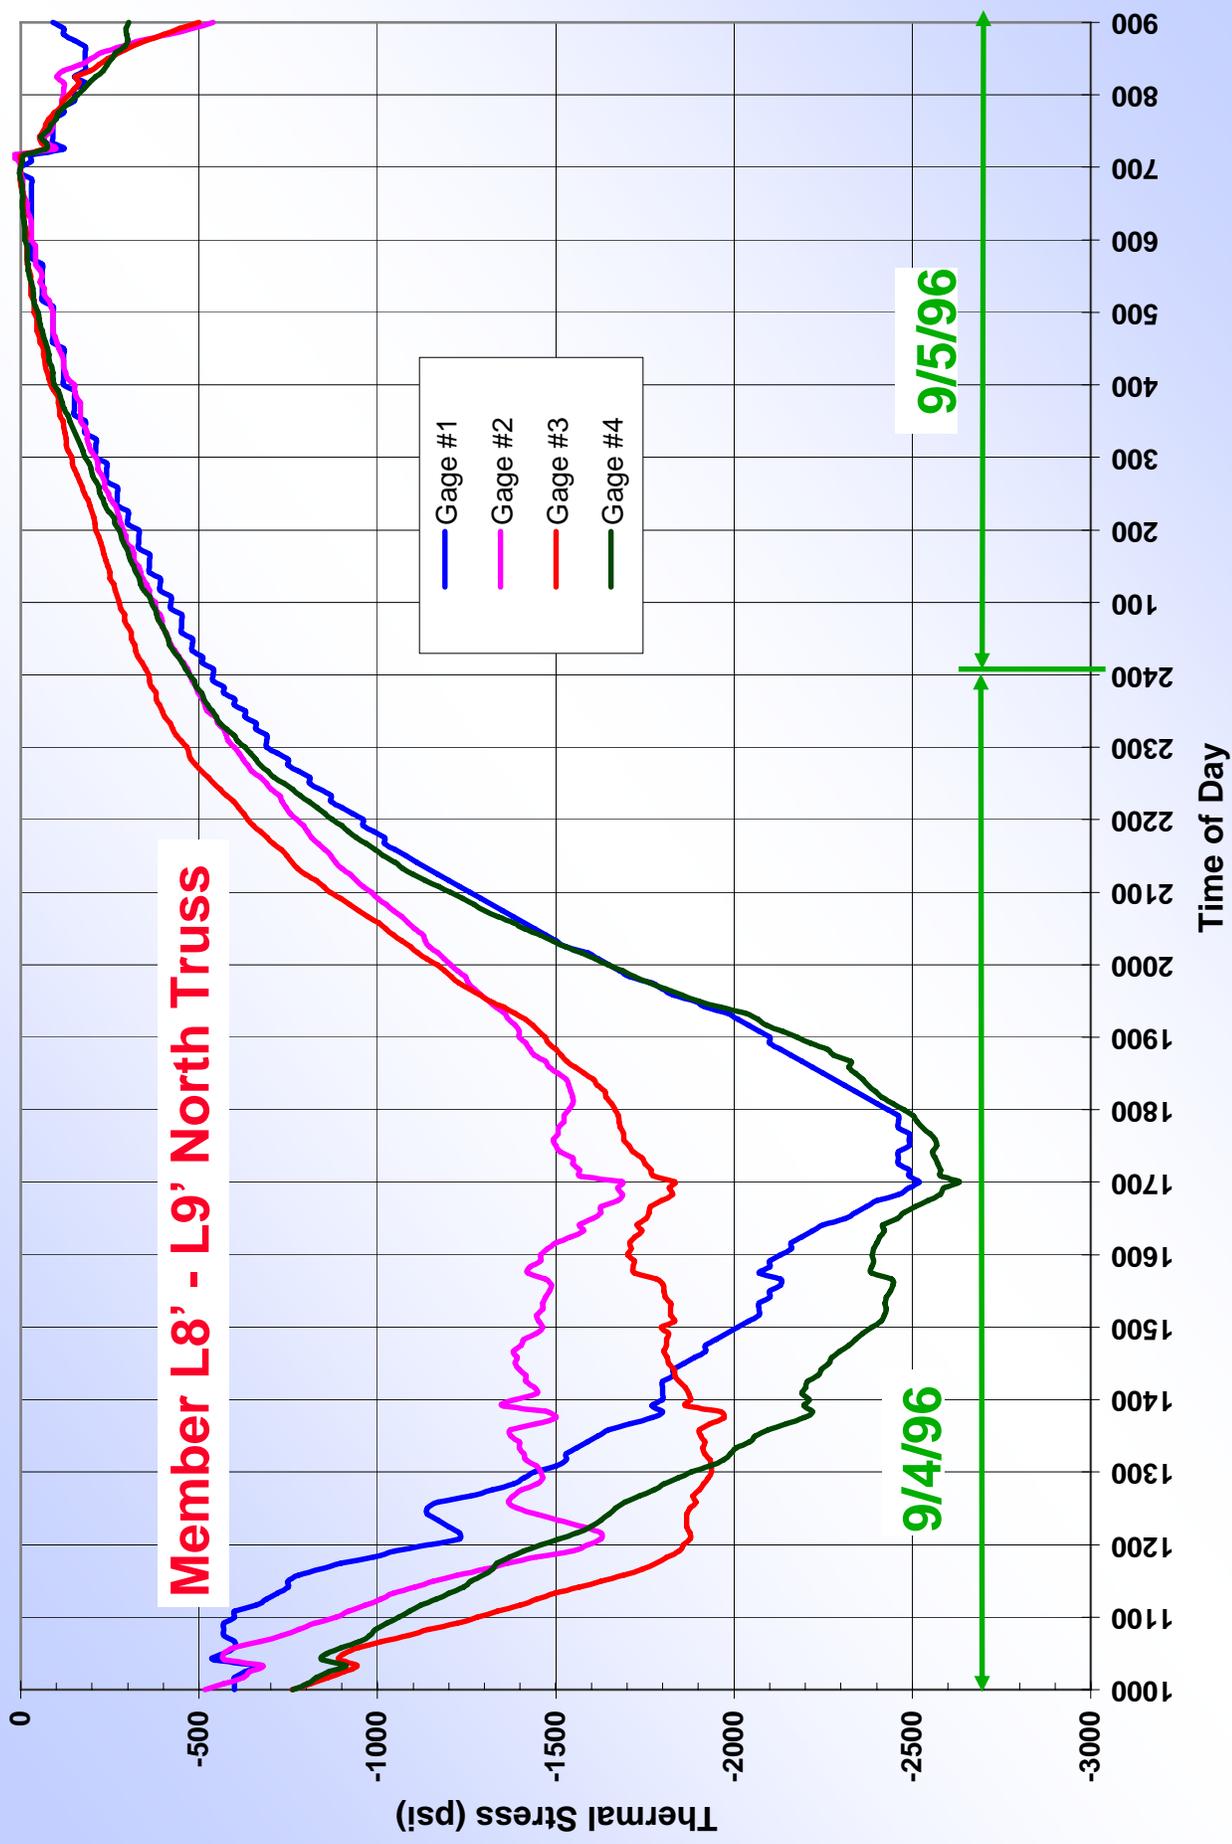
**Typical Daily Thermal Stress Fluctuations Measured on LAK-90-23242 R**

All instrument readings were continually recorded at five minute intervals for the duration of the repair activity. Background thermal stress data, recorded prior to actual repair operations, served as a database to "correct for temperature" during subsequent repair and jacking operations. Daily 5 AM readings (when thermal gradients throughout the structure were minimized) provided a "running record" of the state of the structure, and of the impact of the various repair operations upon the stress distribution in the structure.

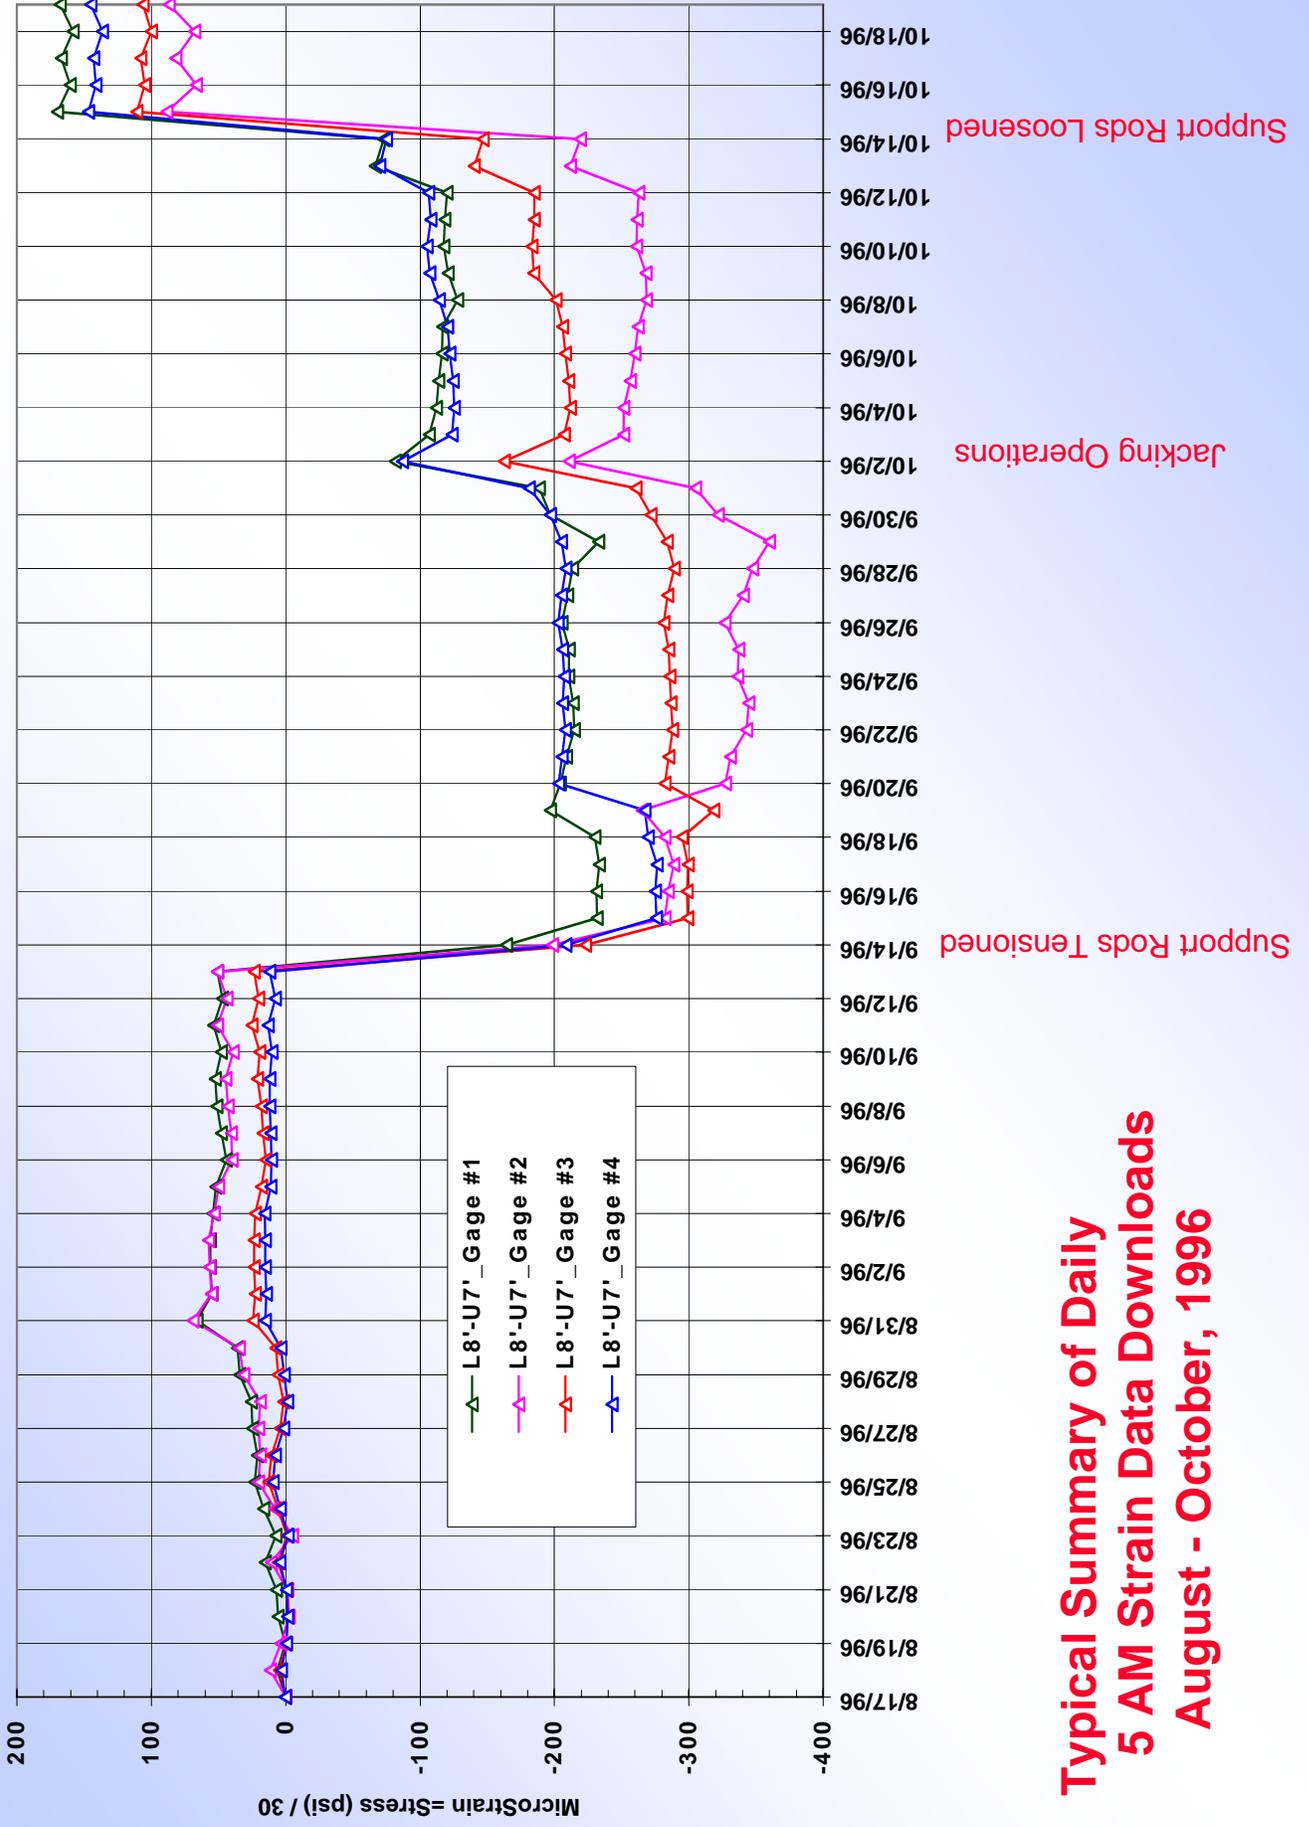
Temp Corrected 5 AM Readings  
Member L8'-U7' North Truss

Typical Summary of Daily  
5 AM Strain Data Downloads  
August - October, 1996

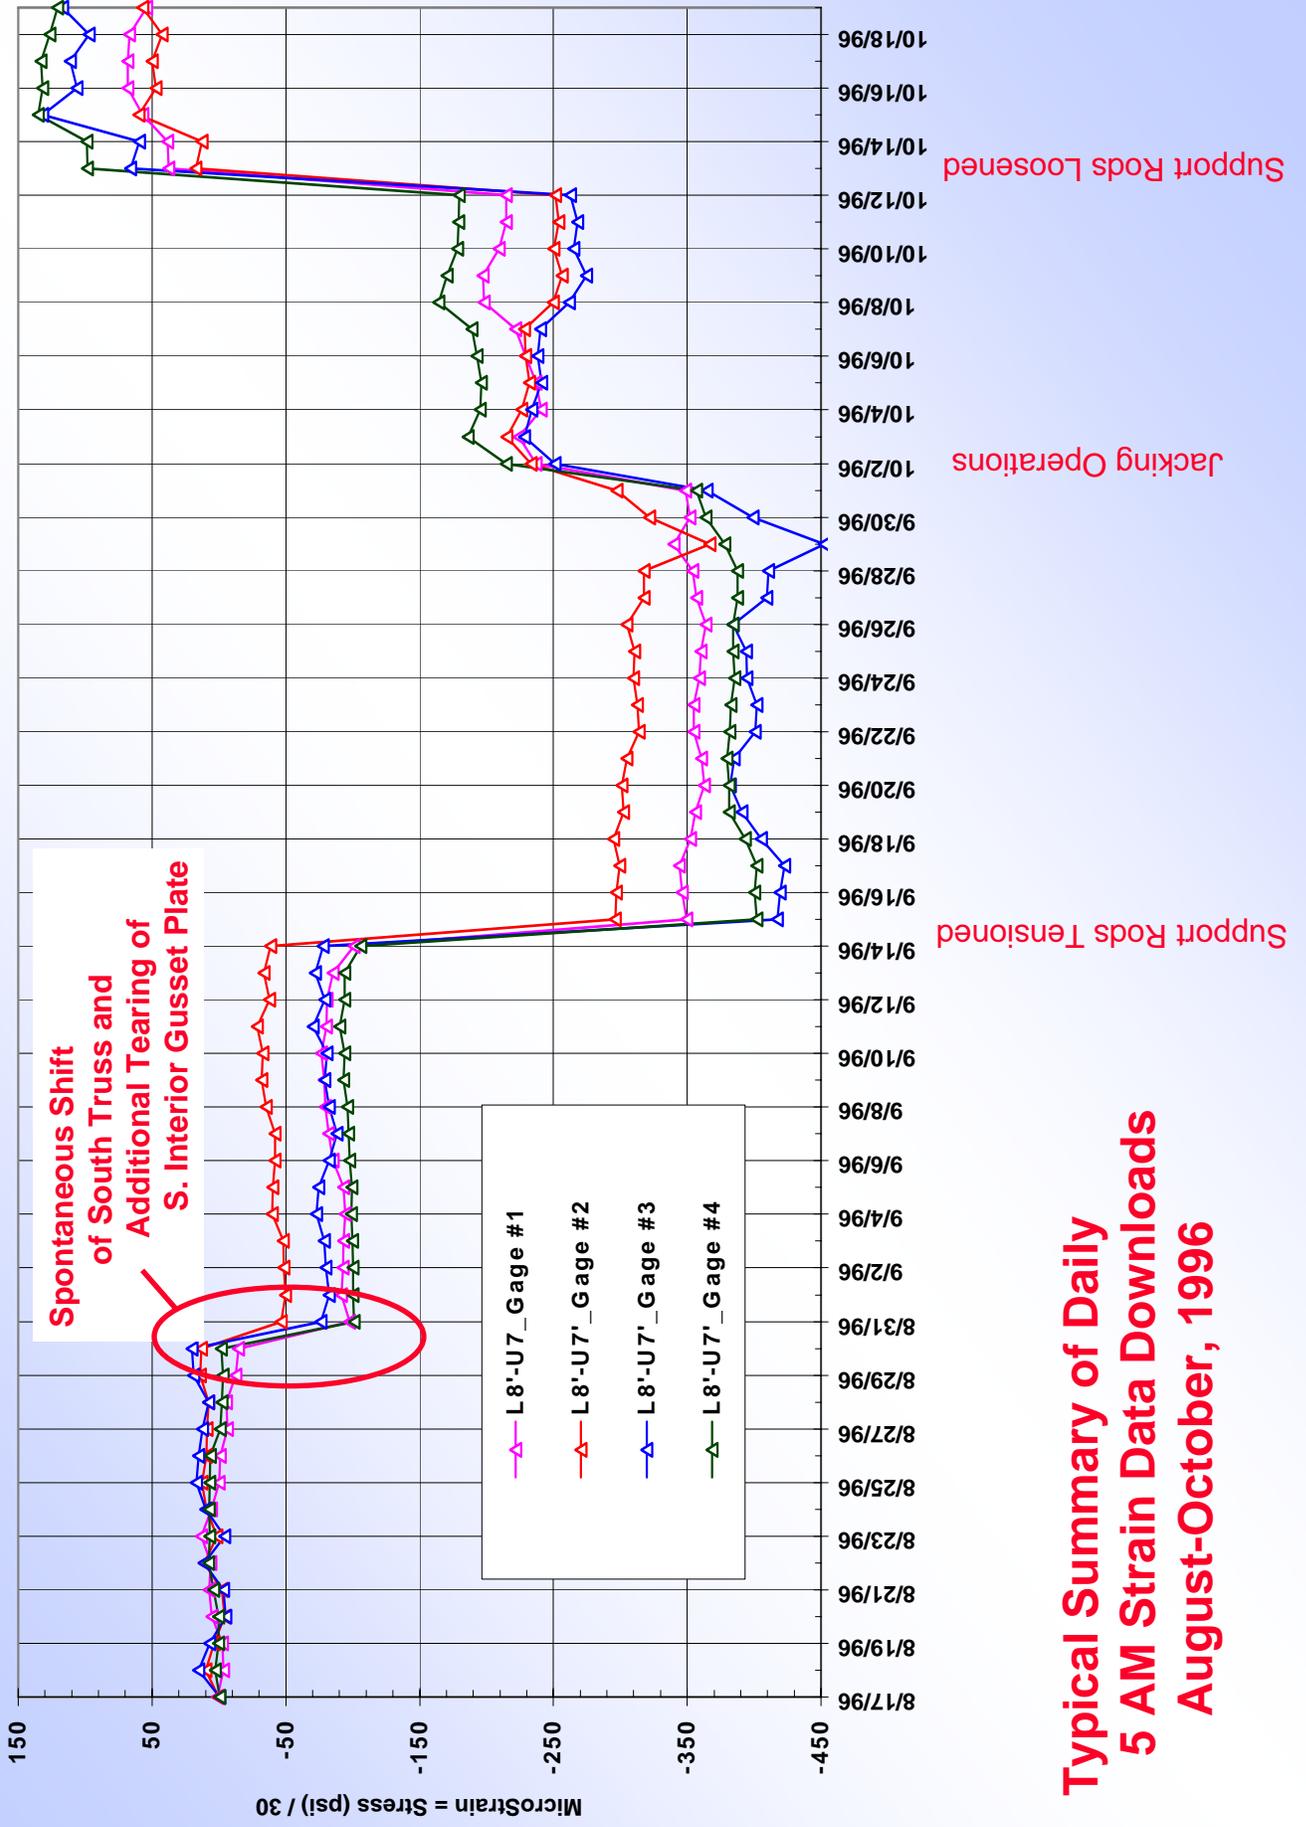
Temp Corrected 5AM Readings  
Member L8'-U7' South Truss

Typical Summary of Daily  
5 AM Strain Data Downloads  
August-October, 1996

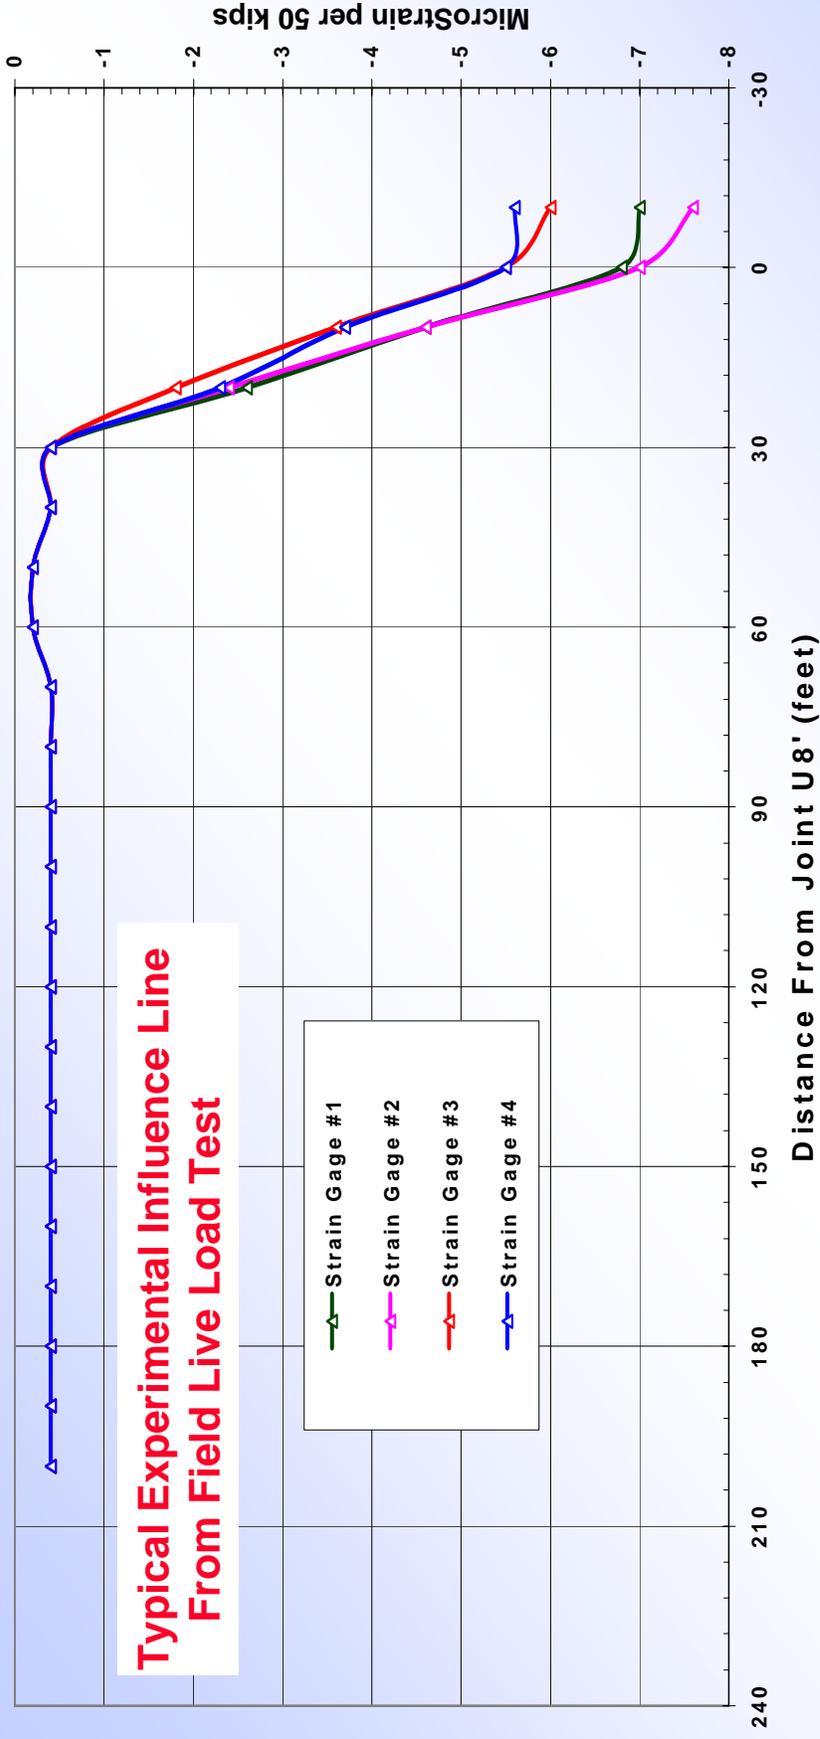
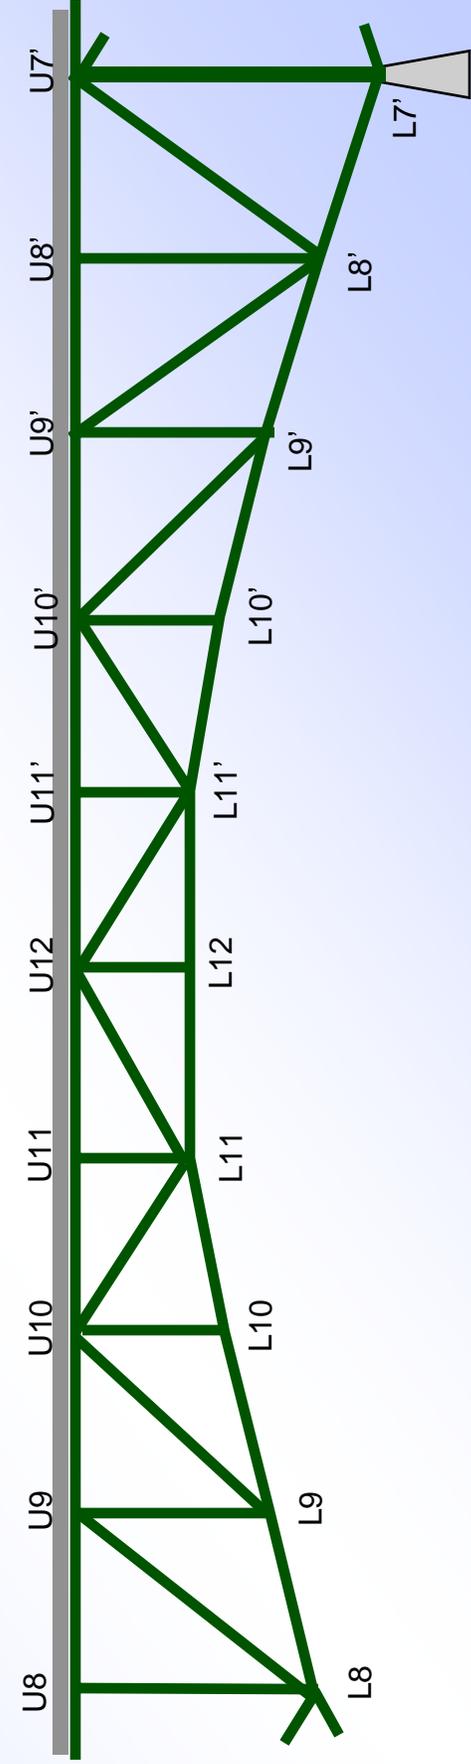
# North Lane Influence Lines For Member L8'-U8' \_S

Prior to reopening of the structure, a "live load" test of the structure was carried out, utilizing an ODOT dump truck loaded to just over 50,000 lbs. "Influence lines" for each of the instrumented main members in the repaired section were obtained for each traffic lane of the bridge.
