# NATIONAL TRANSPORTATION SAFETY BOARD

MATERIALS LABORATORY STUDY

Report No. 08-118

Place : Minneapolis, Minnesota  
Date : August 1, 2007  
Vehicle : I-35W Bridge  
NTSB No. : HWY07MH024  
Investigator : Mark Bagnard

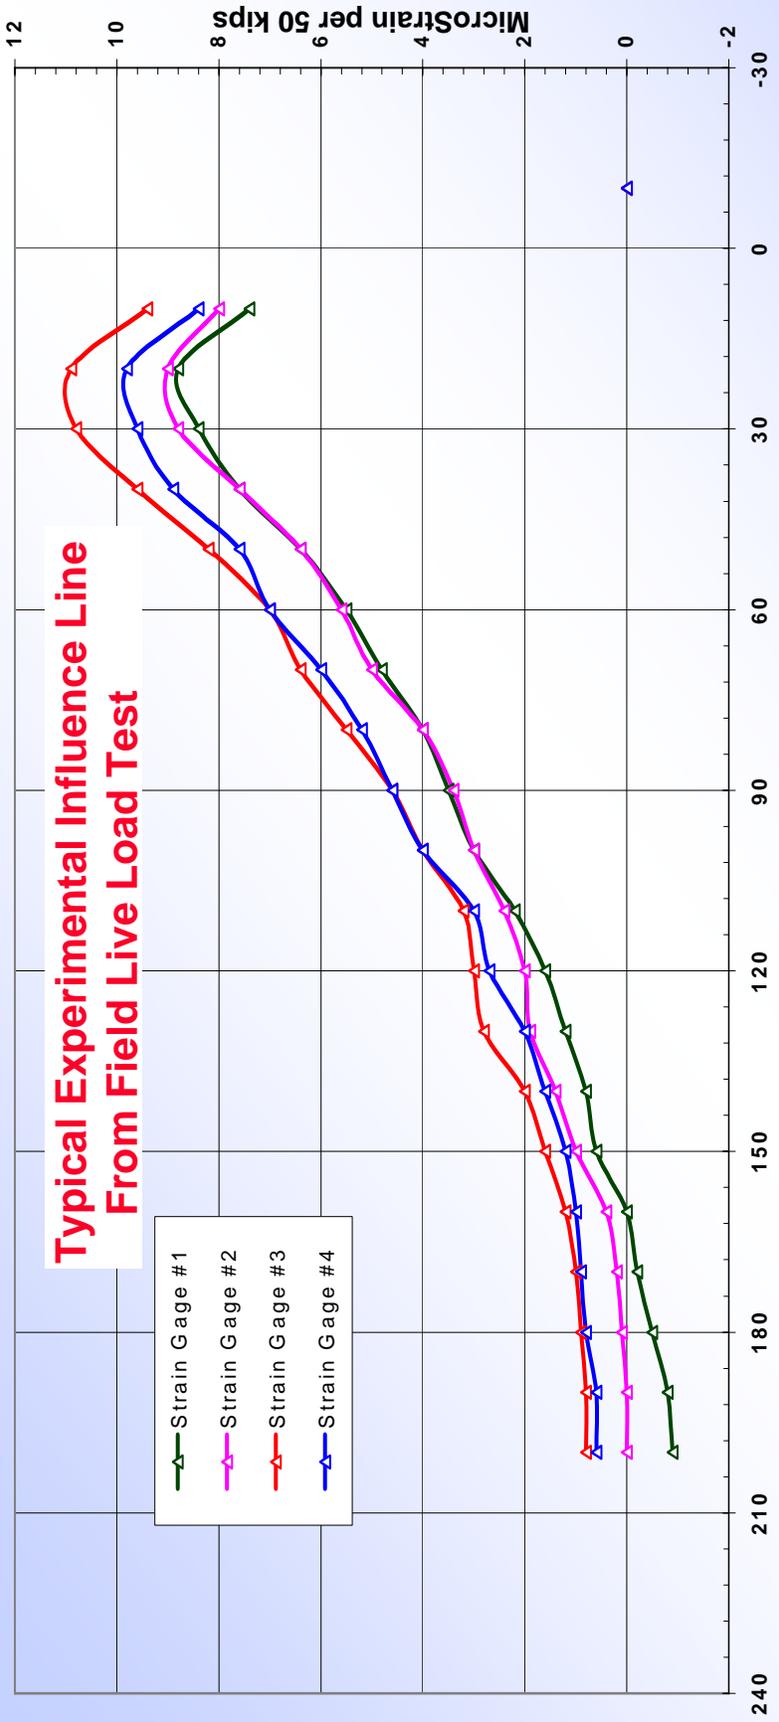
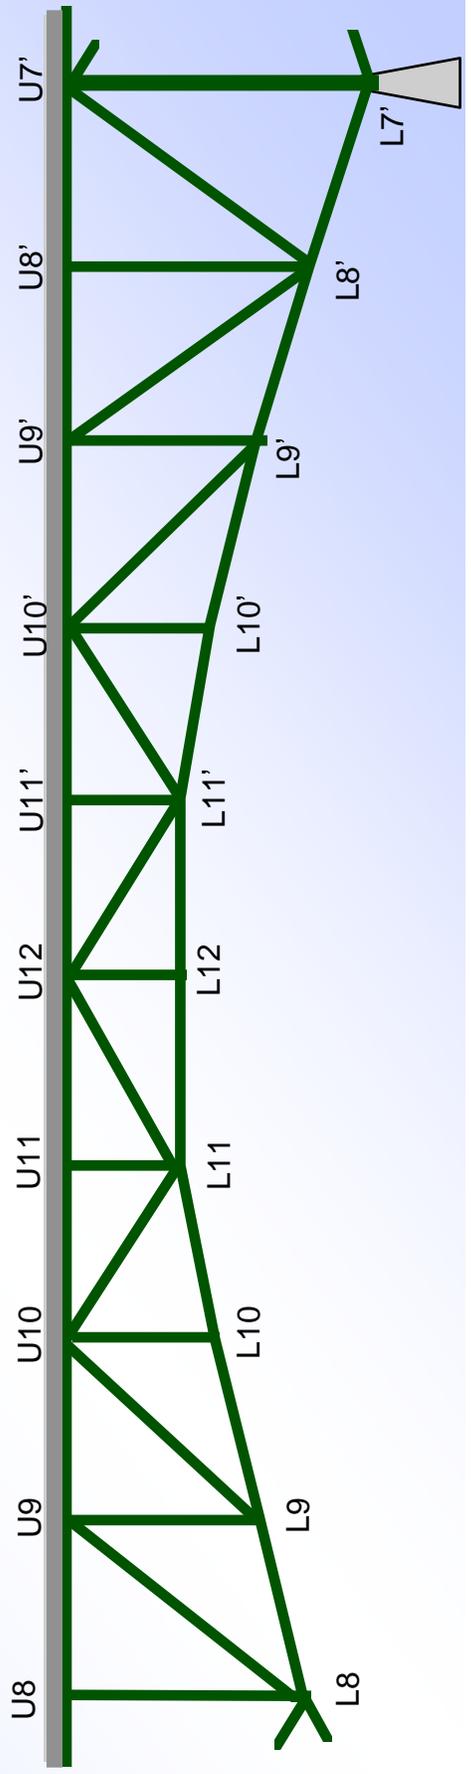
# North Lane Influence Lines For Member L8'-U7' \_S

Prior to reopening of the structure, a "live load" test of the structure was carried out, utilizing an ODOT dump truck loaded to just over 50,000 lbs. "Influence lines" for each of the instrumented main members in the repaired section were obtained for each traffic lane of the bridge.
