NATIONAL TRANSPORTATION SAFETY BOARD
Office of Research and Engineering
Washington, D.C. 20594

Vehicle Performance Factual

NTSB Number:	DCA04MM015
Description:	Capsizing of small passenger ferry
Location:	Northwest Harbor, Baltimore, Maryland
Date:	March 6, 2004
Time:	~1600 EST
Vessel:	M/V Lady D, fully enclosed pontoon boat
Operator:	Seaport Taxi (Living Classrooms Foundation)

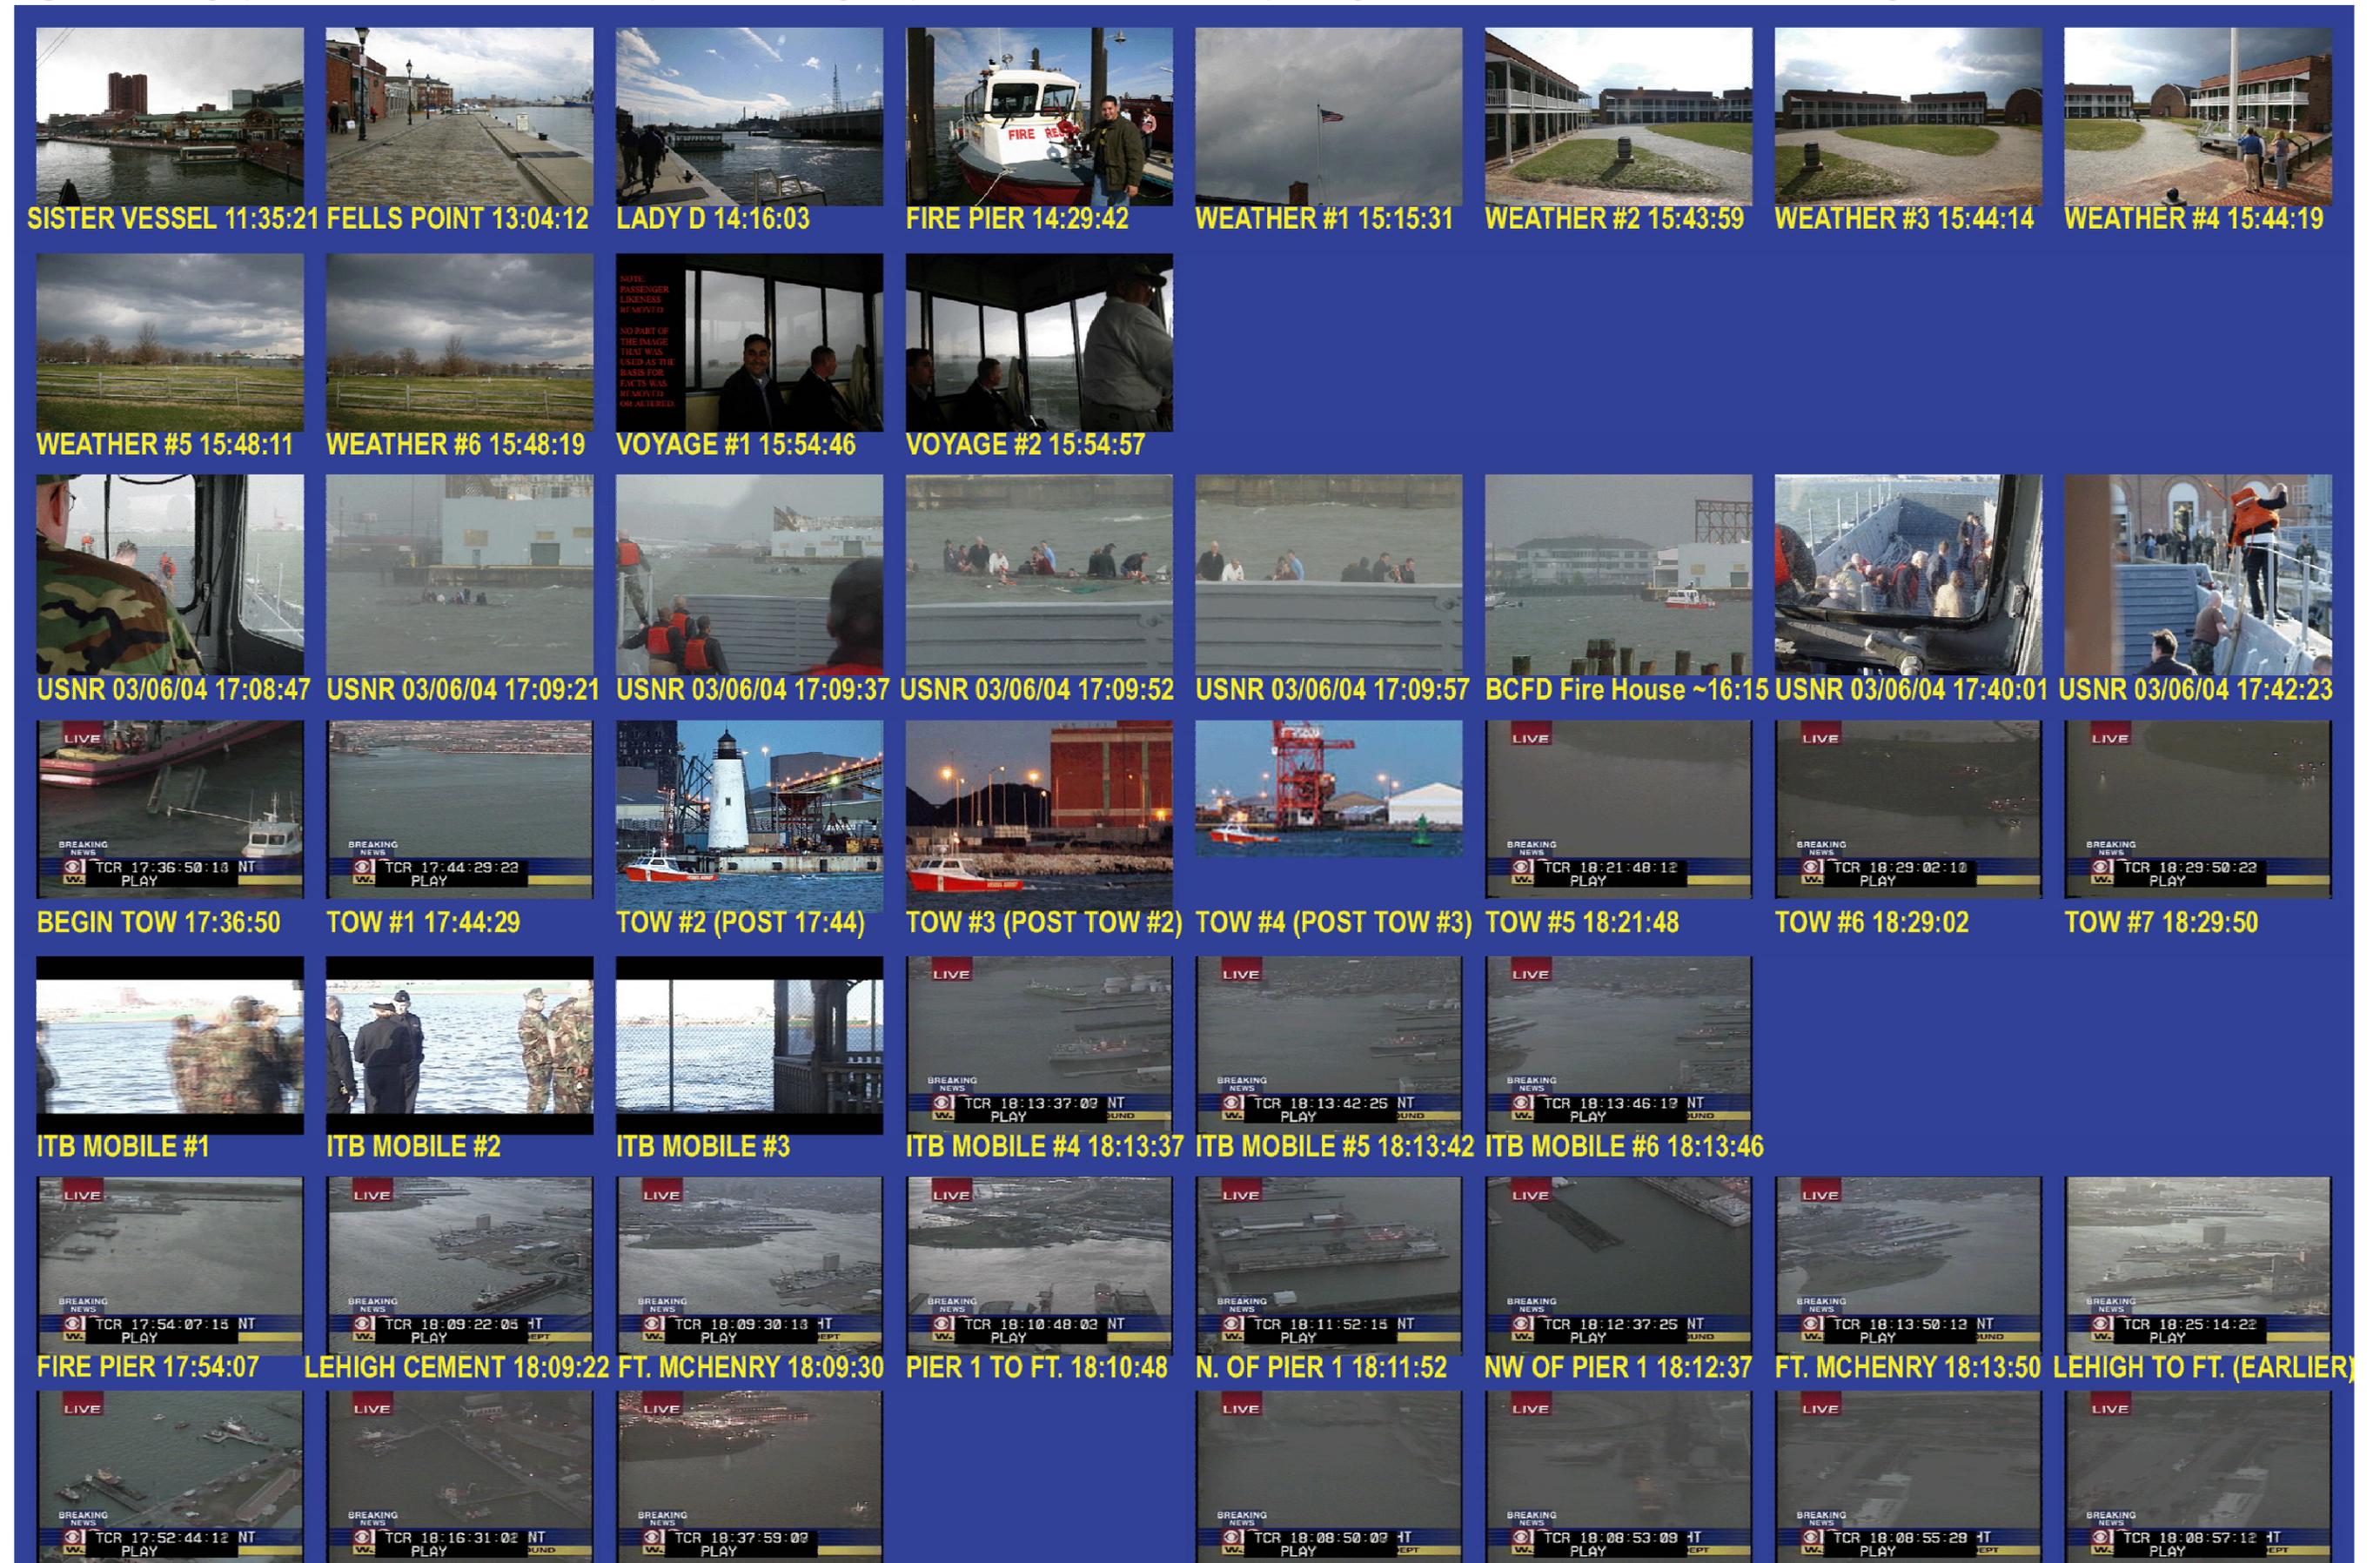
Figure 1: Photographic evidence, ordered in time, sequenced left to right, top to bottom. The likeness of a passenger was removed in the second row, third image.
